FLOOD DYNAMICS IN THE BERTIE WATER CRESCENT

INTEGRATING THE DYNAMICS OF COMPLEX DRAINAGE
SYSTEMS TO MINIMIZE STORM IMPACTS AND MAXIMIZE
AQUATIC ENVIRONMENT VIABILITY, BERTIE COUNTY, NC

NORTH CAROLINA LAND OF WATER (NC LOW)

August 20, 2019

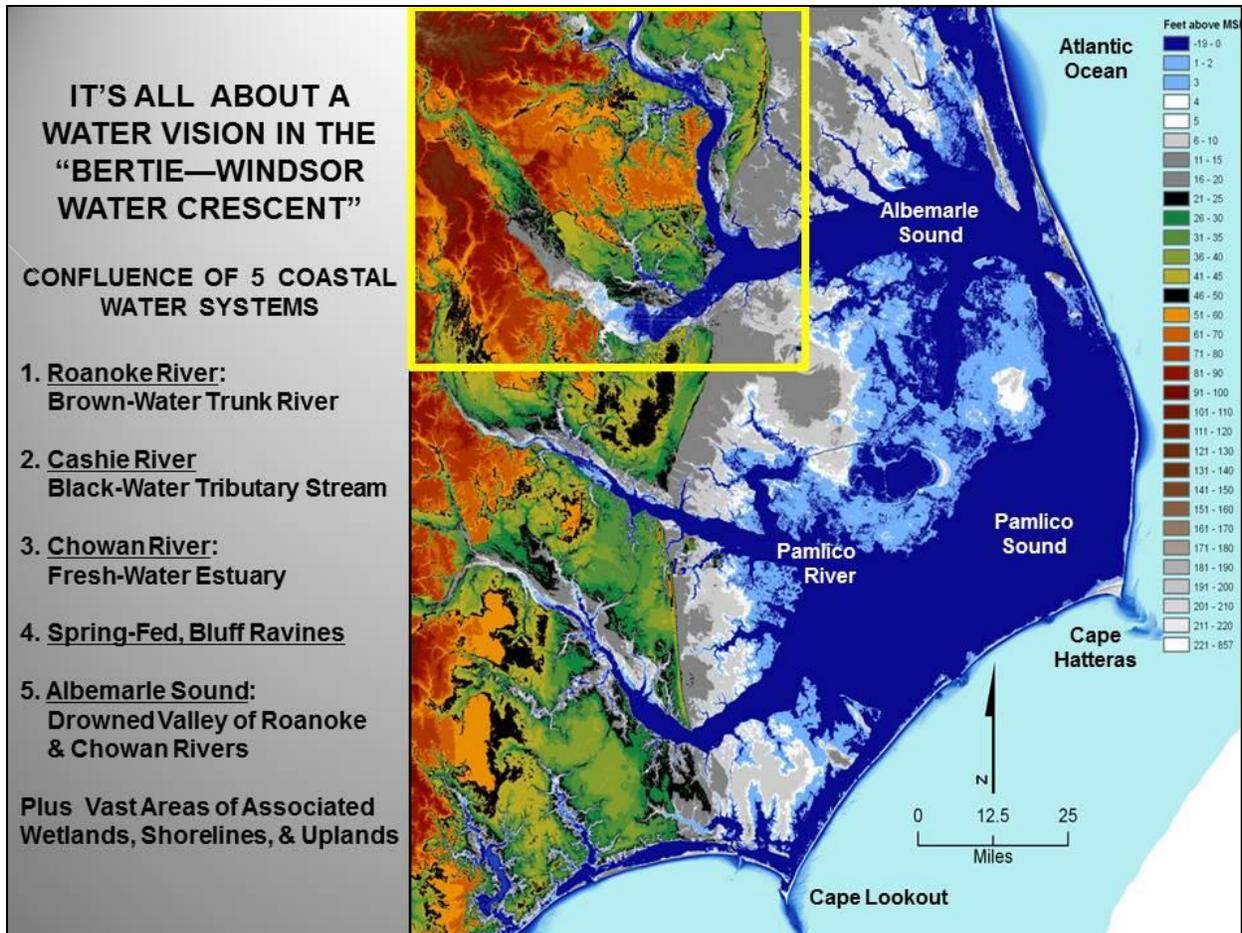
FIGURE 1-2. A color topography map shows the northeastern North Carolina Coastal Plain, the Bertie-Windsor study area (yellow box). The Ravines listed as item 4 and not visible at the scale of this map. Topographic data are from the NC 2015 LiDAR program. Map prepared by D. Ames.

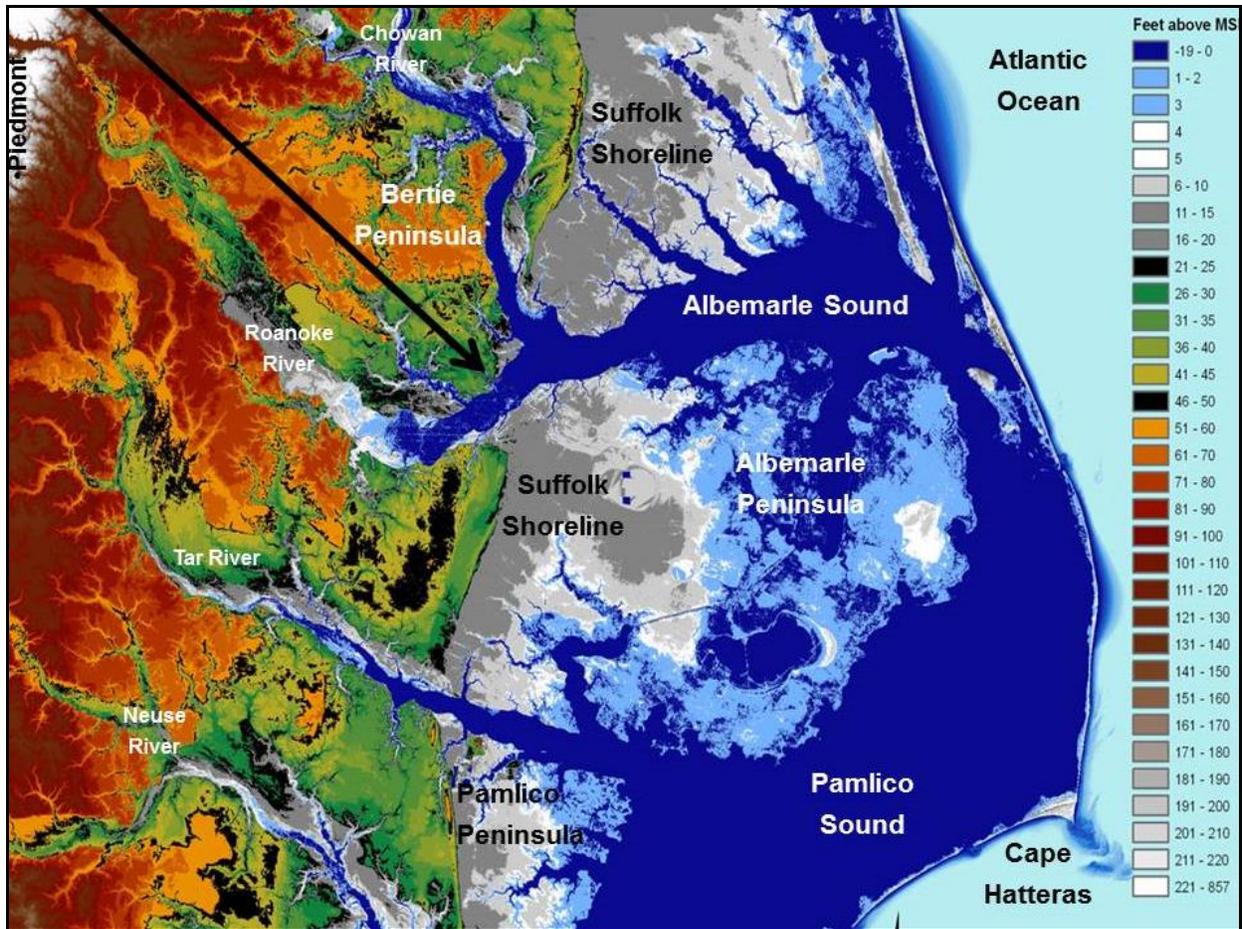
FIGURE 1-3. A color topography map shows the northeastern North Carolina Coastal Plain, the Bertie Peninsula, and the associated water bodies. The black arrow generally indicates the highest crest or inter-stream divide of the Peninsula. Topographic data are from the NC 2015 LiDAR program. Map prepared by D. Ames.

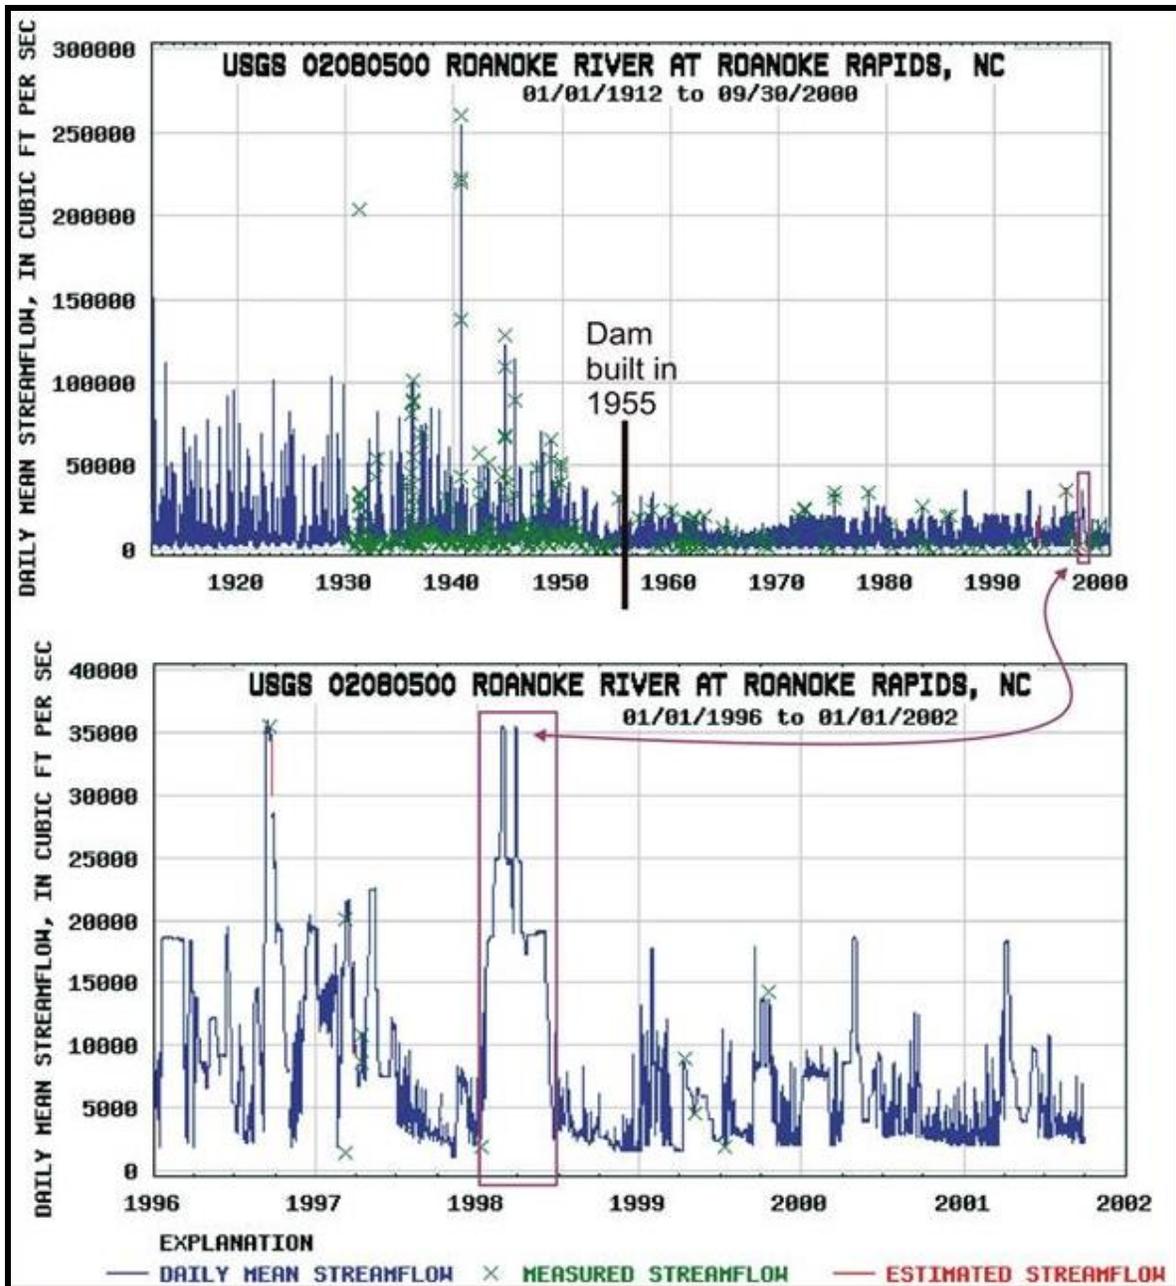
FIGURE 2-4. USGS hydrograph shows the daily mean stream flow for the Roanoke River at Roanoke Rapids below the dam. The upper record shows the natural river flow from 1912 to 1955 and after construction of the dam from 1955 to 2000. The lower panel shows an expanded section of the hydrograph from 1996 to 2002 and includes numerous small storm events when the rates and duration of discharge were substantially increased. The two periods of 35,000 feet³/second discharge resulted primarily from hurricanes Bertha and Fran in 1996 and hurricane Bonnie in 1998. Data are from the U.S. Geological Survey (<http://nwis.waterdata.usgs.gov/nc/nwis/sw>).

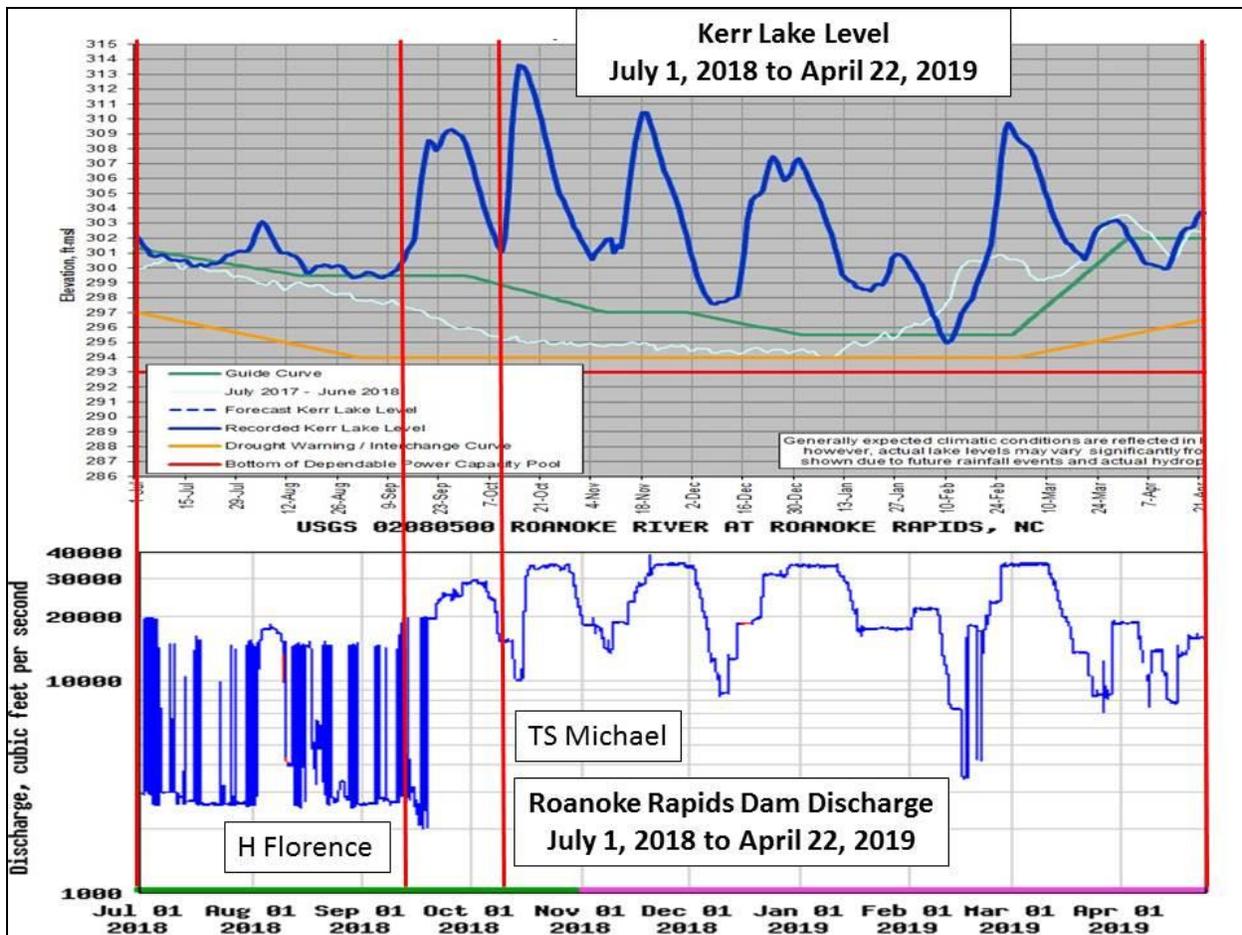
FIGURE 2-5. This plot shows the USGS water level records for the Kerr Reservoir water elevation in feet above sea level vs the water discharge rate in cubic feet per second at the Roanoke Rapids gage for the period from July 1, 2018 to April 15, 2019. The high rate of discharge has generally continued through June, 2019.

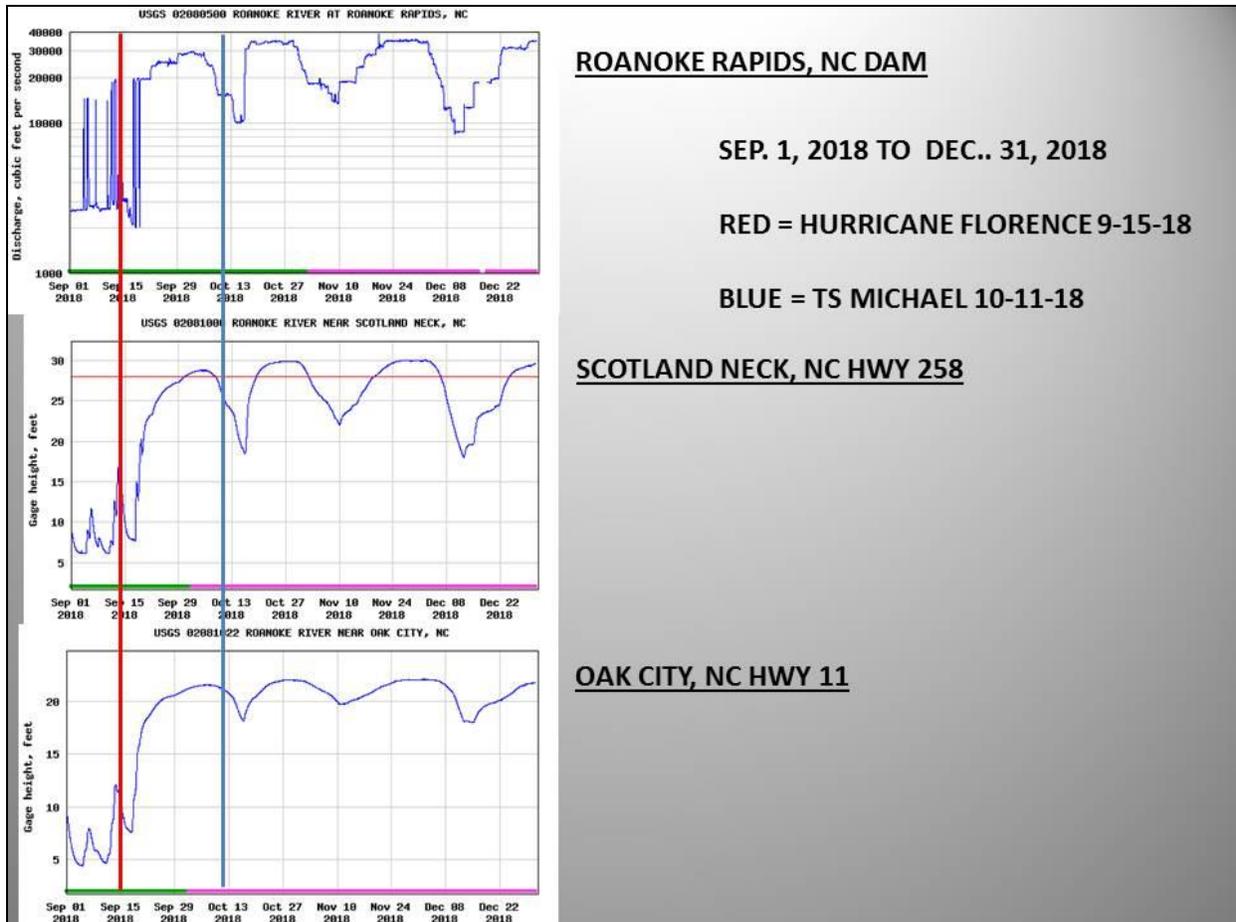
FIGURE 2-9. Plot compares the USGS gage patterns for the Roanoke River from the dam discharge rate in feet³ per second (top panel) with the water level gage height in feet at the Scotland Neck (middle panel) and the Oak City (bottom panel) for the period of September 1, 2018 to December 31, 2018. Since it is the downstream pattern of flow that is important, none of these plots are corrected for absolute elevation and each plot has a different vertical scale (stage height).

The dam discharge history for the USGS Roanoke Rapids water level gage from Jan. 1, 2017 through May 8, 2019 is presented in Figure 2-19. Two major sets of storm water discharge occurred during the spring months of April through June of 2017 and 2018. Both discharge periods had some flooding impact on downstream riverine sections when the discharge exceeded 20,000 cfs. However, a really severe period of downstream flooding occurred when the dam discharge put the entire Roanoke River (Roanoke Rapids to Jamesville) in continuous flood conditions from mid-September 2018 through mid-March 2019 (Figures 2-9, 2-10, and 2-19).

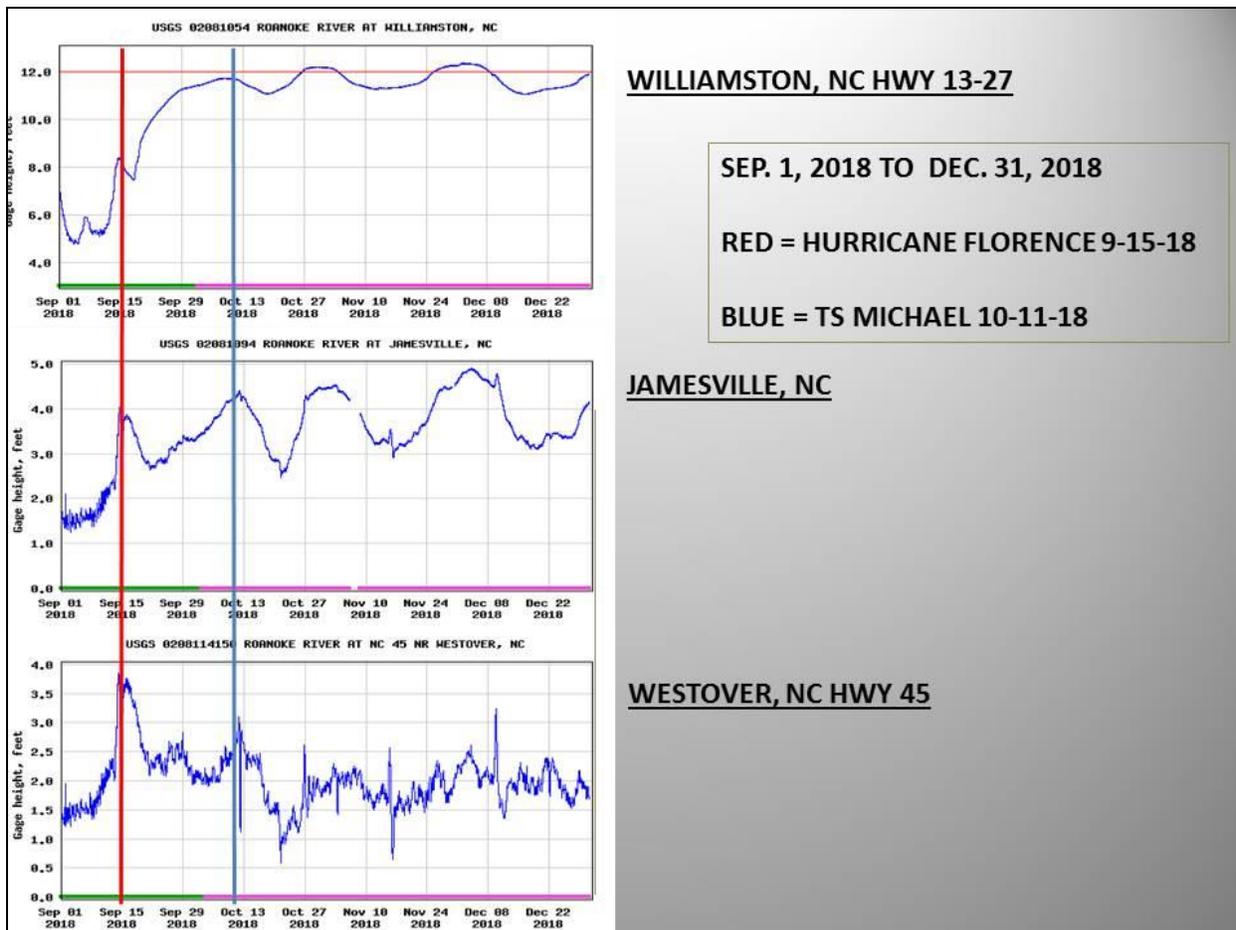
FIGURE 2-10. Plot compares the USGS gage patterns for the Roanoke River from the Williamston water level gage height in feet (top panel) with the water level gage height in feet at the Jamesville (middle panel) and Westover (bottom panel) for the period of September 1, 2018 to December 31, 2018. Since it is the downstream pattern of flow that is important, none of these plots are corrected for absolute elevation and each plot has a different vertical scale (stage height).

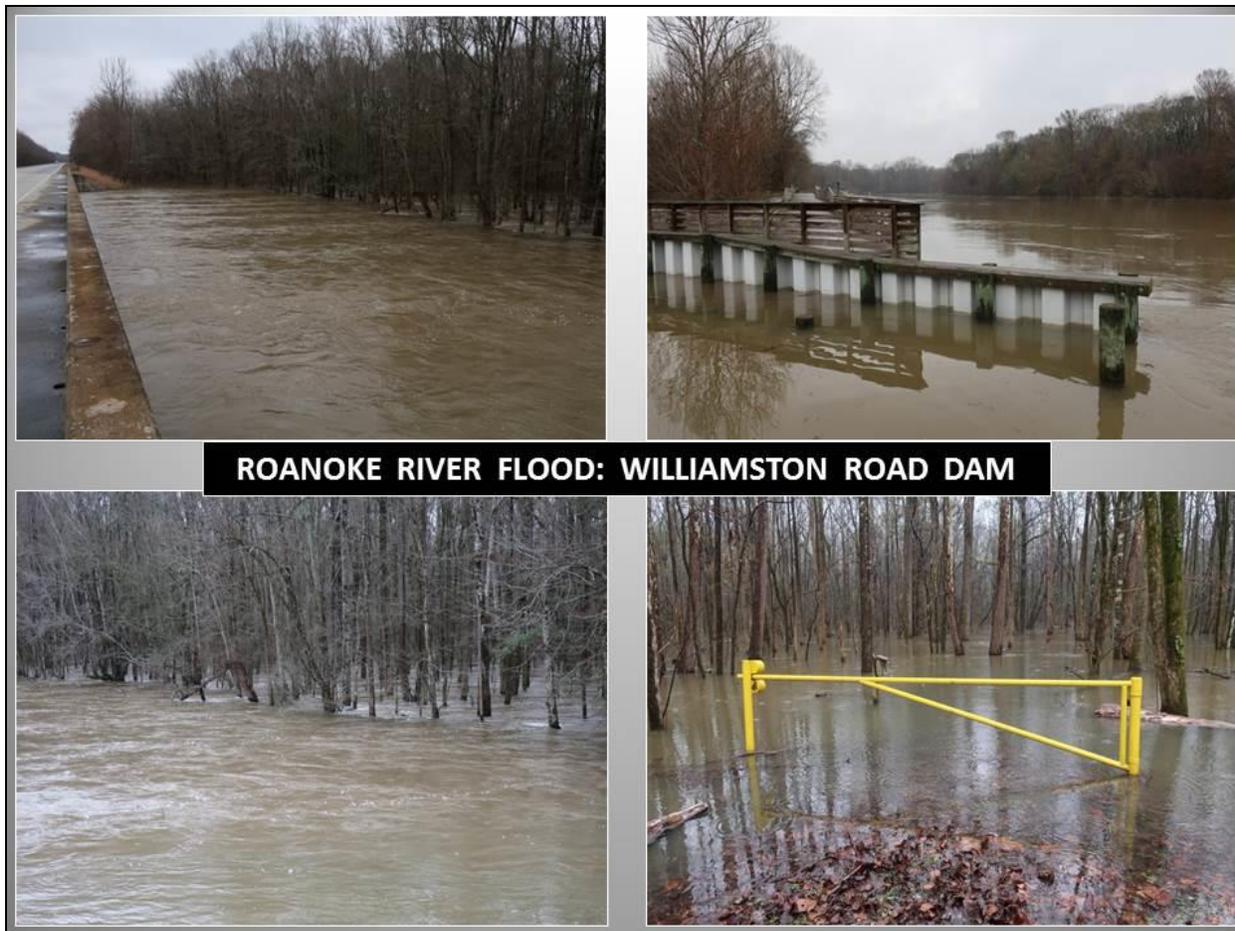
FIGURE 2-11. High flood waters at the Williamston Highway 13-17 road dam (3 floodplain panels) and the NC WRC boat ramp (primary channel in upper right panel) during the period when the Roanoke Rapids dam discharge was up to 35,000 cfs from Sep. 21, 2018 through mid-March 2019. Photographs are by S. Riggs.

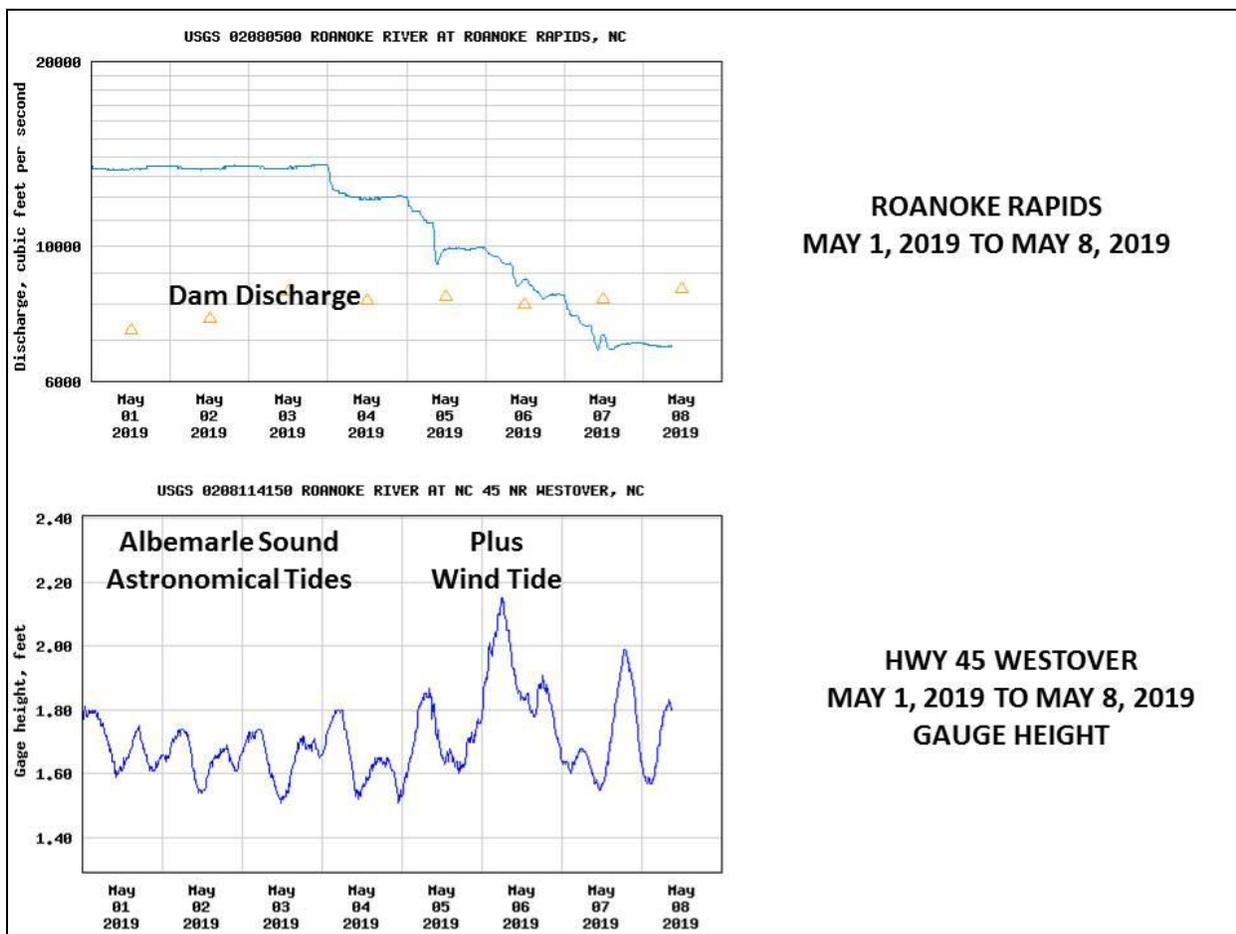
FIGURE 2-12. Plot compares the USGS gage patterns for the Roanoke River from the dam discharge at Roanoke Rapids (upper panel) with the Hwy 45 Westover water level gage height in feet (lower panel) for the period of May 1 to May 8, 2019. Notice that there is no dam discharge signal downstream in panel 11B which is dominated by semi-diurnal astronomical tides and wind tides. Since it is the downstream pattern of flow that is important, none of these plots are corrected for absolute elevation.

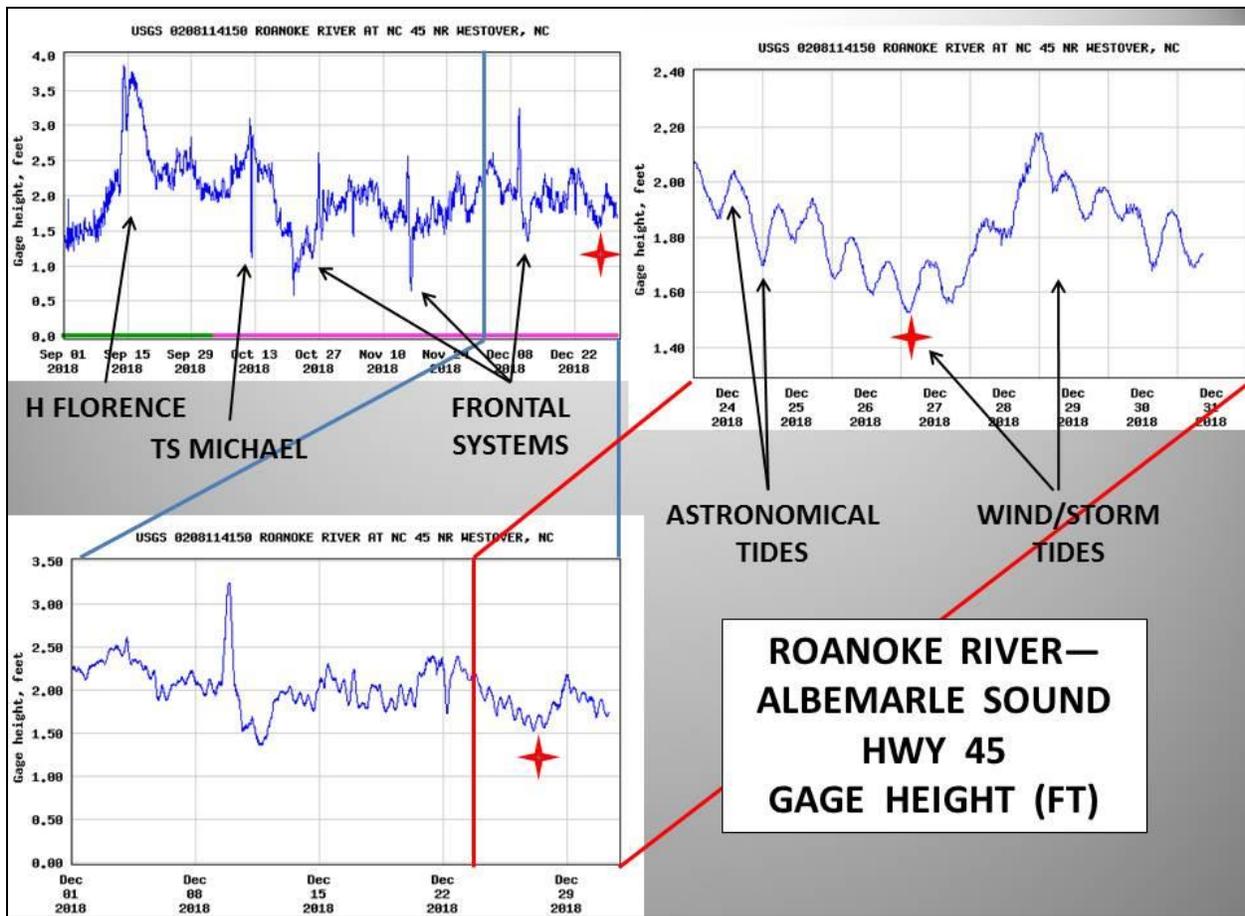
FIGURE 2-13. The upper left plot shows the USGS Westover Highway 45 water level gauge record from Sep. 1, 2018 to Dec. 31, 2018. The lower left plot zooms in and shows the Dec. 1 to Dec. 31 portion of the plot, while the upper right plot shows the same data for the period of Dec. 24 to Dec. 31. Notice that some wind/storm tides are couplets, while others occur as westerlies or easterlies depending on the direction, intensity, and duration of the weather event. The red star identifies the same time in all three panels. Since it is the flow pattern that is important, this plot has not been corrected for absolute elevation.

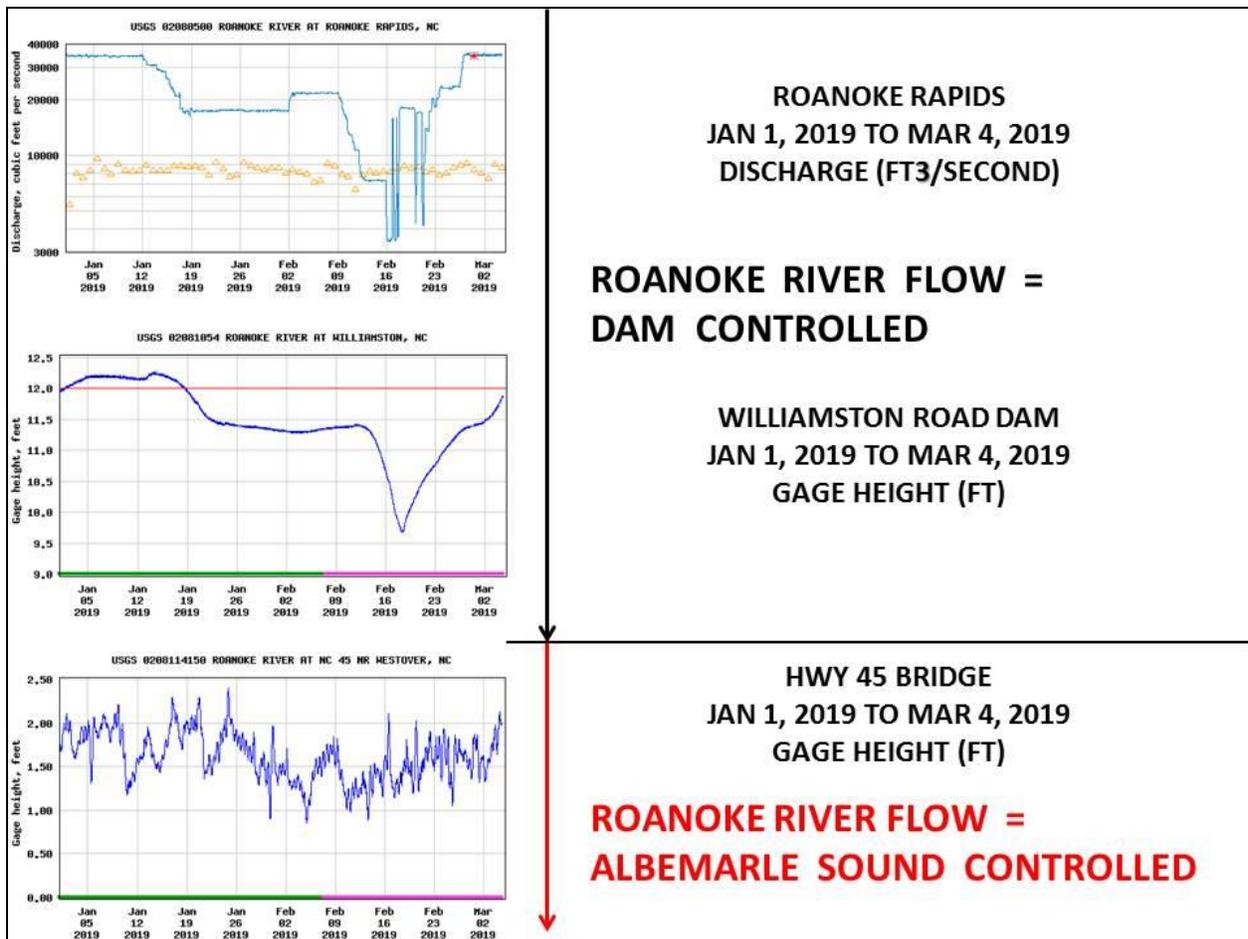
FIGURE 2-14. The three plots summarize the Lower Roanoke River water level gage records from Jan. 1, 2019 to Mar. 4, 2019. Under high flow conditions, the records from the Roanoke Rapids gage to the Williamston Hwy 13-17 gage are totally dam discharge controlled. Whereas, the Westover Hwy 45 record is totally controlled by Albemarle Sound dynamics. The Jamesville gage is in the transition zone and reflects the Albemarle (low dam discharge), records both signals (intermediate dam discharge), or has no Albemarle signal (high dam discharge) (middle panel in Figure 2-10). The red line in panel B is the flood stage at Williamston. Since it is the flow pattern that is important, this plot has not been corrected for absolute elevation and each plot has a different vertical scale (stage height).

Consequently, if the Roanoke River is in flood due to large volume Kerr Lake discharges (25,000 to 35,000 cfs rates), the entire river from Roanoke Rapids down to the Williamston highway 13-17 road dam is in flood conditions (Figure 2-14). The Williamston road dam is about 3.4 miles in length with only one main channel bridge and six overflow bridges resulting in a road dam across about 89% of the Roanoke River floodplain. The road dam appears to initiate the decline of the Kerr Lake dam discharge signal. The Jamesville gage represents the transition zone as the flood waters reach sea level and spread out over the extremely broad floodplain. However, the Westover gage at Highway 45 shows only slight increase in water level from the Kerr Lake dam discharge and is dominantly controlled by the Albemarle Sound dynamics of the small astronomical tides superimposed on the larger-scale wind tides (Figure 2-14).

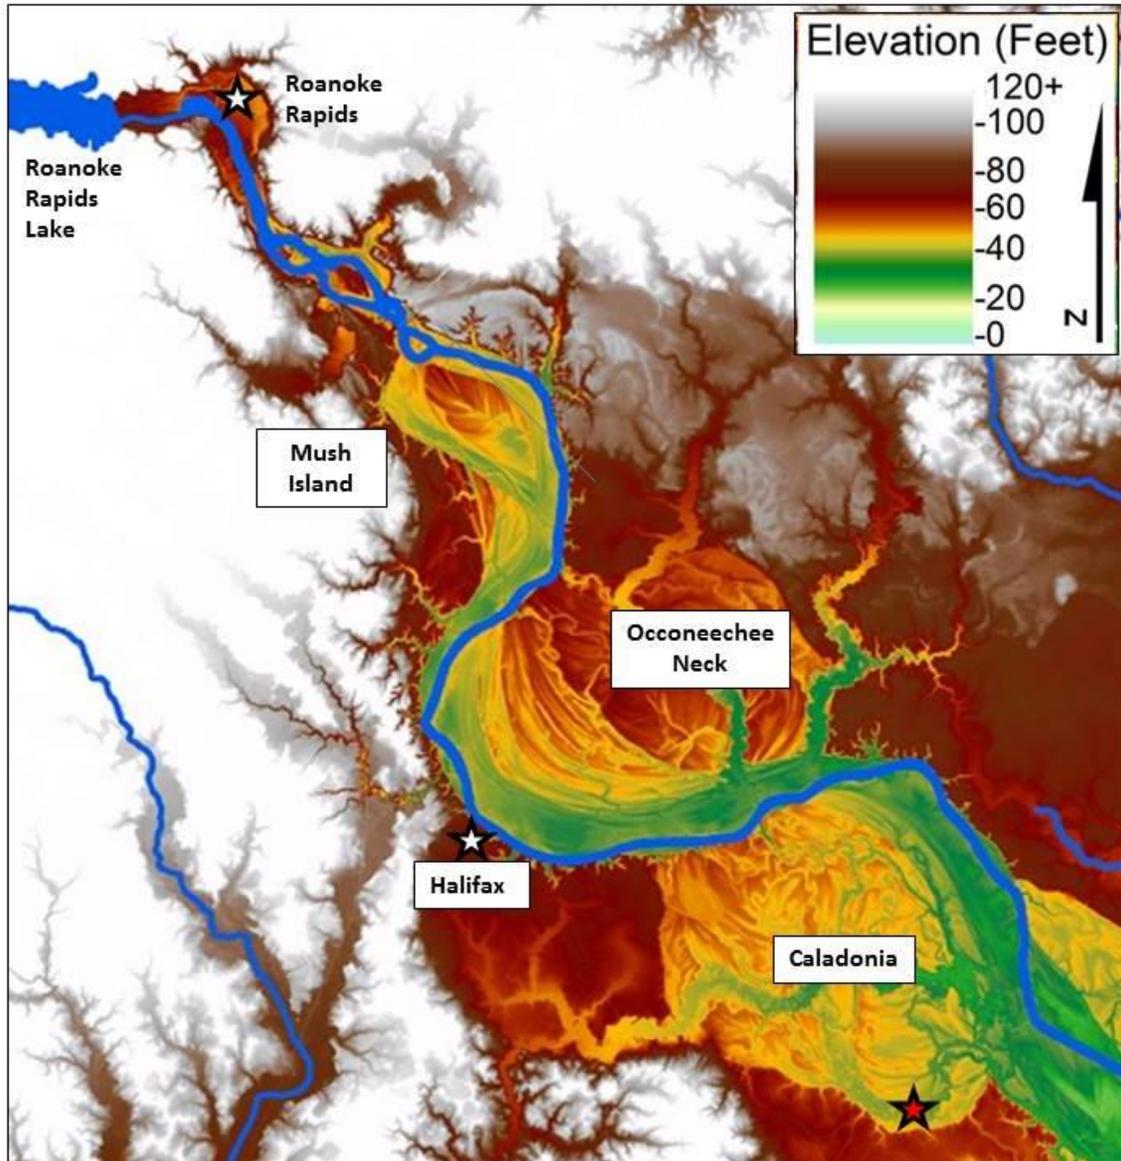
FIGURE 2-15. A color topography map shows the two upper river segments of the Lower Roanoke River. The fall line segment is cut deeply into the crystalline rocks of the Piedmont Province and extends from the dam at Roanoke Rapids Lake downstream to the western edge of Mush Island. River segment 2 begins to flatten out onto the Coastal Plain and extends from the paleo-meander terraces at Mush Island to the downstream edge of the Caledonia paleo-meander terrace. The white stars show the locations of USGS water level gages and the red star is the overlap with Figure 2-17. Topographic data are from the NC DOT's 2007 LiDAR program. Map prepared by D. Ames.

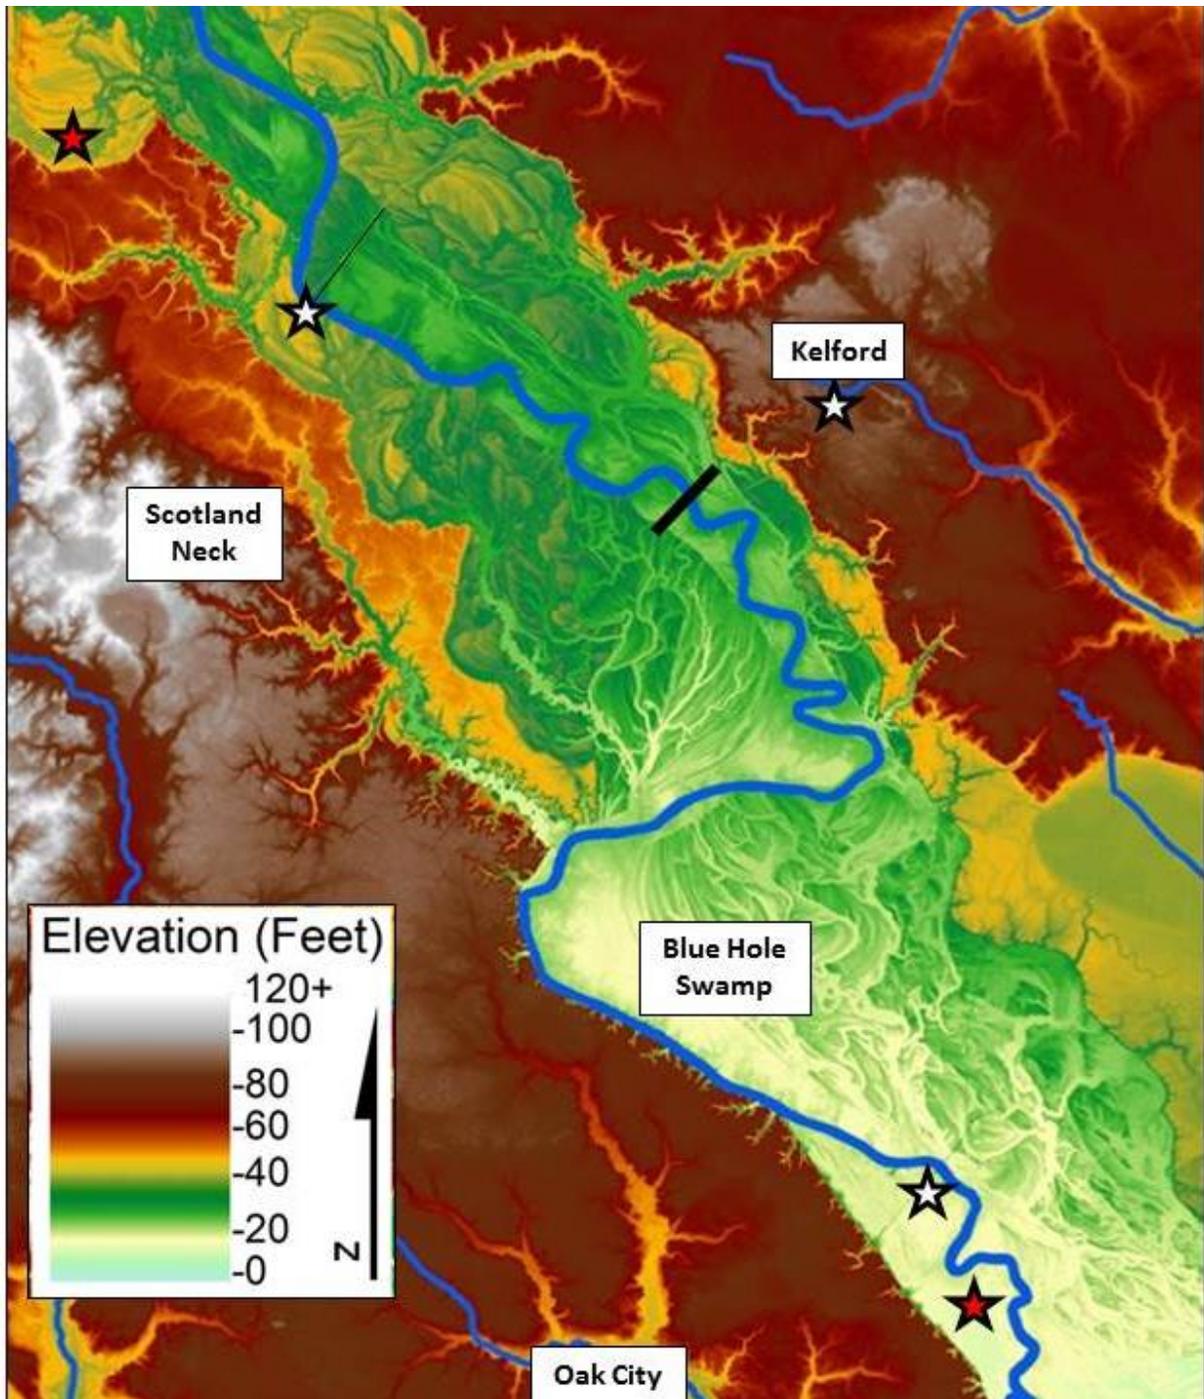
FIGURE 2-17. A color topography map shows the Lower Roanoke River segment 3 and a portion of segment 4. River segment 3 begins at the red star in the upper left corner and extends southeast to the Kelford area. River segment 4 starts on the north side of Blue Hole Swamp and extends downstream into Figure 2-18. The white stars show the locations of USGS water level gages and the red stars are the overlaps with Figures 2-17 and 2-18. Topographic data are from the NC DOT's 2007 LiDAR program. Map prepared by D. Ames.

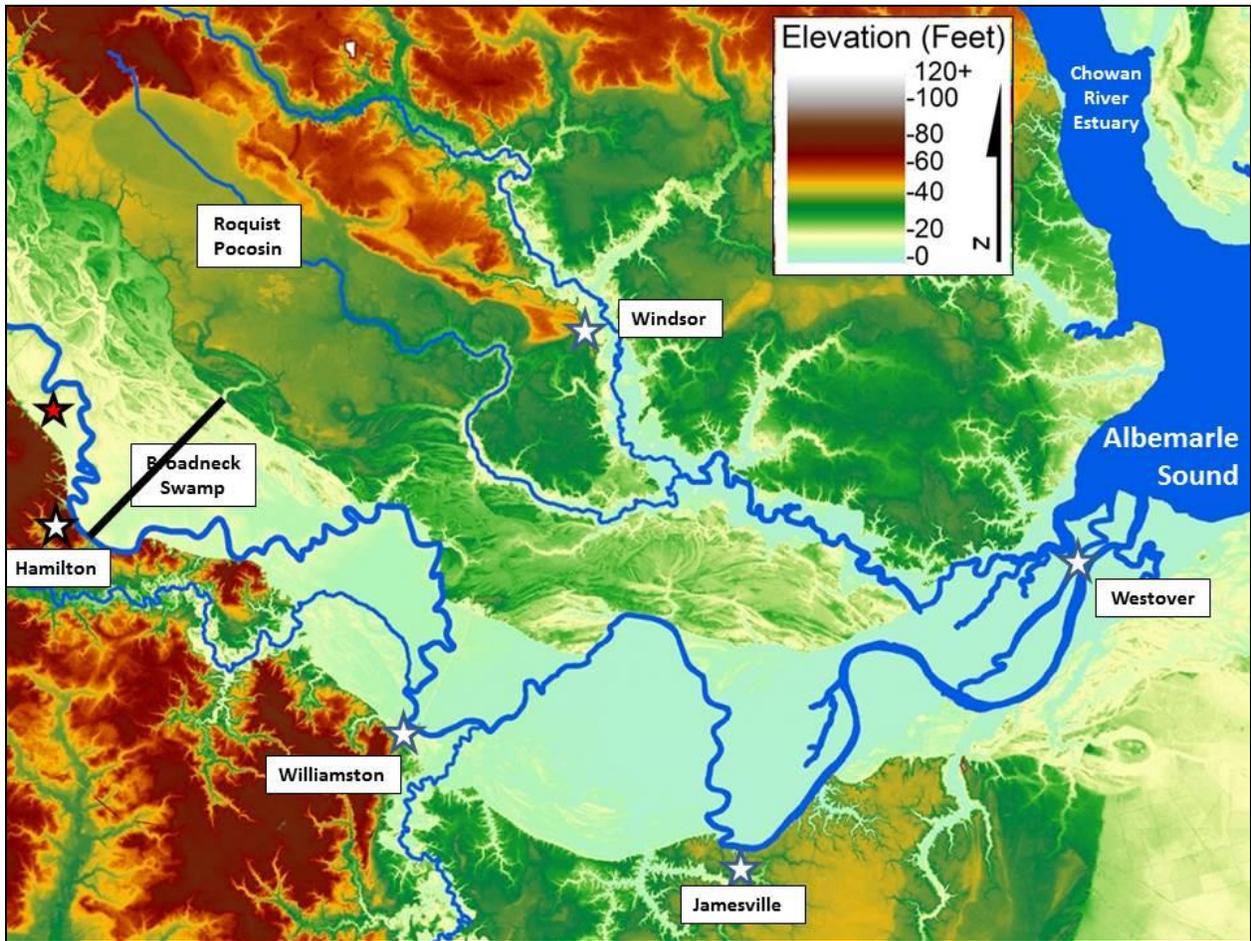
FIGURE 2-18. A color topography map shows the lower portion of river segment 3 and river segment 4 of the Lower Roanoke River. River segment 3 begins on Figure 2-17 and extends southeast to Williamston. River segment 4 starts on the east side of the Hwy 13-17 road dam and extends downstream to Batchelor Bay in western Albemarle Sound. The white stars show the locations of USGS water level gages and the red star is the overlap with Figure 2-17. Topographic data are from the NC DOT's 2007 LiDAR program. Map prepared by D. Ames.

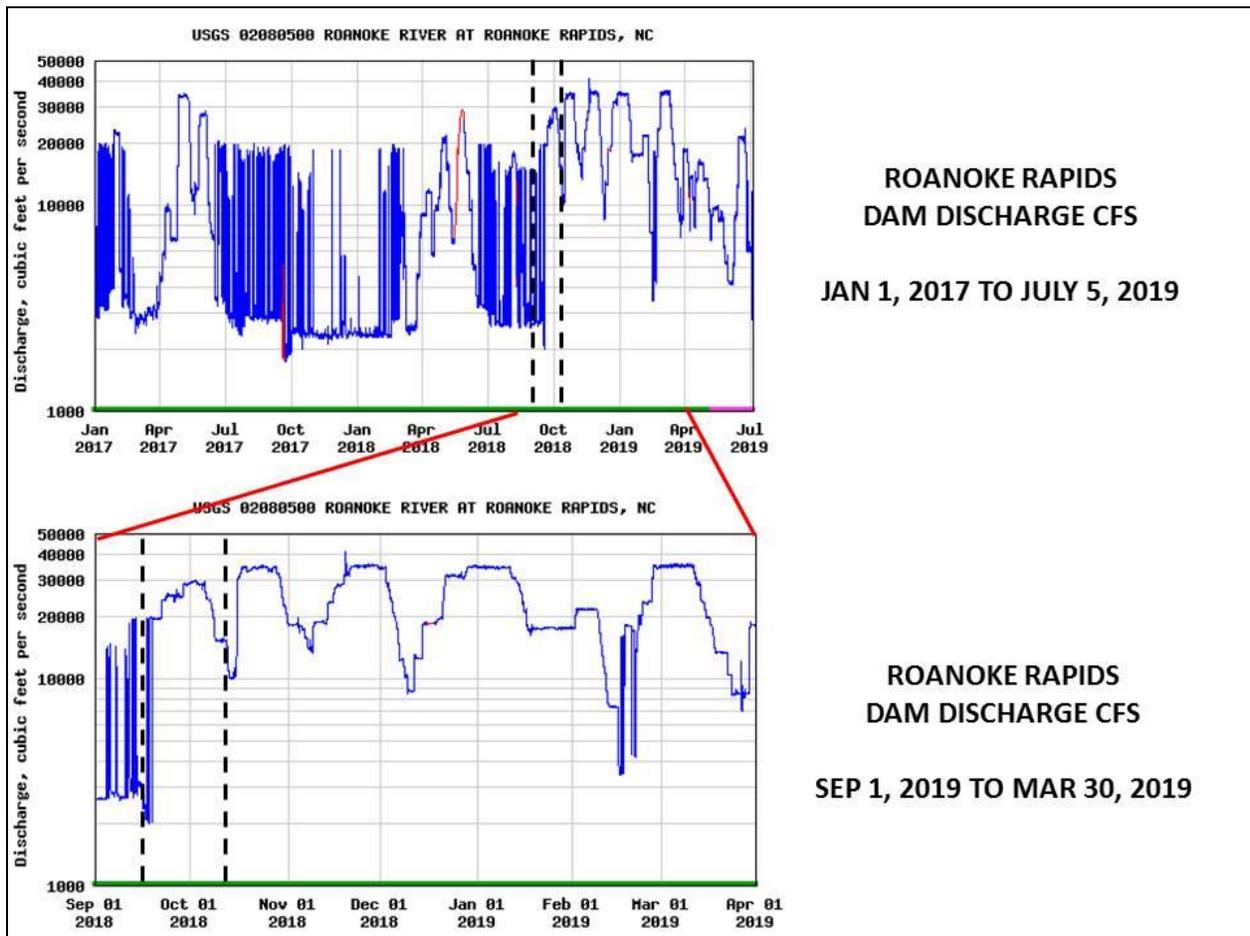
FIGURE 2-19. Plot records the pattern of dam water discharge (in cubic feet per second) to the Lower Roanoke River at the USGS gage at Roanoke Rapids (panel 18A) for the period of January 1, 2017. Panel 18B expands the record for the period seven month period from September 1, 2018 to March 31, 2019. The two dashed black lines show the time of Hurricane Florence (left) and Tropical Storm Michael (right). Since it is the pattern of flow that is important, these plots are not corrected for absolute elevation.

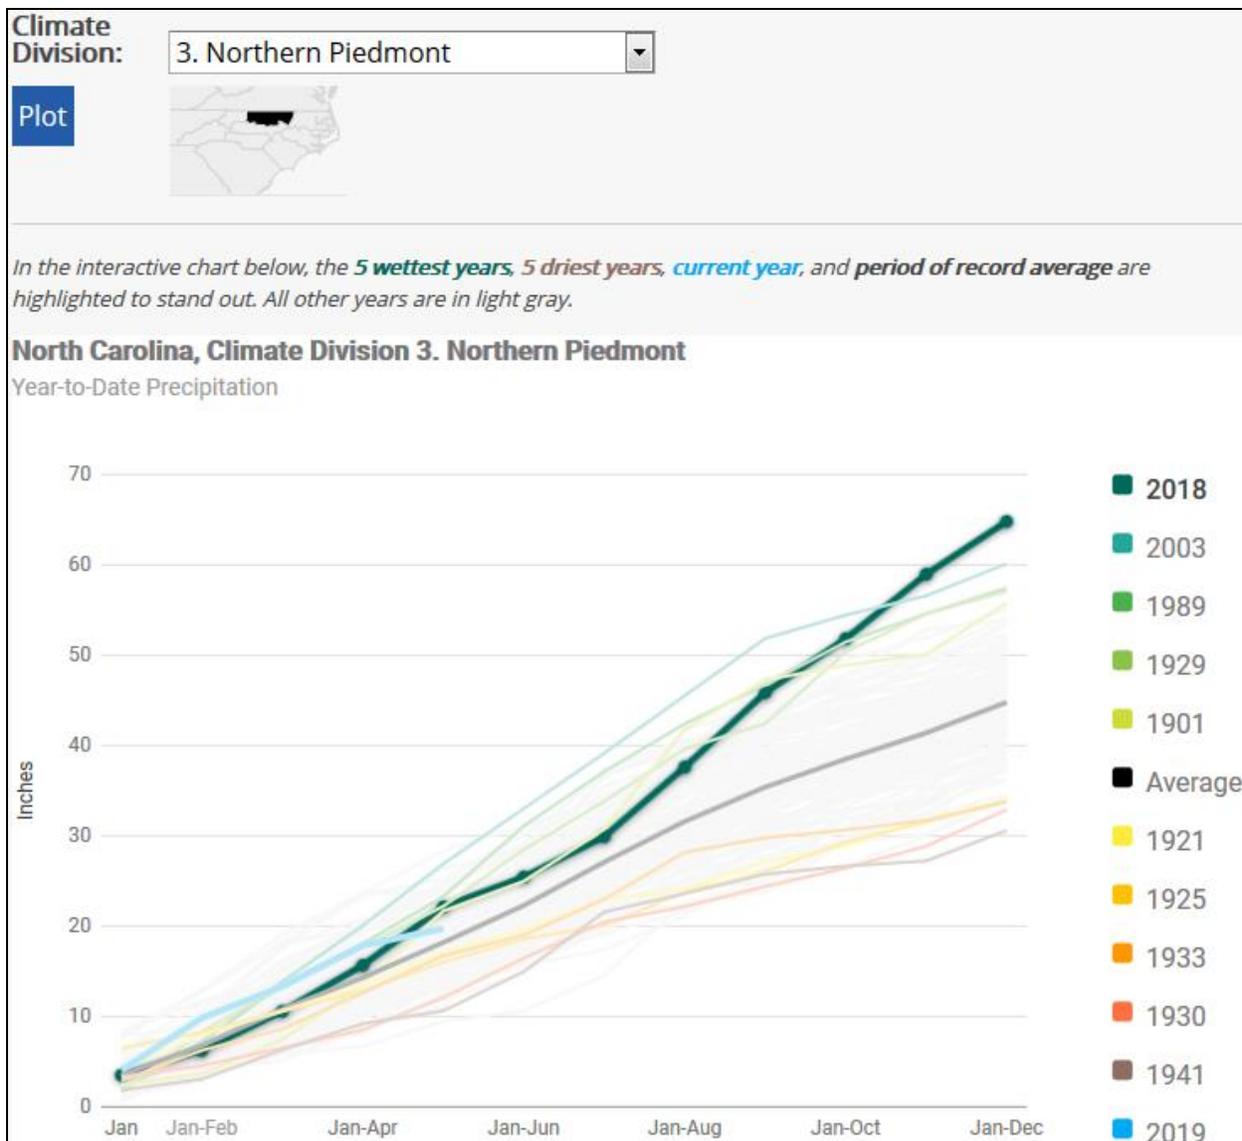
FIGURE 2-21. Plot shows the record amounts of precipitation that occurred with 64.81 inches in 2018 in the Northern NC Piedmont Climate Division 3 (dark green). This is the largest amount recorded since 1895. Also, the head-waters in the Northern Mountain Climate Division 2 received record precipitation amounts. The Northern Coastal Plain had 59.39 inches of rainfall for 2018. Data are from NOAA National Centers for Environmental information, Climate at a Glance: Divisional Mapping, published June 2019 (<https://www.ncdc.noaa.gov/cagl/>).

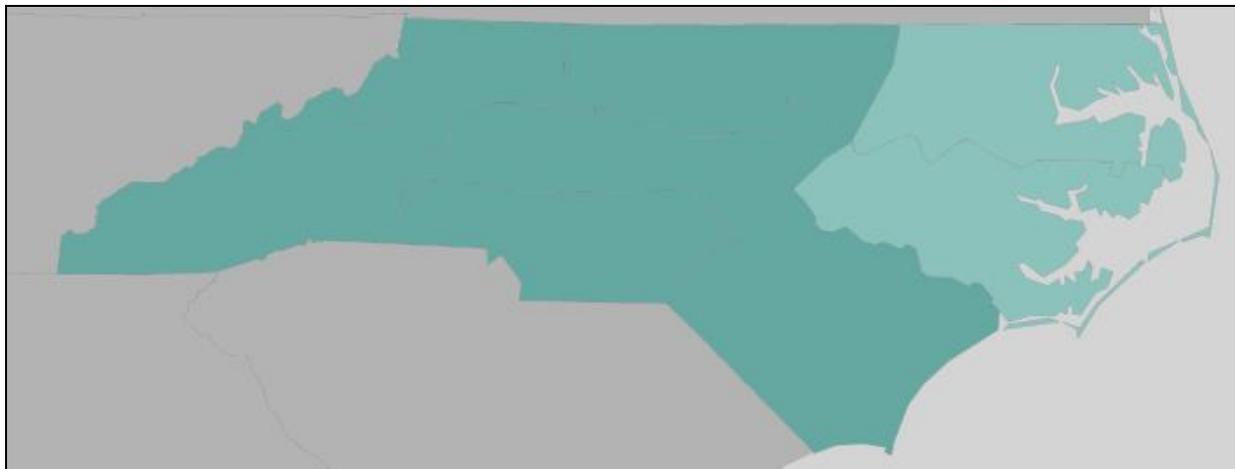
CLIMATE DIVISION	VALUE	RANK (124 YEARS)	1901-2000 MEAN	ANOMALY
North Carolina CD 1. Southern Mountains	48.80"	124	32.04"	16.76"
North Carolina CD 2. Northern Mountains	43.33"	124	27.00"	16.33"
North Carolina CD 3. Northern Piedmont	40.53"	124	23.98"	16.55"
North Carolina CD 4. Central Piedmont	40.51"	124	25.05"	15.46"
North Carolina CD 5. Southern Piedmont	42.69"	124	25.38"	17.31"
North Carolina CD 6. Southern Coastal Plain	41.35"	124	25.07"	16.28"
North Carolina CD 7. Central Coastal Plain	38.10"	121	26.21"	11.89"
North Carolina CD 8. Northern Coastal Plain	30.28"	106	25.18"	5.10"

FIGURE 2-22. Rainfall data are for NC Climate Division for the period of September 1, 2018 through March 31, 2019. Notice how anomalously high above the mean all climate divisions are with CD 1 through CD 6 ranking as the wettest on record since 1895. Data are from NOAA National Centers for Environmental information, *Climate at a Glance: Divisional Mapping*, published June 2019 (<https://www.ncdc.noaa.gov/cag/>).

The six month flooding event in the Lower Roanoke River (Figure 2-19) began with Hurricane Florence and Tropical Storm Michael on Sept. 15 and Oct. 11, 2018, neither of which directly impacted the Lower Roanoke River. In Bertie County, these two tropical storms dropped about 3.5 inches of total rain (Figure 2-20). Rather both storms crossed the Piedmont and Appalachian portions of the Roanoke River Basin dropping substantial amounts of rain into Kerr Lake to bring the lake elevation from 300 to 309 and 314 feet, respectively (Figure 1-5). Subsequent rains through March maintained a high lake level requiring major discharge levels to continue into July 2019. The rainfall amounts for 2018 (Figure 2-21) in the Appalachians (Climate Division 2) and North Piedmont (Climate Division 3) (Figure 2-22) were the “wettest on record since 1895” according to NOAA.
