FLOOD DYNAMICS IN THE BERTIE WATER CRESCENT

INTEGRATING THE DYNAMICS OF COMPLEX DRAINAGE
SYSTEMS TO MINIMIZE STORM IMPACTS AND MAXIMIZE
AQUATIC ENVIRONMENT VIABILITY, BERTIE COUNTY, NC

NORTH CAROLINA LAND OF WATER (NC LOW)

August 20, 2019

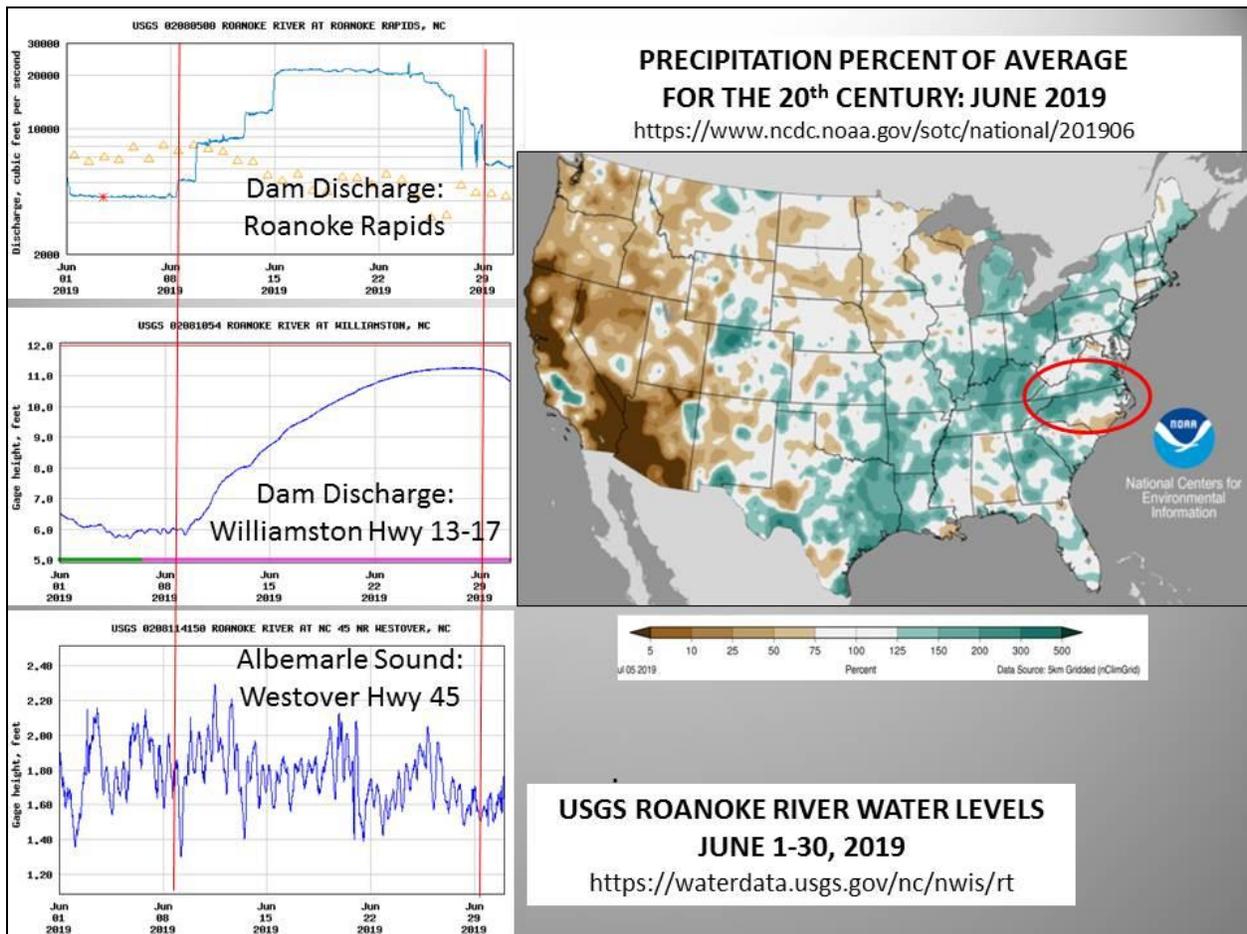
FIGURE 2-23. USGS Lower Roanoke River water level gages for June 1-30, 2019 show a major dam discharge from June 9-29 in response to abnormally high rainfalls within the Roanoke River drainage basin that were from 125% to 200% above the 20th century average for the month of June based on NOAA precipitation data. Notice that there is no apparent record of the dam discharge in the pattern at the Westover Hwy 45 gage, which is dominated by the Albemarle Sound signals. Since it is the pattern of flow that is important, these plots are not corrected for absolute elevation.

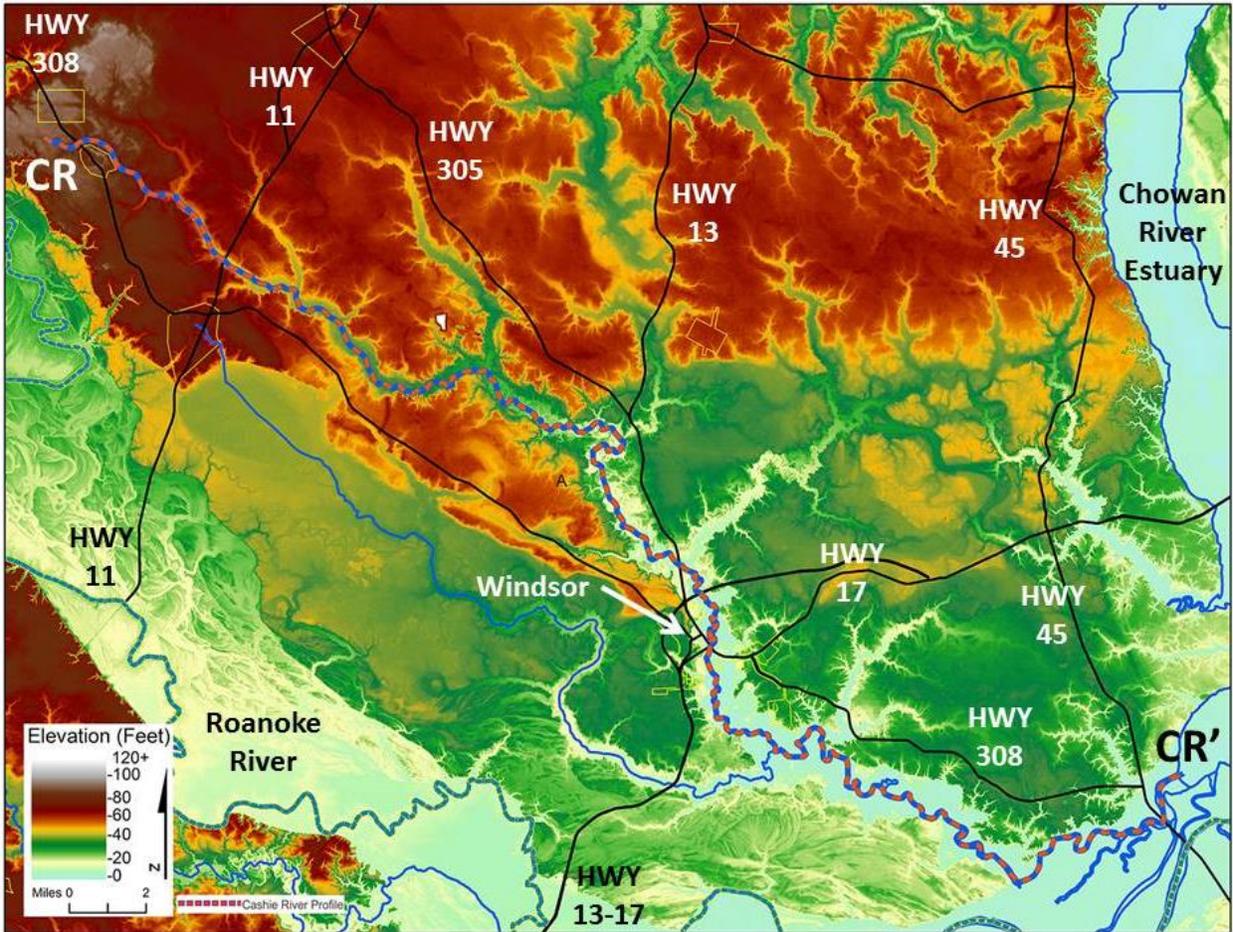
FIGURE 3-2. A color topography map shows the southern portion of the Bertie Peninsula in the northeastern North Carolina Coastal Plain and including all of Bertie County. The trace of the CR-CR' profile of the Cashie River in Figure 3-3 occurs as a red-blue dashed line. Topographic data are from the NC 2015 LiDAR program. Map was made by D. Ames.

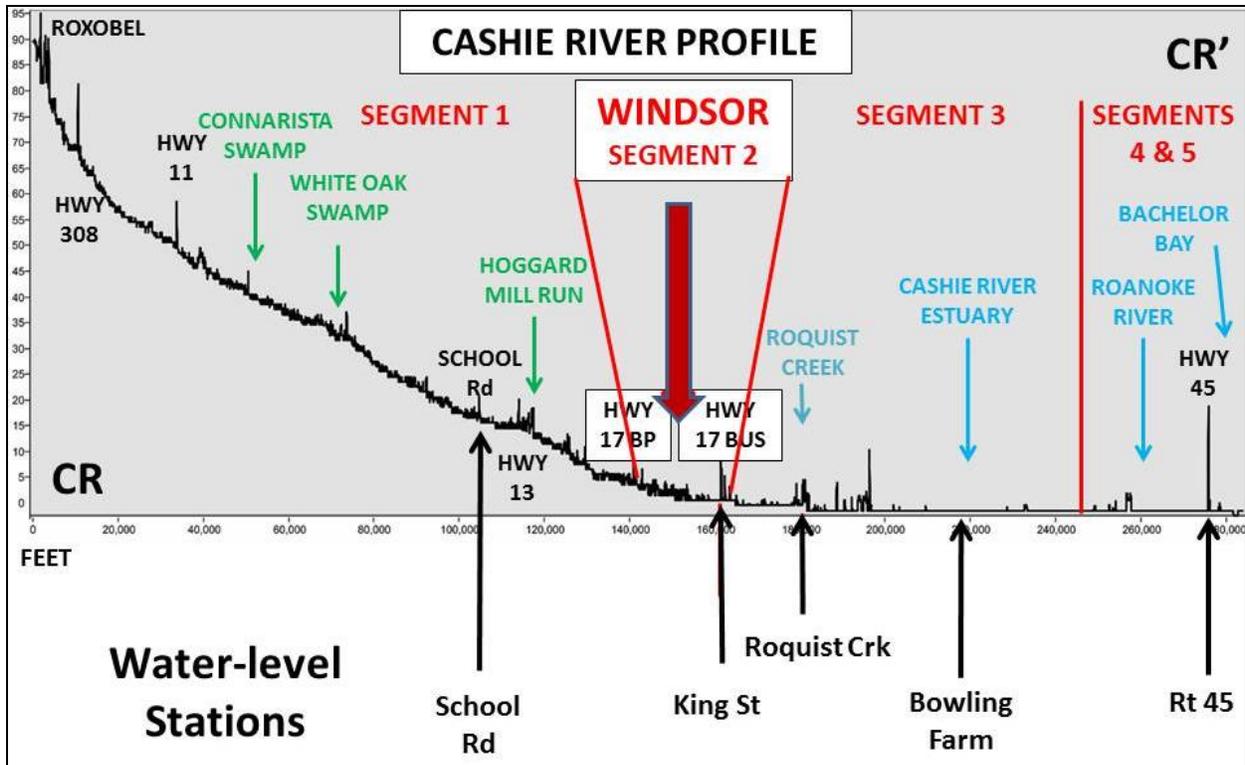
FIGURE 3-3. Topographic profile is along the water surface of the Cashie River during normal water flow conditions. The profile starts at the headwaters near Roxobel and goes into the estuarine waters of Albemarle Sound at Bachelor Bay. Elevation data were obtained from the NC 2015 LiDAR data, USGS topographic data, and 5 water-level recorder gages (in black). Key locations are indicated in green and blue and the river segments are in red (segments 1 and 2 were primarily covered by the NCSU (2018 report) and segments 1 (at School Rd. to segment 5 in Albemarle Sound) are covered by the NC LOW (2019 report). The profile location is indicated in Figure 3-2. Profile was made by D. Ames.

The USGS School Rd. water level gage is located within the lower portion of segment 1 and is located just above the input of Hoggard Mill Run in Figure 3-3. Consequently, this gage only measures what water is coming down the main stem. The Town of Windsor from the new highway 17 bypass bridge to the King St. highway 17 business bridge, is located in segment 2 of the Cashie River. This is the zone where the channel bottom drops below modern sea level and the river transitions from riverine flow conditions to estuarine back-flooding. The river gradient decreases in segment 3 and the Cashie River spreads out latterly to develop a broad, primary floodplain swamp forest. The water surface expands downstream as the adjacent upland decreases in elevation into the Roanoke River valley. Segment 3 is an estuarine mixing basin where the riverine waters interact with the sea level waters of Albemarle Sound (Figure 3-5). When the black estuarine water of the Cashie reaches the Roanoke River, it flows into a small side channel (Thoroughfare Channel) of brown-river water (segment 4) and shortly flows into Batchelor Bay and Albemarle Sound (segment 5 in Figure 3-3).

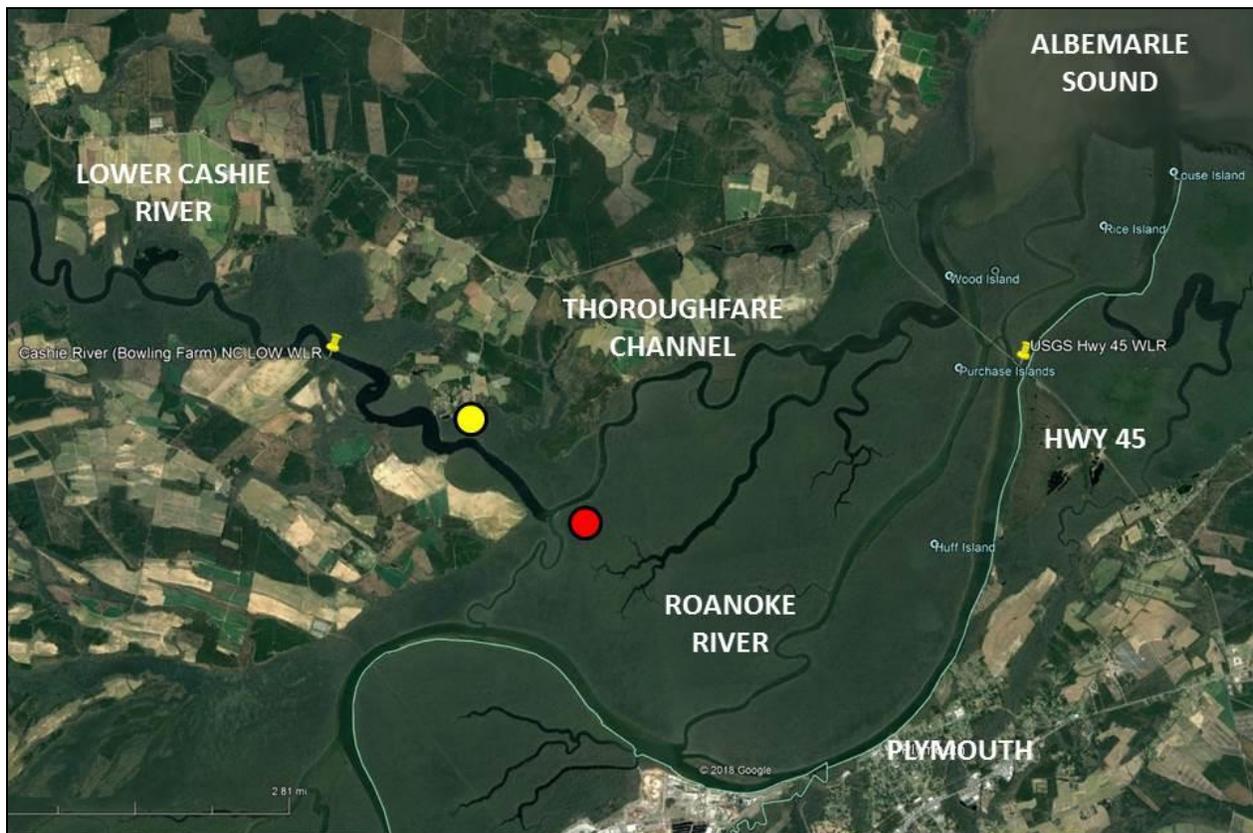
FIGURE 3-5. Google Earth image shows the black-water lower Cashie River (segment 3) that flows southeast into a much smaller Thoroughfare channel (segment 4) of the Roanoke River (red dot) and then northeast into Bachelor Bay of Albemarle Sound (segment 5). The yellow dot locates the San Souci Ferry and the two yellow pins locate the NC LOW and USGS water level recorders. The blue line is the Bertie-Martin county line.

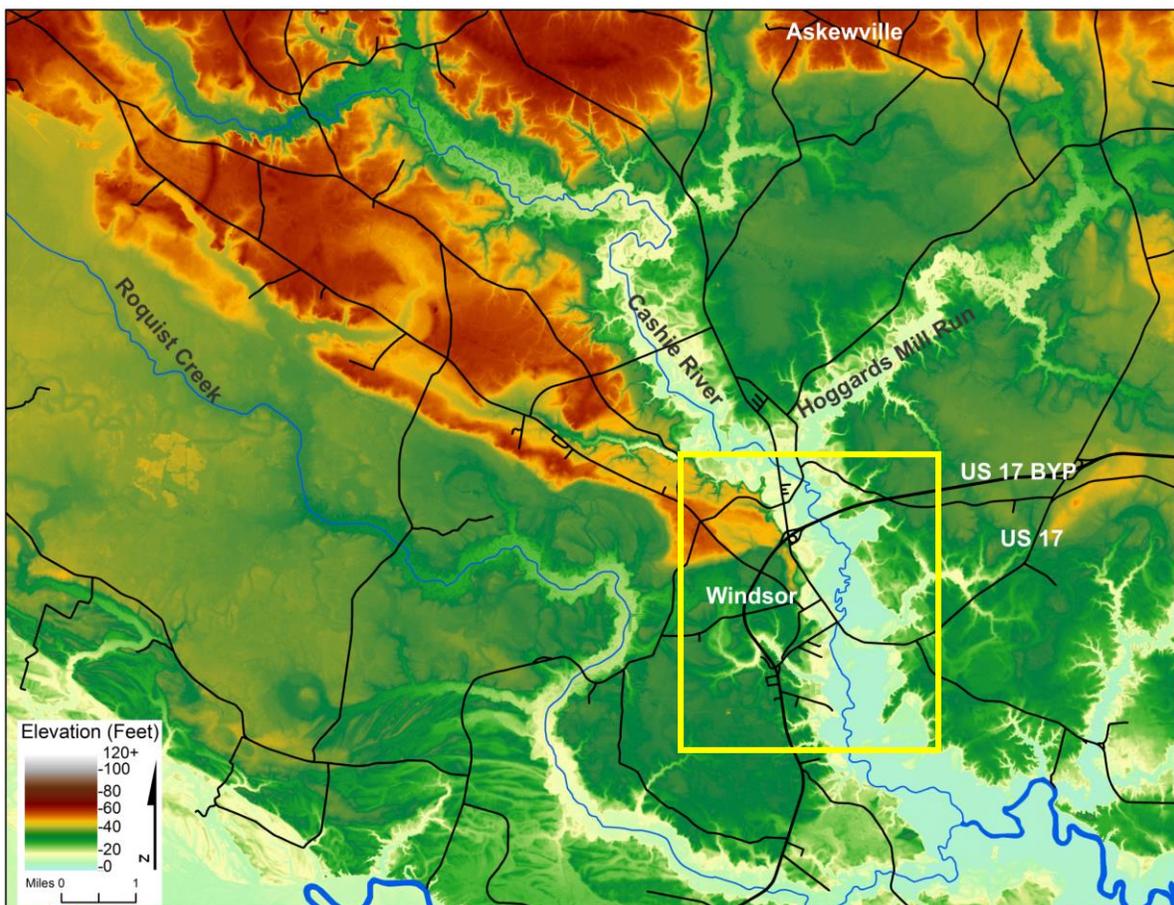
FIGURE 3-6. A color topography map shows the central portion of the Cashie River valley with the Town of Windsor within the yellow box. Notice the location of Windsor relative to the Windsor Ridge, the main stem of the Cashie River, and the Hoggard Mill Run tributary stream. Topographic data are from the NC 2015 LiDAR program. Map was made by D. Ames.

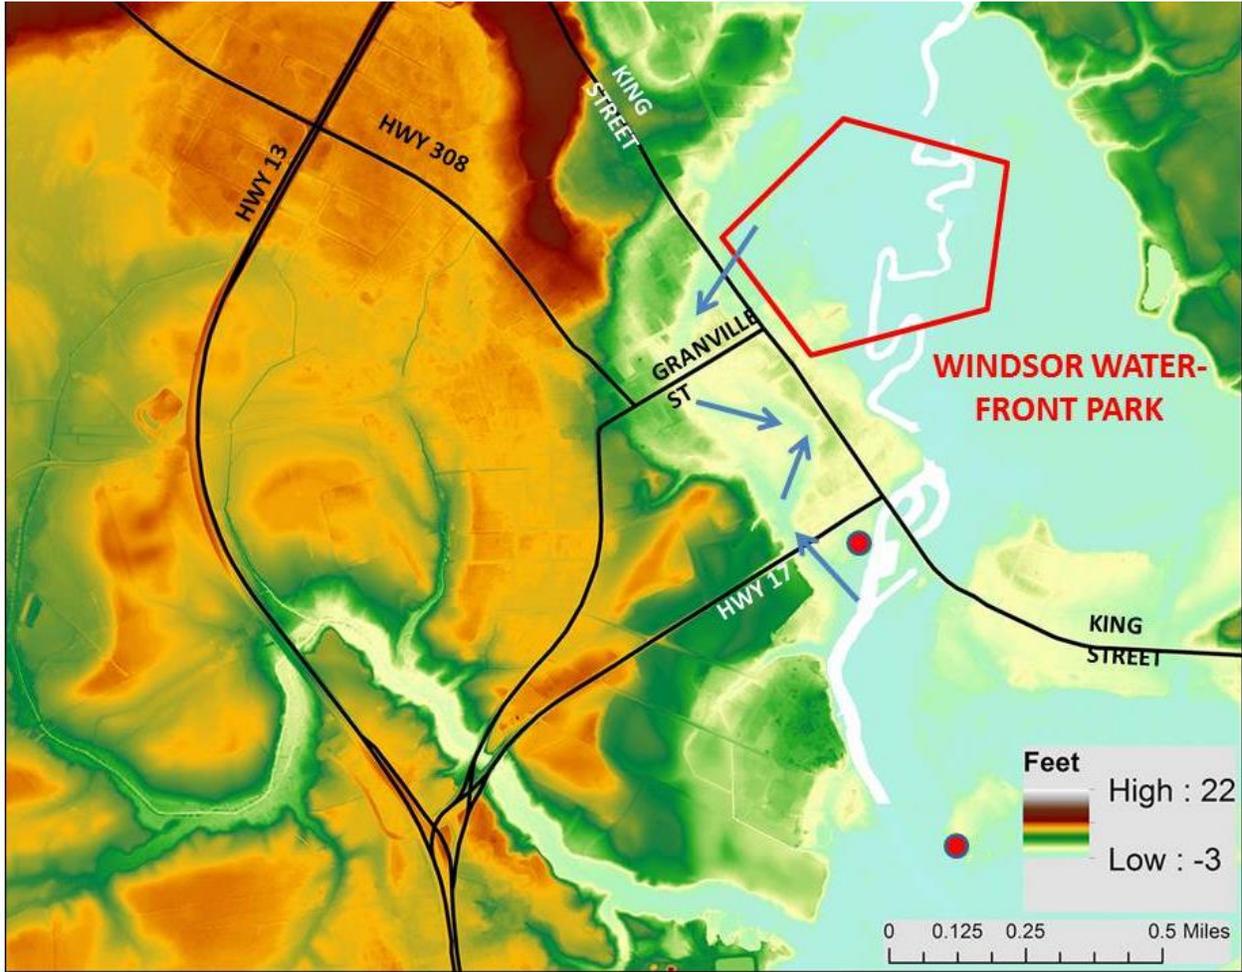
FIGURE 3-7. A color topography map is a close up view of the Town of Windsor. Pale blue color is the primary floodplain of the Cashie River (white). The flood-prone section of Windsor is cream to pale green and the upland is dark green, orange, and dark red (about 20 to 60 feet elevation). Notice the low flood-way shown by blue arrows that cause flooding of the center of Windsor downtown. The red dots, along with the red pentagon, are part of the town's eco-tourism program to utilize the flood-prone areas. Topographic data are from the NC 2015 LiDAR program. Map was made by D. Ames.

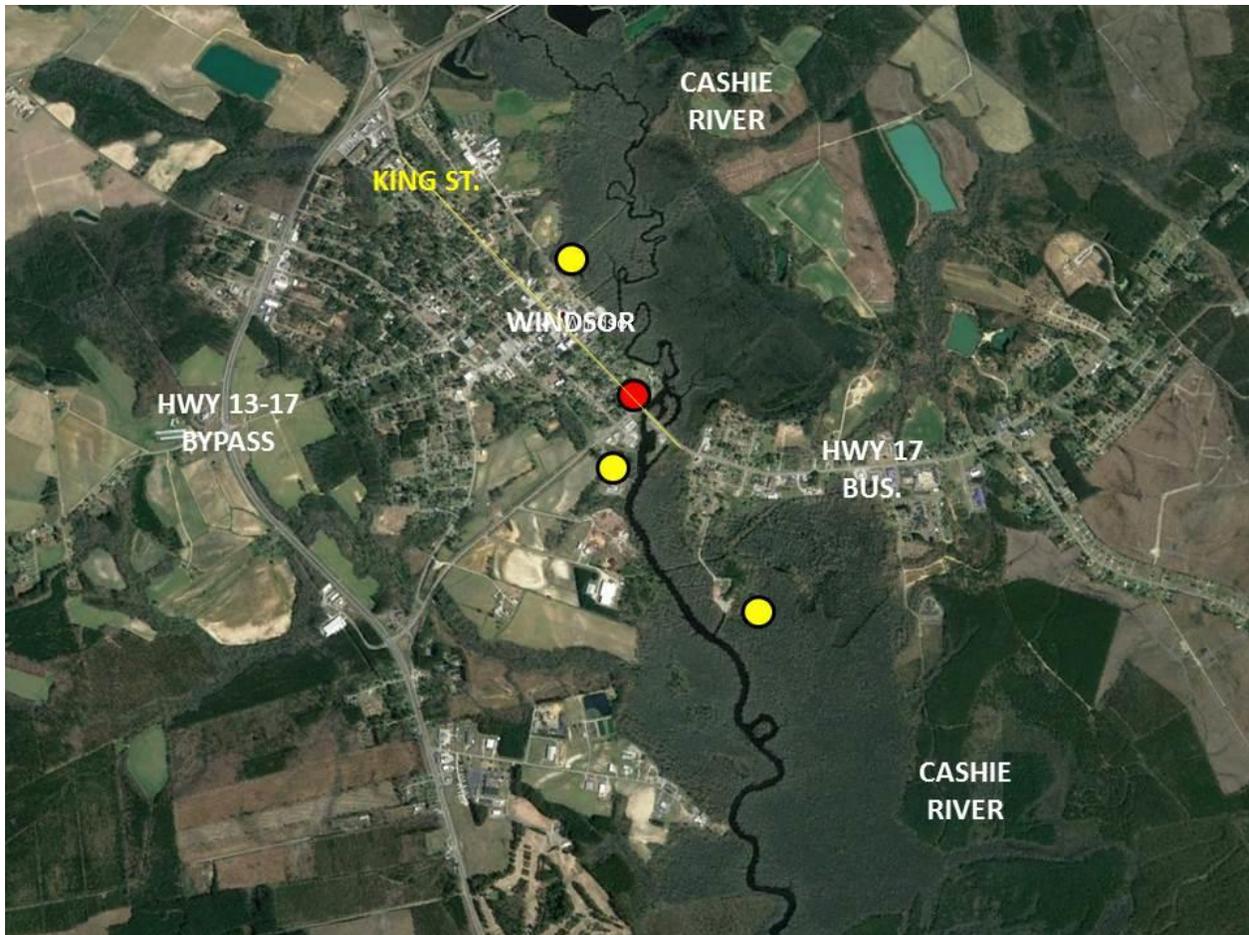
FIGURE 3-8. Google Earth image shows the black-water Cashie River at Windsor with the narrow and highly meandering channel and wide floodplain north of King St., a major pinch point at the King St. bridge (red dot), and a wider estuarine channel south of King St.. The yellow line indicates King St. and the yellow dots locate portions of Windsor’s Cashie River related eco-tourism facilities. The red dot at the King St. Bridge is adjacent to the NC water-level recorder on the NW side of the bridge. Notice the dredged cutoff channel south of the lowermost yellow dot and the dredged turning basin just south of the King St. Bridge. This dredging was done in the 1930s to eliminate 3 tight meanders downstream of Windsor

Location within the topographic valley of the Cashie River dictates the dynamics and impact of different climatic conditions (floods and droughts) affecting the water flow within that river system. The original town was located at Hoggard Mill in 1722. But this was too far upstream for shipping; the condition of the river channel was too “crooked and narrow” from Gray’s Landing to Hoggard Mill (windsornc.com/history-of-windsor/). Consequently, the shipping trade slowly retreated downstream to the present site of Windsor at Gray’s Landing by 1768. Figure 3-6 clearly demonstrates the reason why the Town of Windsor is located on the “Windsor Ridge” where the Cashie River transitions from riverine to estuarine conditions. The eastern tip of “Windsor Ridge” is the southernmost piece of high land with elevations that range up to 60 feet above sea level. The topography decreases in elevation to 5 to 10 feet along the floodplain fringes where the main part of downtown has been developed over the past 200 years (Figure 3-7). To the north of Windsor the river is shallow with relatively steep gradients, whereas to the south there is a relatively deep-water channel with very low stream gradients and little high land due to the very broad floodplain (Figure 3-8).

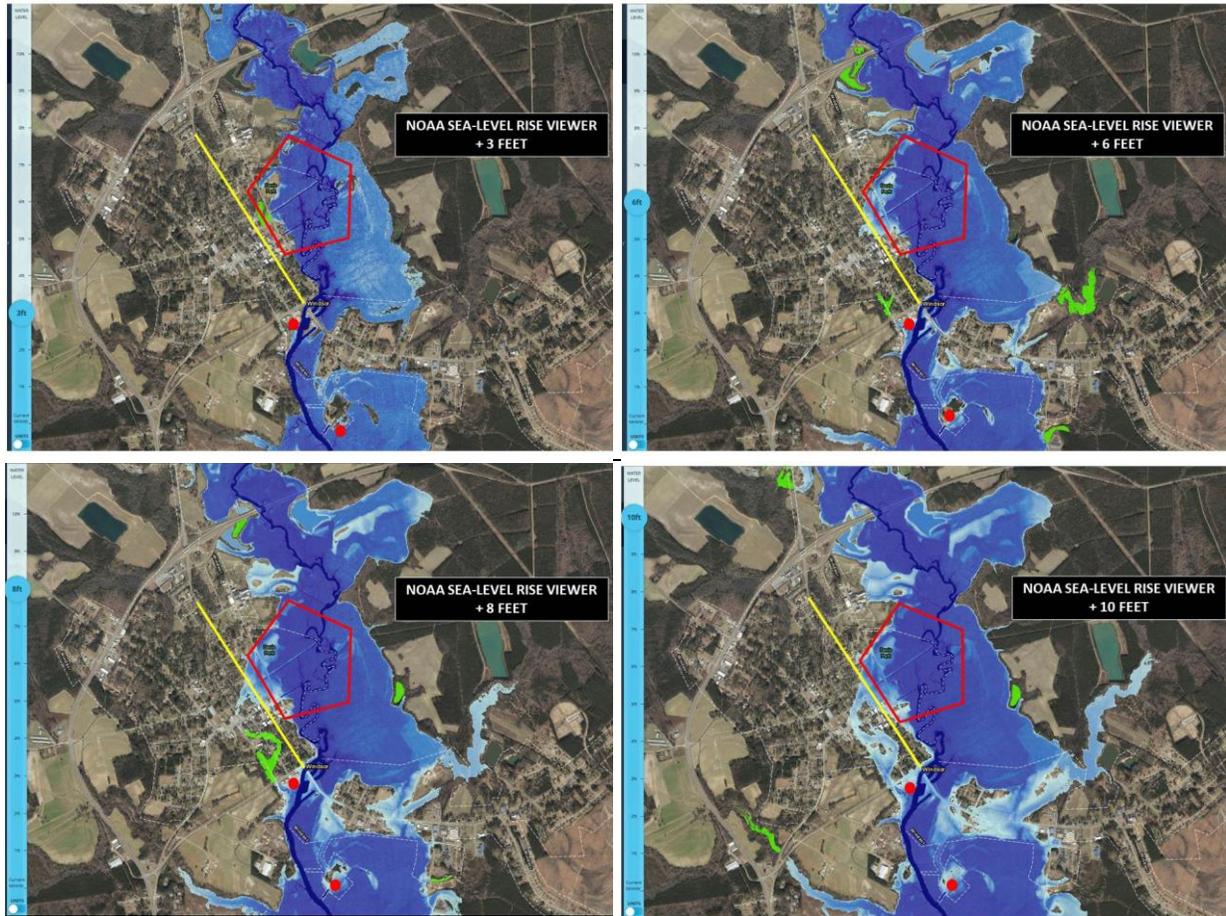
FIGURE 3-9. Four panels show the extent of flooding in Windsor in response to storm-water levels of +3, +6, +8, and +10 feet above normal based on NOAA’s “sea-level rise viewer”. The red pentagon is the site NC LOW’s proposed Windsor Waterfront Park that connects to the two waterfront sites at the red dots (NC LOW, 2018). The yellow line is King St.

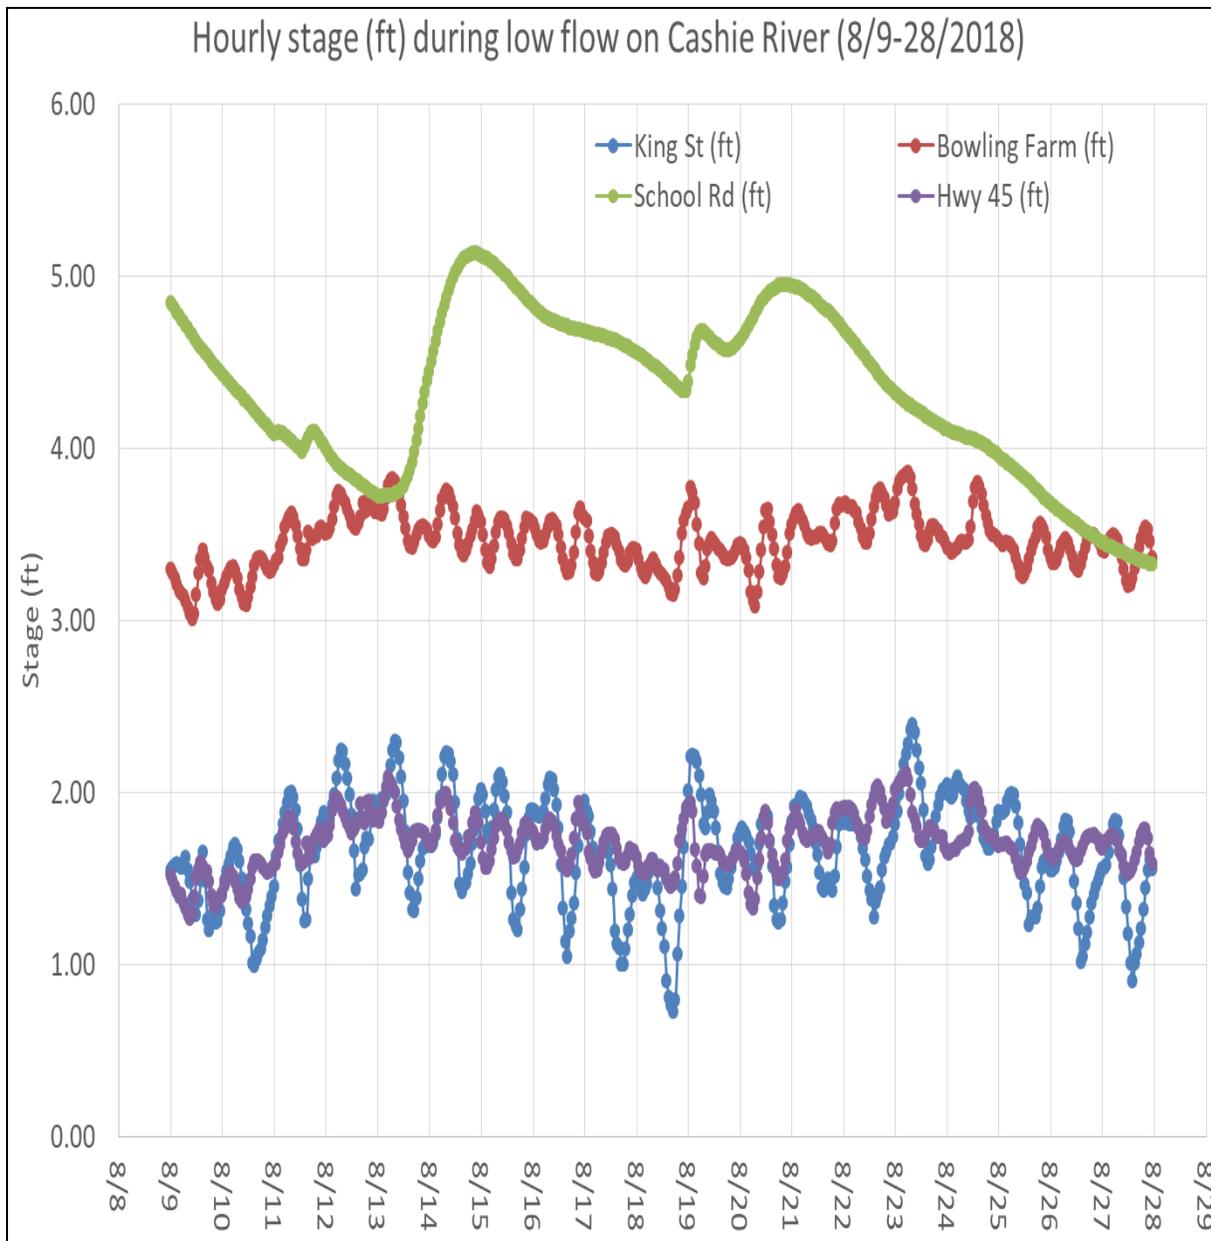
*FIGURE 3-11. Patterns of average hourly stage heights (water levels in feet) at each of four sites are shown over time during a low streamflow period. Notice that stage heights represent the bottom of the river as zero feet at each site. Therefore, the overall vertical positions of the lines are not comparable. School Road signal is **green** and dominantly driven by upstream rainfall. The Windsor King Street (**blue**), Bowling Farm (**red**), and Westover Hwy 45 (**purple**) display both astronomical tide and wind tide signals.*

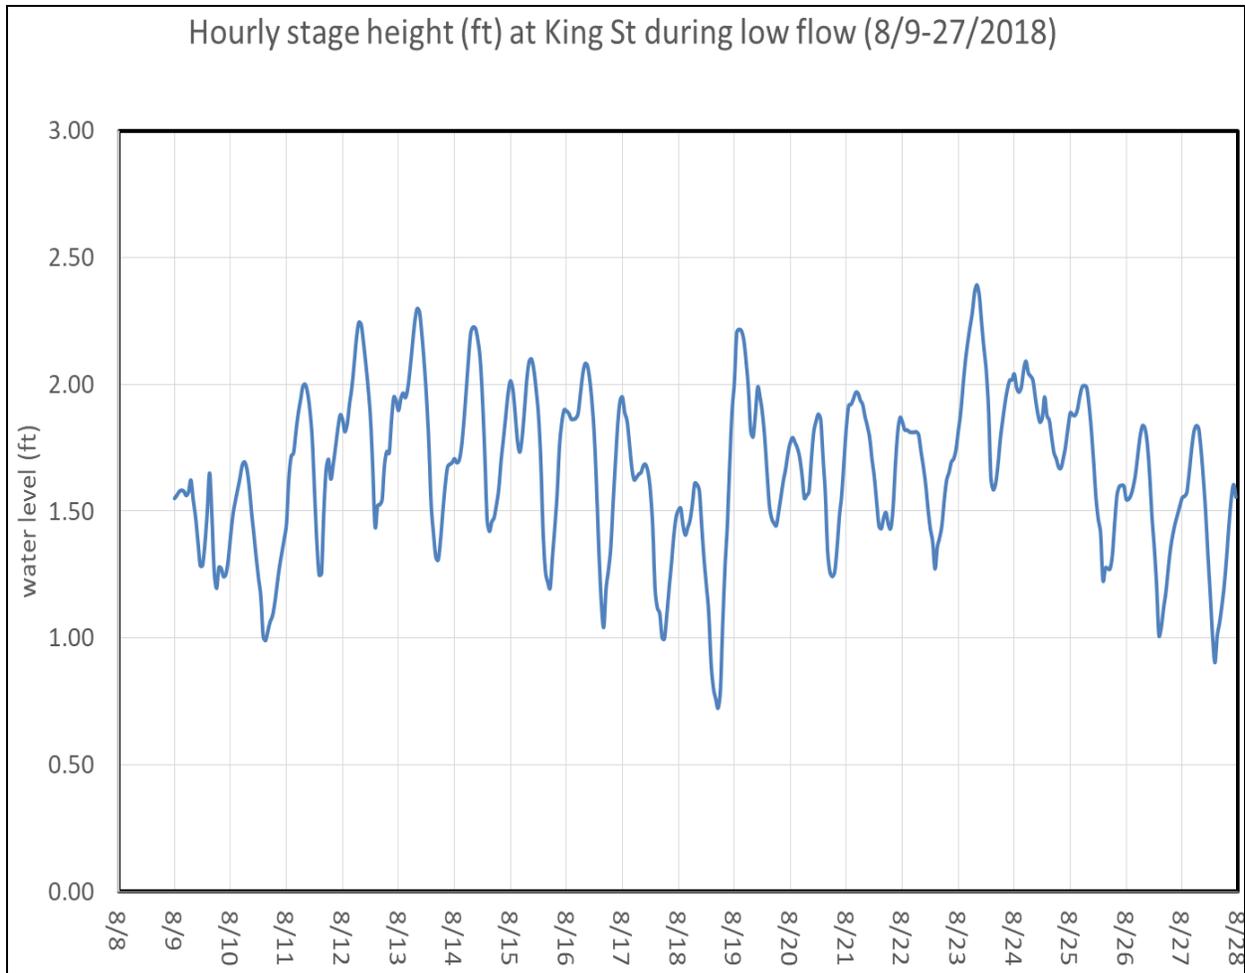
FIGURE 3-12. Hourly water level fluctuations at the King St. gage in Windsor illustrate the daily astronomical diurnal tidal signal, a weekly wind tide signal, and possibly a component of daily evapotranspiration signal. The period represented in the plot extends from August 8 to 28, 2018. The plot is not corrected for elevation.

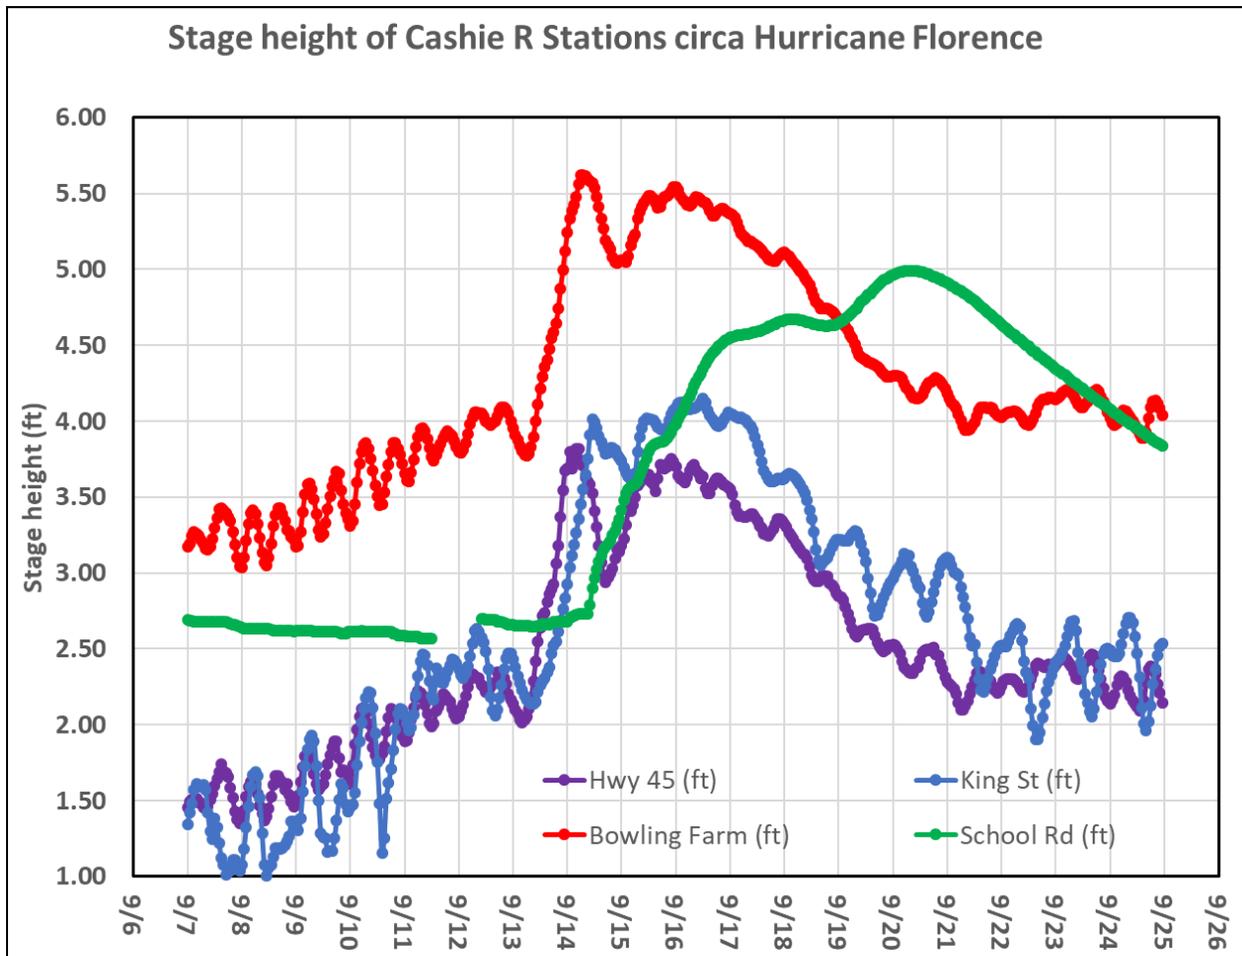
FIGURE 3-14. Patterns of average hourly stage heights (water levels in feet) at each of the four sites are shown over time during the period associated with Hurricane Florence. Note that stage heights represent the bottom of the river as zero feet at each site. Therefore, the overall vertical positions of the lines are not comparable. School Rd is represented as green, Windsor at King St. as blue, Bowling Farm as red, and Hwy. 45 is purple.

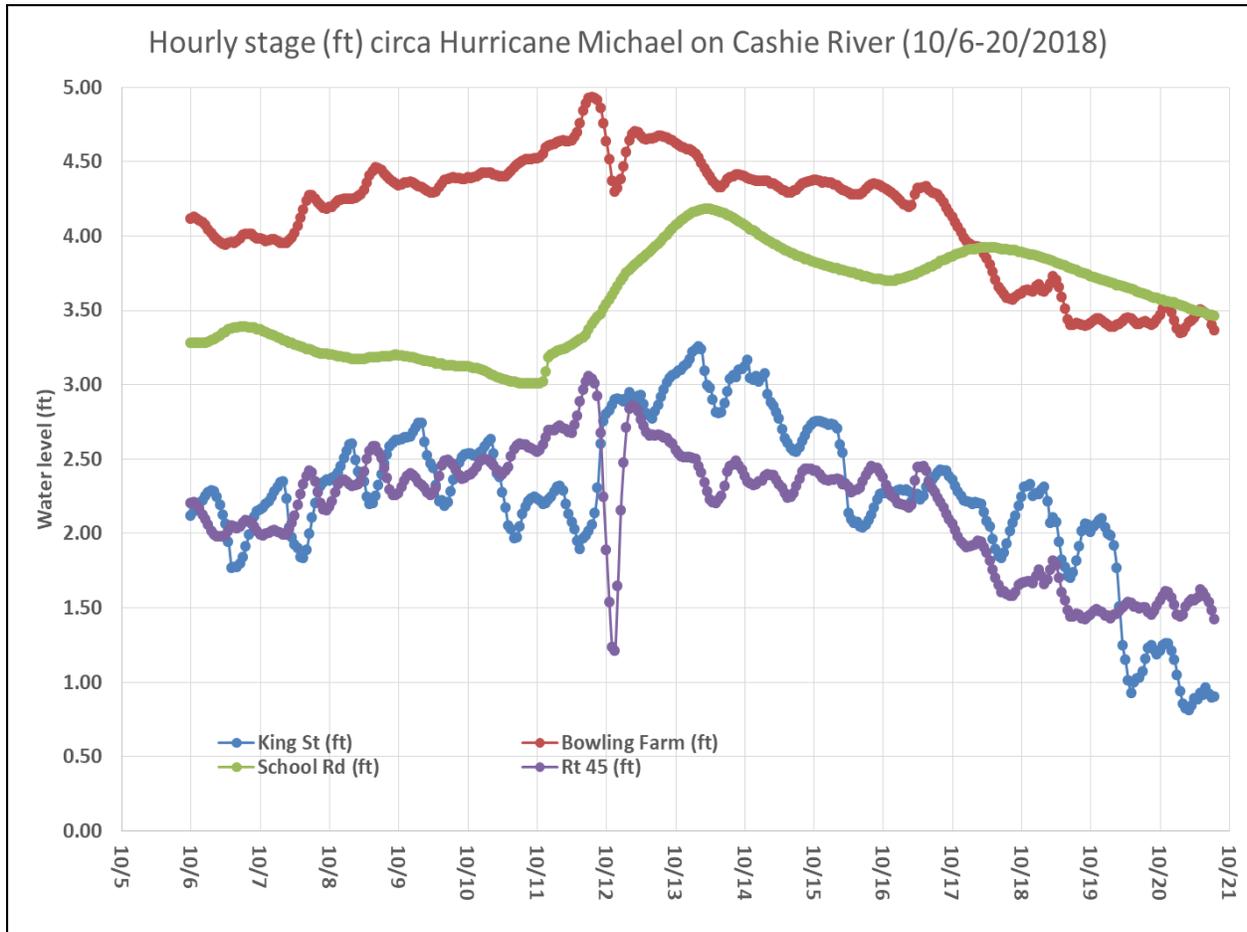
FIGURE 3-15. Patterns of average hourly stage heights (water levels in feet) at each of the four sites are shown over time during the period associated with Tropical Storm Michael. Note that stage heights represent the bottom of the river as zero feet at each site. Therefore, the overall vertical positions of the lines are not comparable. School Rd is represented as green, Windsor as blue, Bowling Farm as red, and Rt. 45 is purple.

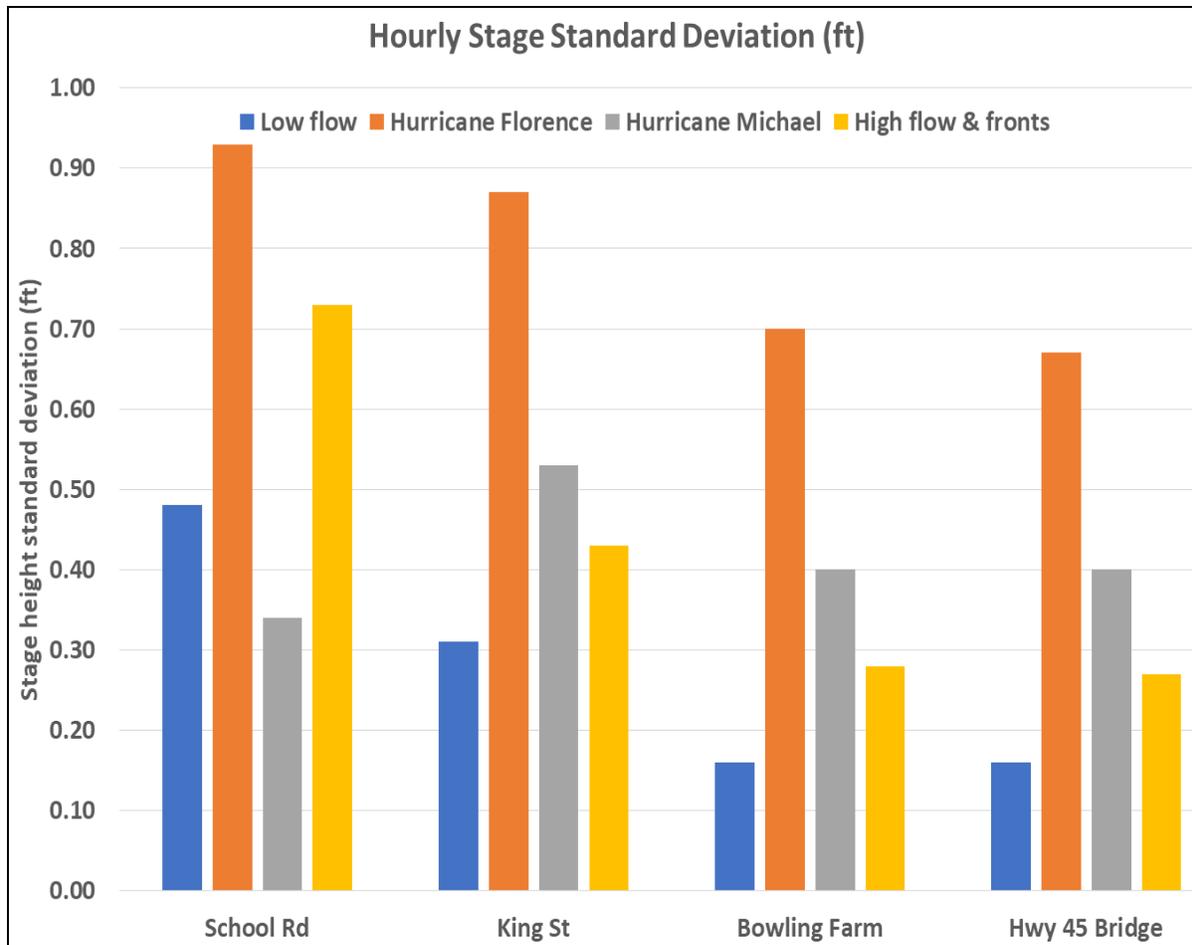
FIGURE 3-16. This plot shows the standard deviations of stage height for each site and the four time periods. Each bar represents the variation of water level through time for a period at each site. A longer bar indicates more variation in height through a time period. The low flow period (Aug. 8-27, 2018) is displayed in blue, Hurricane Florence (Sept. 7-24, 2018) is in orange, Tropical Storm Michael (Oct. 6-20, 2018) is in grey, and high flow and frontal periods (Nov. 20 to Dec. 20, 2018) is in yellow.

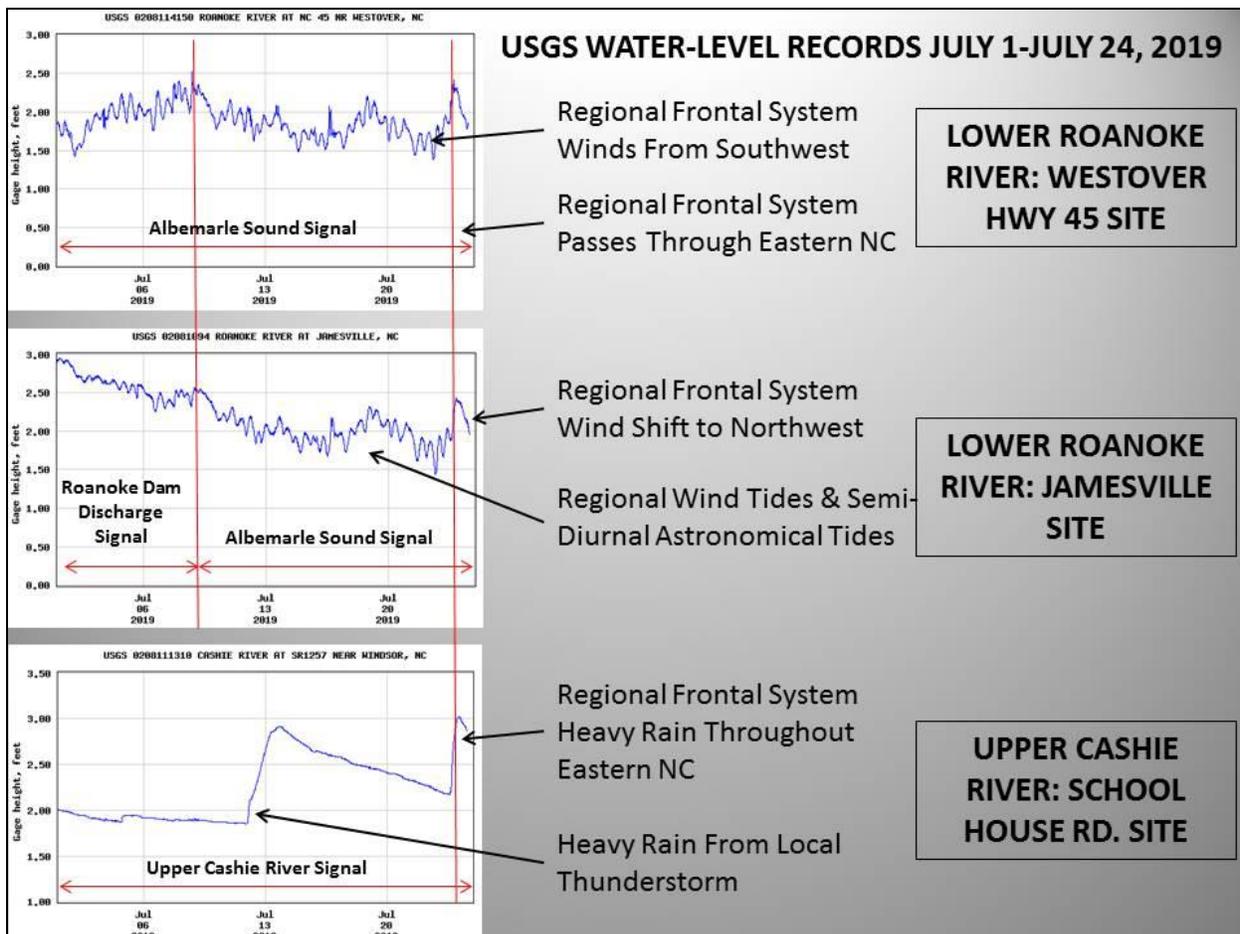
FIGURE 3-18. Plot compares the water-level gage patterns on the two lowermost gages in the lower Roanoke River with the uppermost gage on the upper Cashie River (School Road) for the period of July 1 through July 24, 2019. The upper panel is dominated by the Albemarle Sound signals of frontal systems, wind tides, and semi-diurnal astronomical tides. The middle panel is in the transition zone reflecting the decline of a dam discharge and a small Albemarle Sound signal superimposed on top for the first week. Then the second and third weeks are identical to the top panel. The bottom panel represents the upstream rainfall signal from a local heavy thunderstorm and one regional frontal system recorded on all three gages. None of these plots are corrected for absolute elevation.

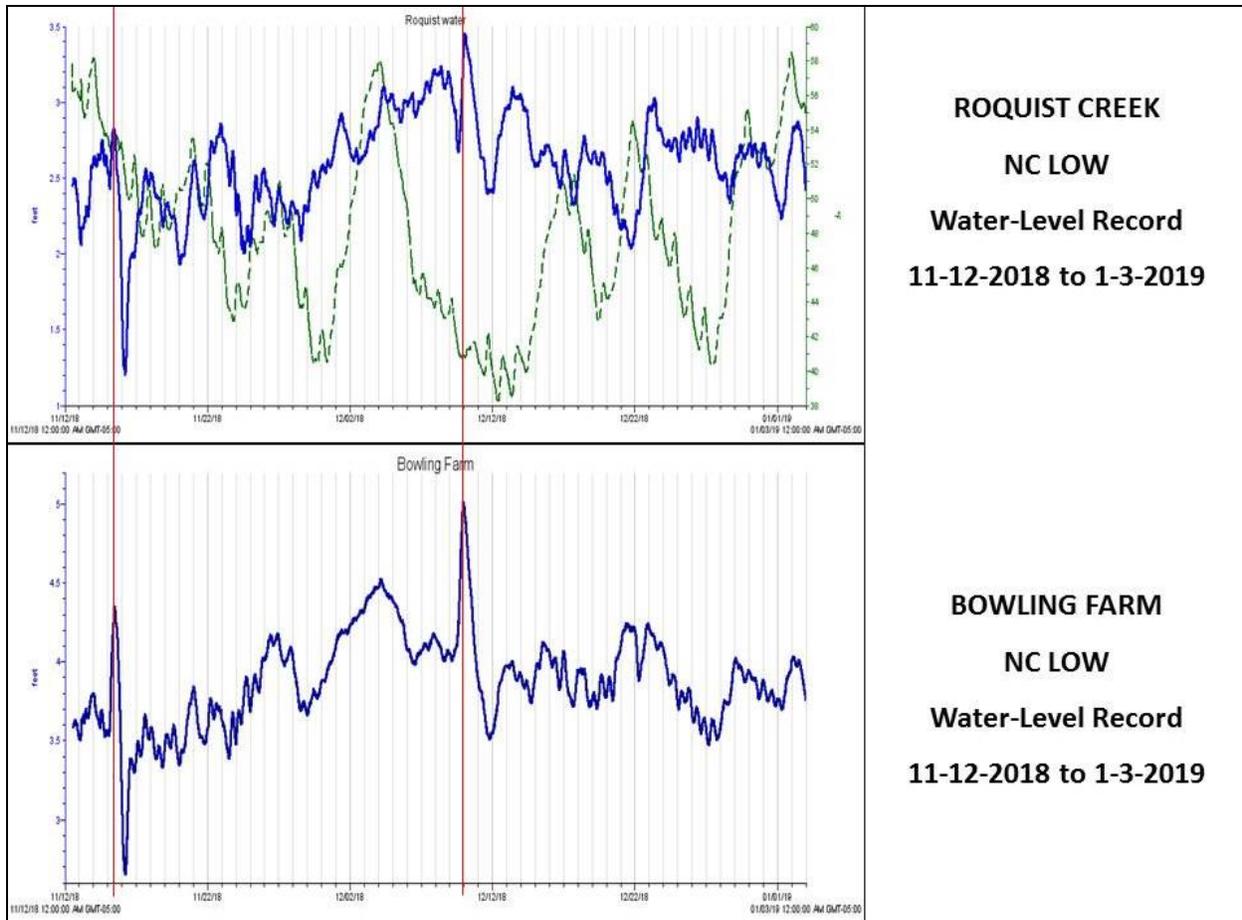
Figure 3-19. Plot compares the water-level gage patterns (in blue) for Roquist Creek (top panel) with the Bowling Farm gage (bottom panel and lowermost Cashie River) for the period 11-12-2018 (in blue) to 1-3-2019. Water temperatures at Roquist Creek are in green. The red lines are two examples of small storm surges that first blew Albemarle Sound waters to the west and then back to the east as the front passed through the region. Neither of these plots is corrected for absolute elevation.

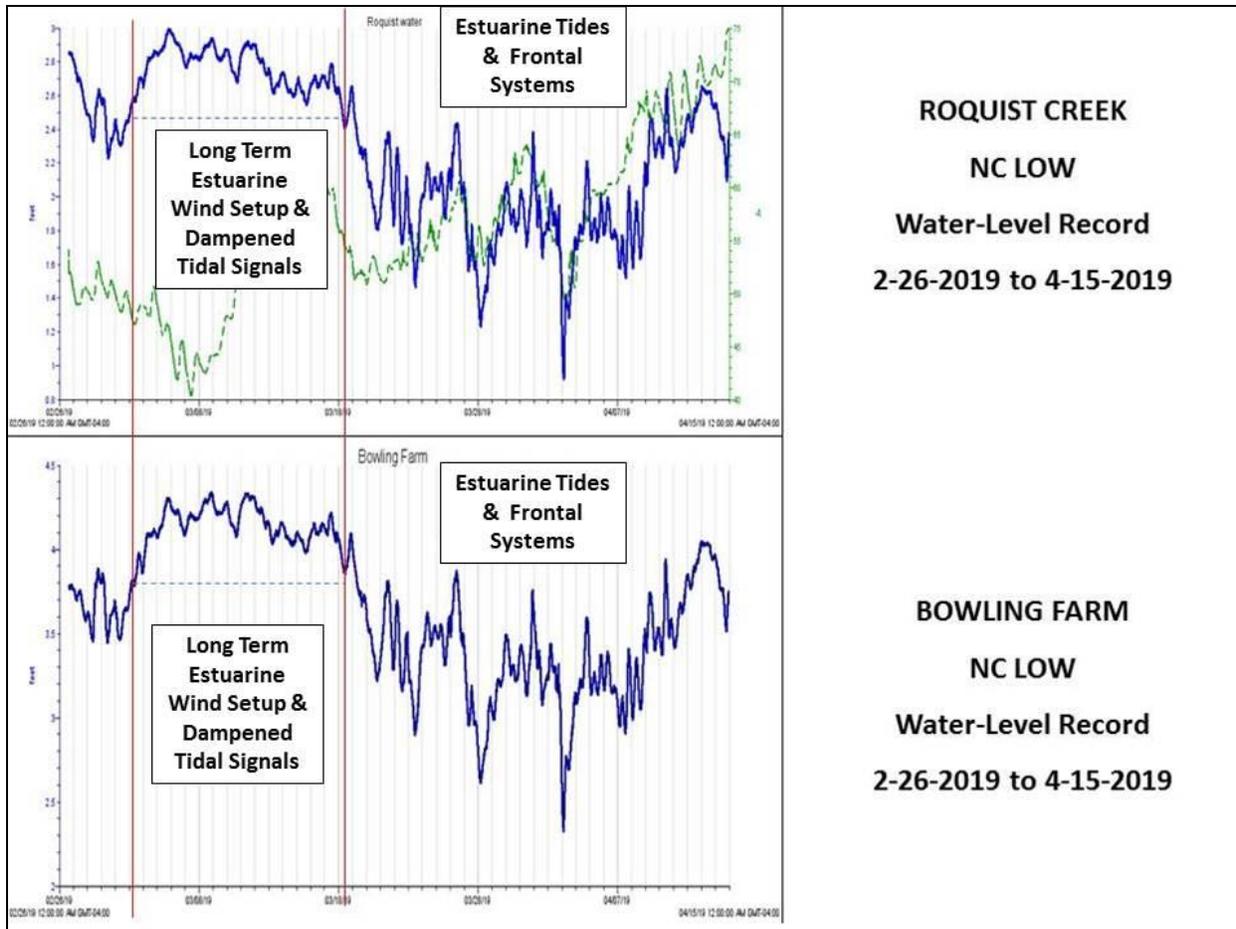
FIGURE 3-20. Plot compares the water-level gage patterns (in blue) for Roquist Creek (top panel) with the Bowling Farm gage (bottom panel and lowermost Cashie River) for the period 2-26-2019 (in blue) to 4-15-2019. Water temperatures at Roquist Creek are in green. The two red lines delineate an extended period of high water set up by a persistent wind pattern on Albemarle Sound. The higher water level caused a dampened tidal signal superimposed on top as compared to more prominent tidal signals and frontal systems during period of lower water levels on the right side. Neither of these plots is corrected for absolute elevation.

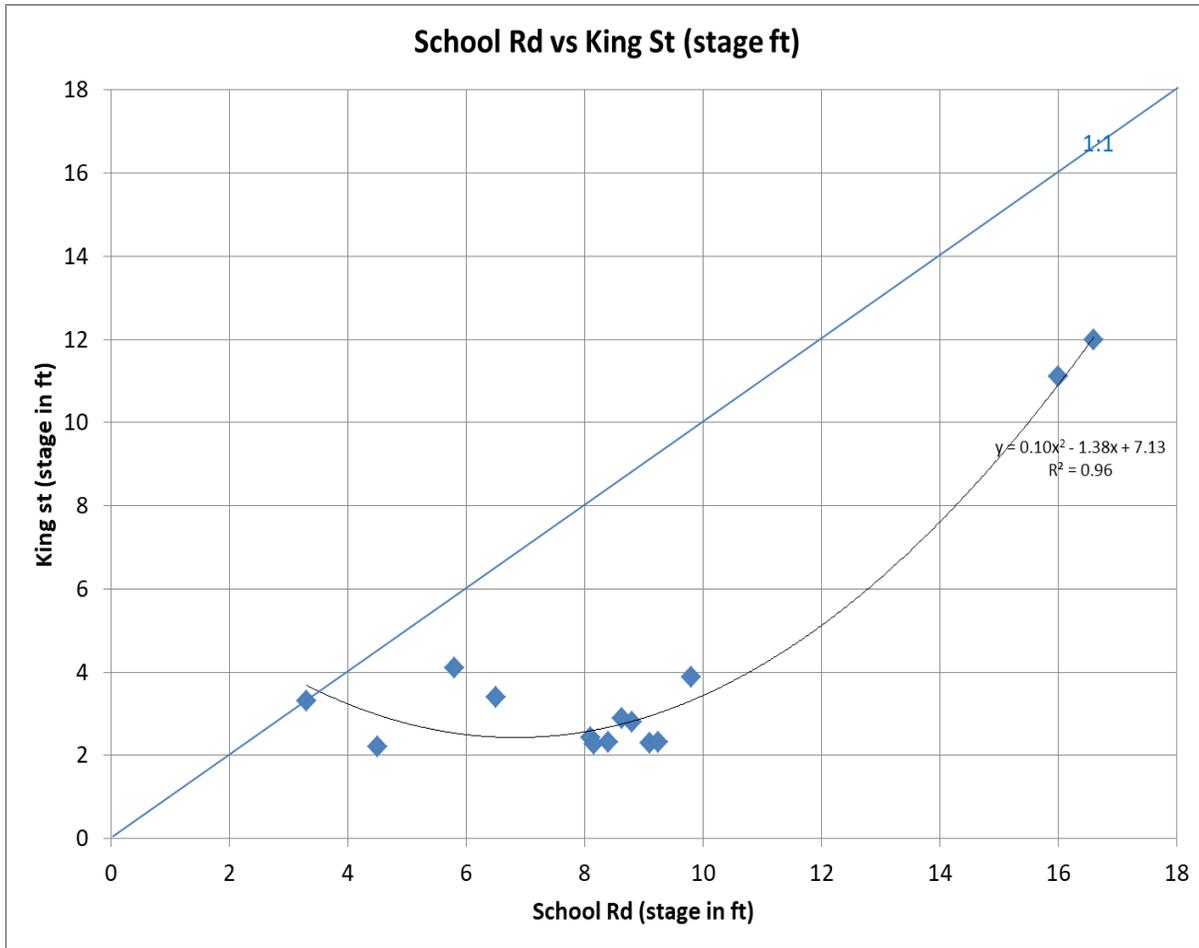
FIGURE 3-22. Cashie River water-level stages at King St. in Windsor and School Rd. during 15 high crest conditions. The blue line represents the 1:1 relationship between the two sites. A 4th order polynomial regression is used to predict the relationship between sites (black line).
