FLOOD DYNAMICS IN THE BERTIE WATER CRESCENT

INTEGRATING THE DYNAMICS OF COMPLEX DRAINAGE
SYSTEMS TO MINIMIZE STORM IMPACTS AND MAXIMIZE
AQUATIC ENVIRONMENT VIABILITY, BERTIE COUNTY, NC

NORTH CAROLINA LAND OF WATER (NC LOW)

August 20, 2019

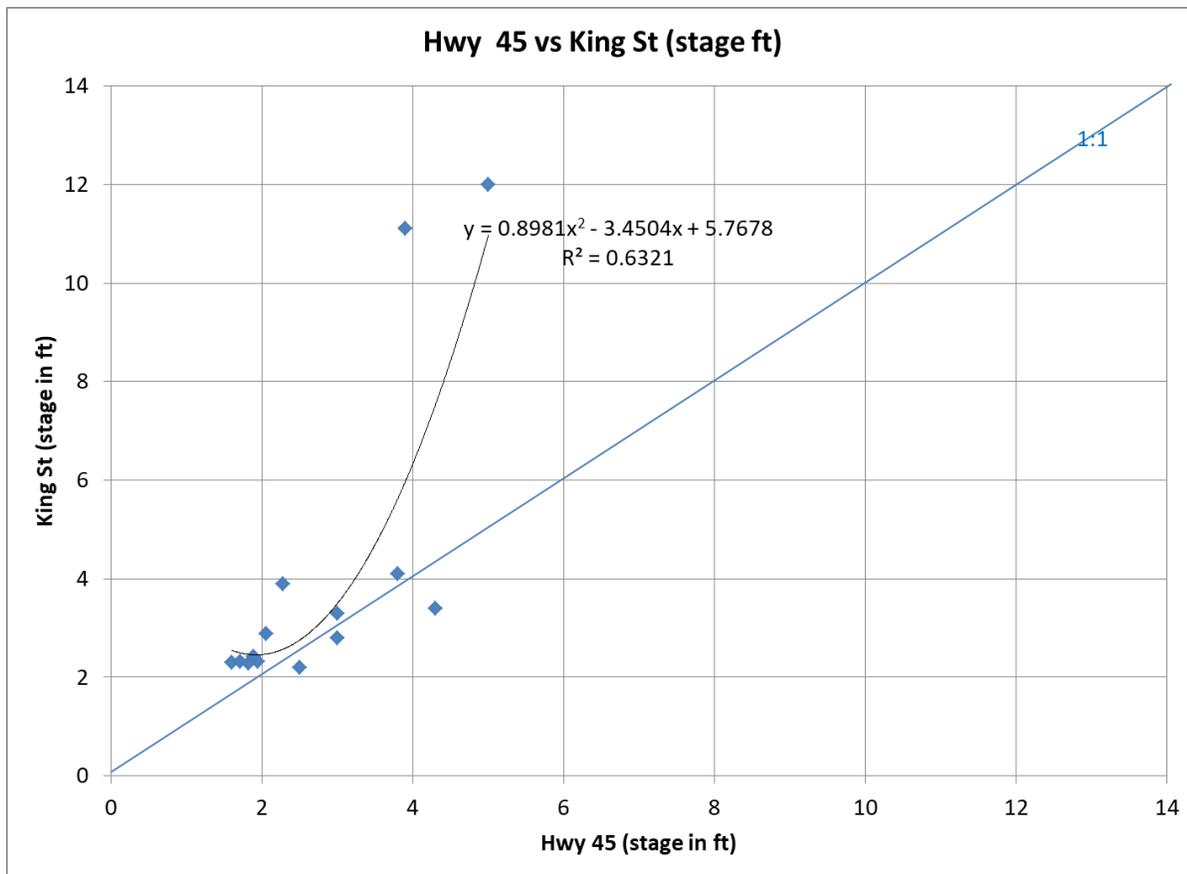
FIGURE 3-23. Water level stages at King Street and Hwy 45 Bridge are plotted for 15 high crest conditions. The blue line represents the 1:1 relationship between the two sites. Two regressions are shown. A 3rd order polynomial regression is used to predict the relationship between sites for all samples (black line). A simple linear regression running through zero is used to predict results for all but the 3 highest crests at School Rd.

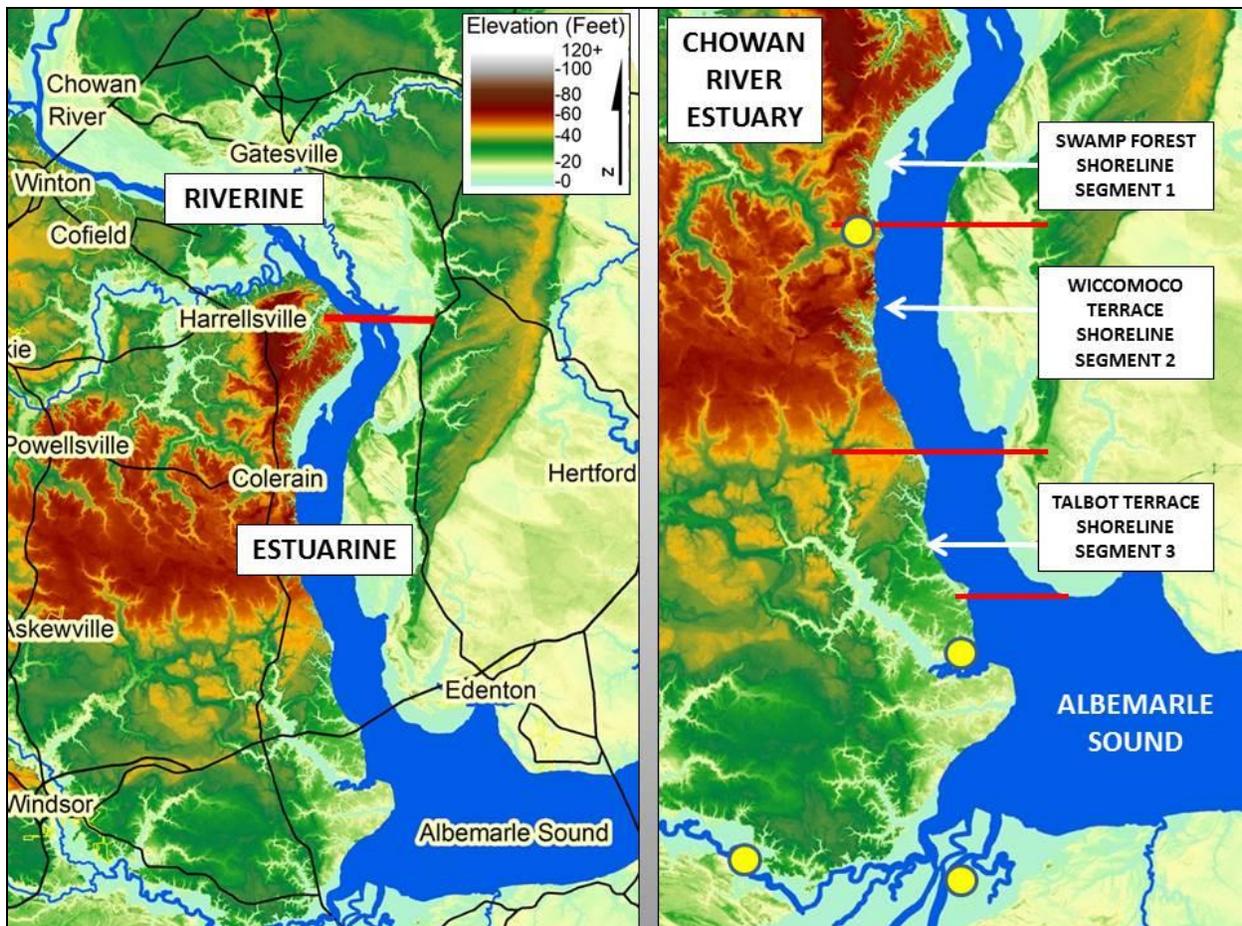
FIGURE 4-1. Two color topography maps of the Albemarle and Chowan estuarine systems that border Bertie County. The left panel shows the narrow Chowan River channel and wide floodplain to the north that gradually changes at the red line to a wide channel with only local floodplains to the south. This drowning of the riverine system is due to the ongoing rise of global sea level. The right panel is a closer view of the three shoreline segments of the western side of the Chowan River estuary. Yellow dots in the right panel show locations of water level recorders utilized in this section of the report; from N to S they are Colerain and Salmon Creek, Hwy 45 in the lower Roanoke River, and Bowling Farm in the lower Cashie River (location information is in Appendix A). Topographic data are from the NC 2015 LiDAR program. Map prepared by D. Ames.

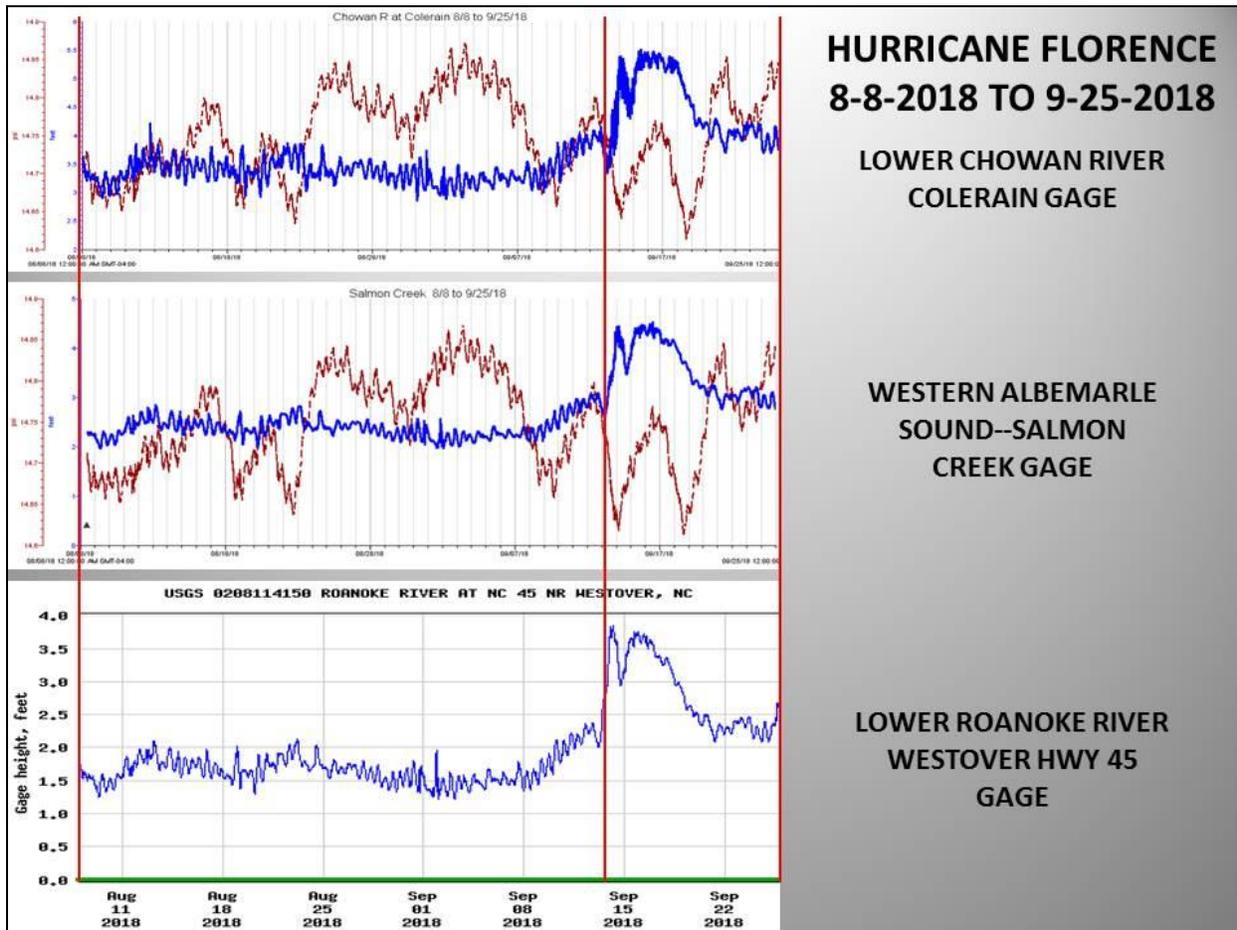
FIGURE 4-2. Water levels are shown for the period 8-8 to 9-25-2018 in blue and atmospheric pressure in red. Top panel is the Chowan River at Colerain, middle panel is west Albemarle Sound (in mouth of Salmon Creek), and bottom panel is the lowermost Roanoke River (Westover Hwy 45 Bridge). Notice the different types of wind setups, small frontal systems, hurricane Florence (middle red line) and astronomical tides that are superimposed on the background. Also, notice how all three systems are intimately connected. The water-level plots in this report are not corrected for absolute elevation.

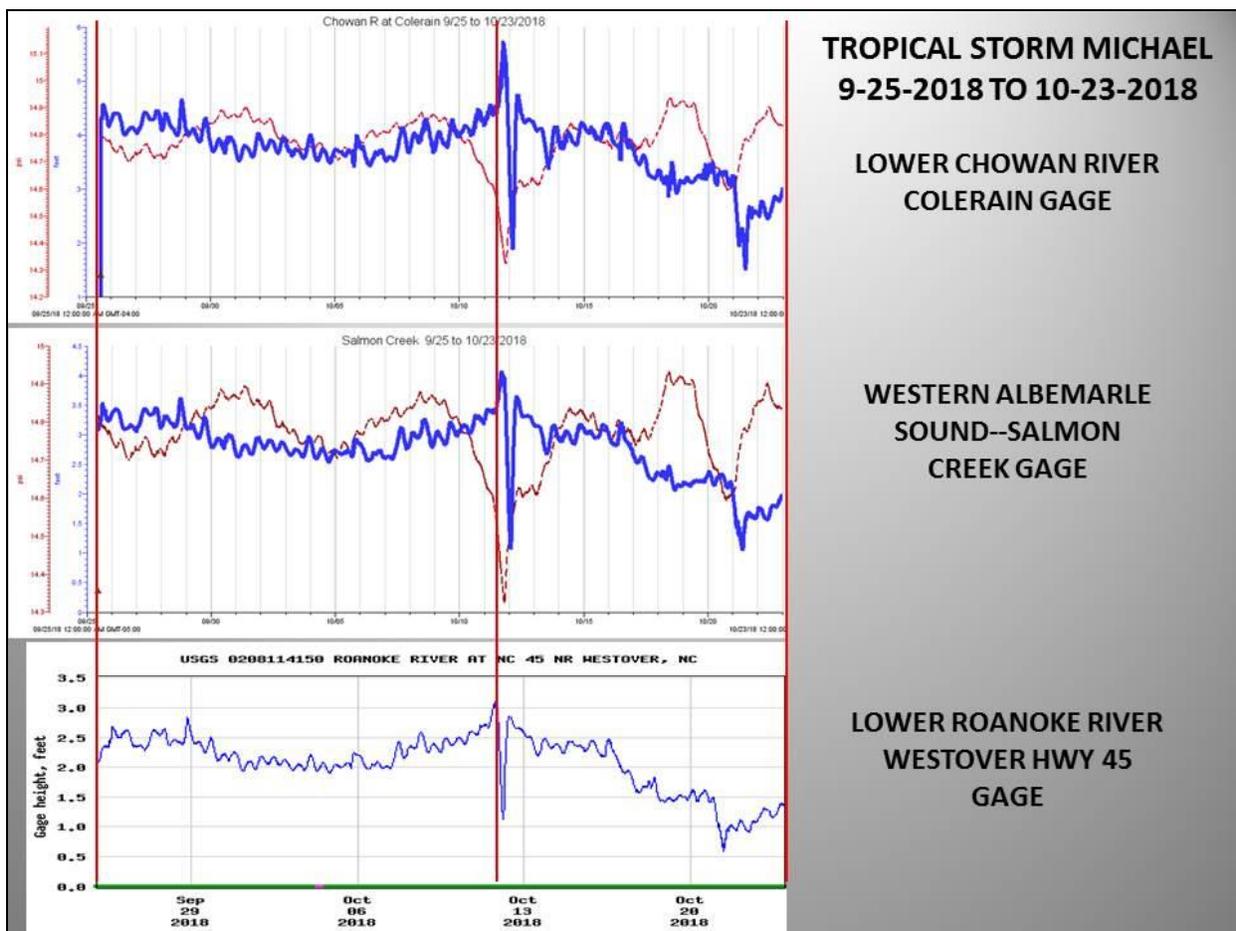
FIGURE 4-3. Water levels are shown for the period 9-25 to 10-23-2018 in blue and atmospheric pressure in red. Top panel is the Chowan River at Colerain, middle panel is west Albemarle Sound (in mouth of Salmon Creek), and bottom panel is the lowermost Roanoke River (Westover Hwy 45 Bridge). Notice the different types of wind setups, small frontal systems, tropical storm Michael (middle red line) and astronomical tides that are superimposed on the background. Also, notice how all three systems are intimately connected. The water-level plots in this report are not corrected for absolute elevation.

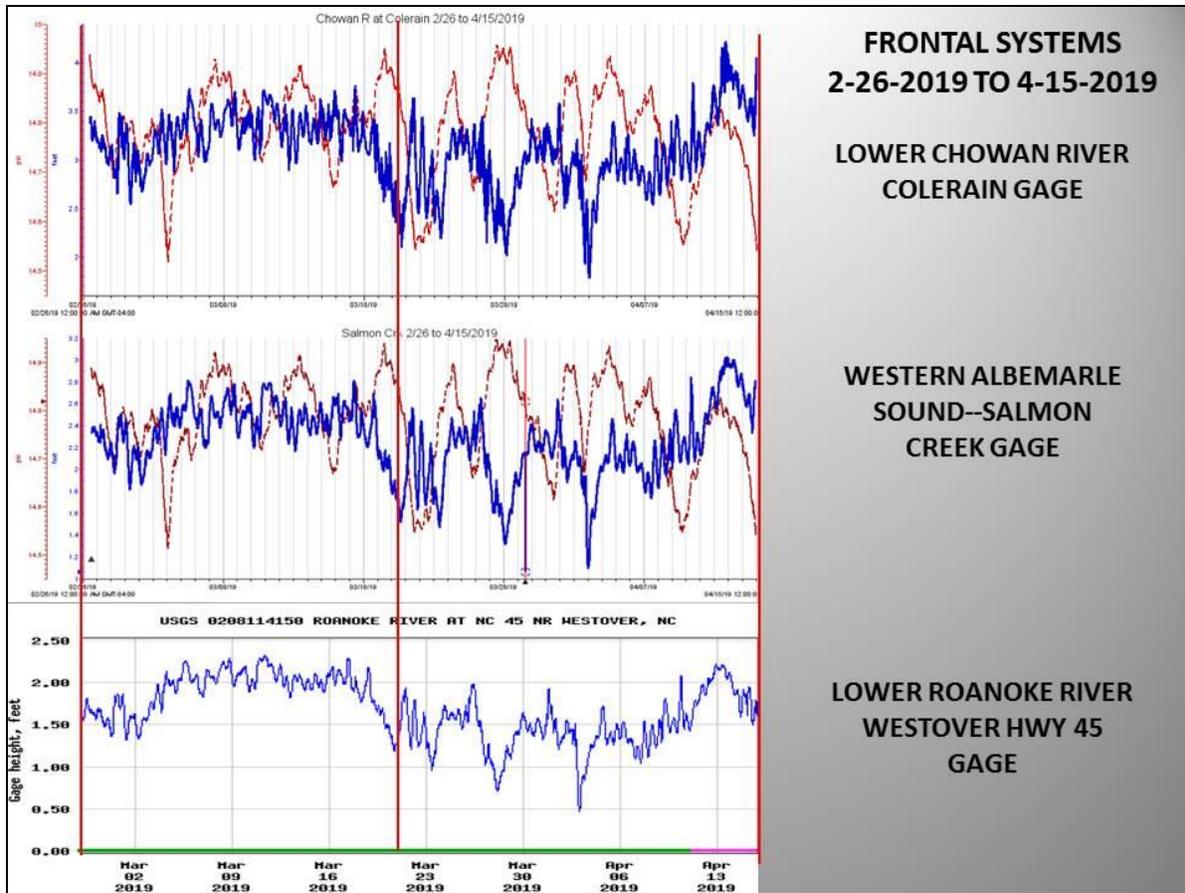
FIGURE 4-4. Water levels are shown for the period 2-26 to 4-15-2019 in blue and atmospheric pressure in red. Top panel is the Chowan River at Colerain, middle panel is west Albemarle Sound (in mouth of Salmon Creek), and bottom panel is the lowermost Roanoke River (Westover Hwy 45 Bridge). Notice the different types of wind setups, frontal systems, and astronomical tides that are superimposed on the background. Also, notice how all three systems are intimately connected. The water-level plots in this report are not corrected for absolute elevation.

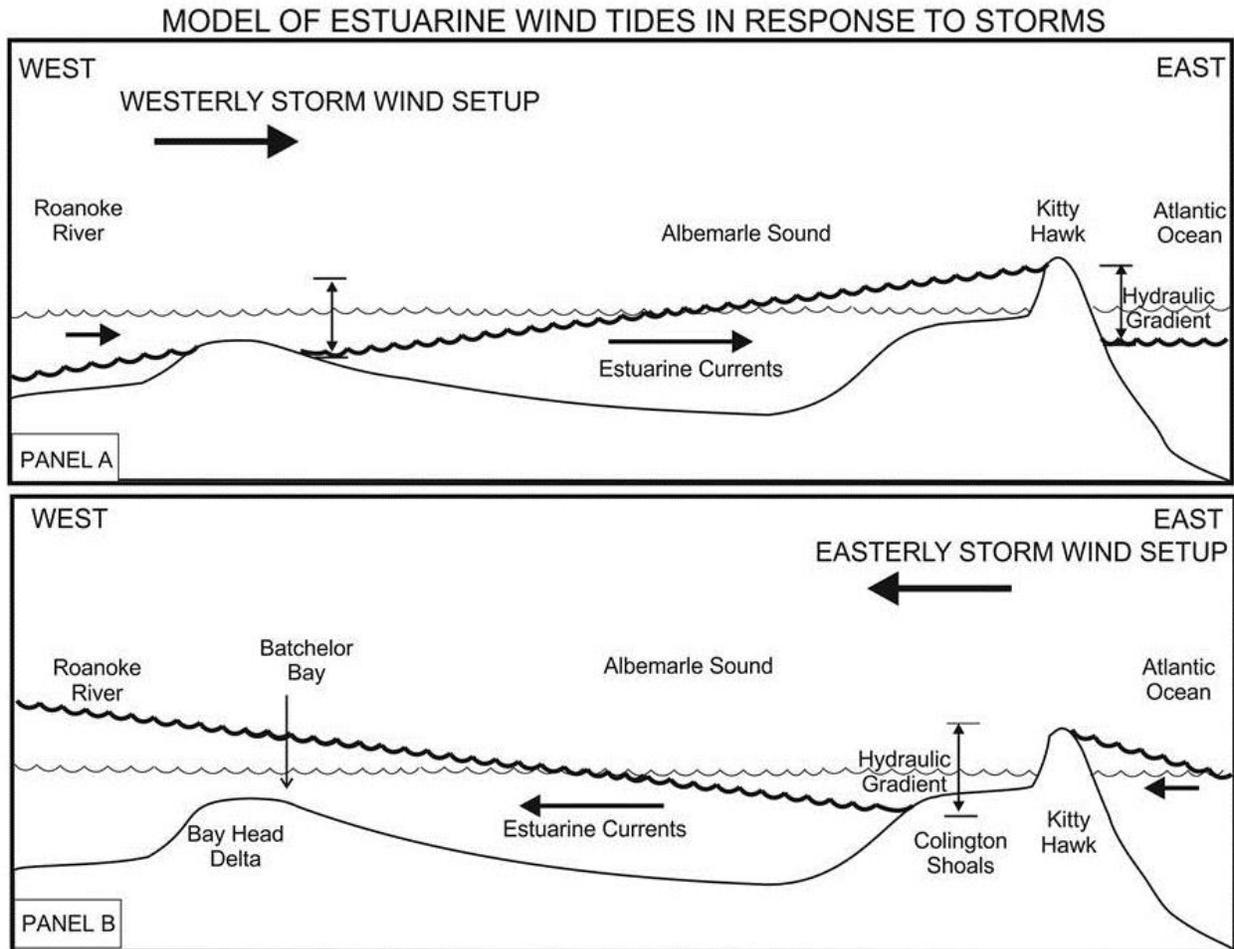
FIGURE 4-6. Schematic model shows two west to east cross-sections of A-A' in Figure 4-5. The profile in panel A and B show two important concepts. First is the generalized bathymetric profile from the mouth of the Roanoke River, across the bay head delta in Bachelor Bay, to the Outer Banks barrier island. Second is the exaggerated effect of the "teeter-totter" resulting from the westerly storm winds (Panel A") and easterly storm winds (Panel B) of a major hurricane moving across the waters of Albemarle Sound. The profiles are not drawn to scale.

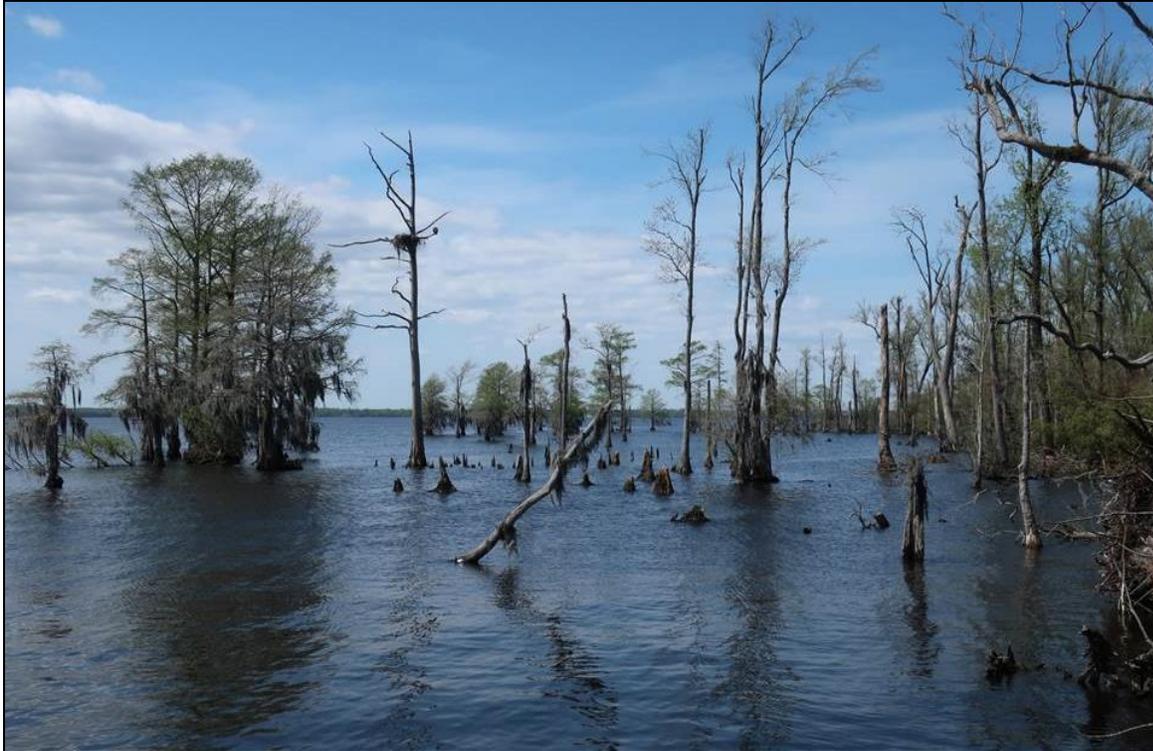
FIGURE 4-8. Photograph of the Rocky Hock remnant floodplain swamp forest that occurs on the eastern side of the Chowan River estuary and on both sides of the Highway 17 Bridge. Notice the effects of ongoing process of drowning due rising sea level: 1) bald cypress trees survive with permanent flooding, 2) whereas the other swamp forest trees can't and stand as dead soldiers, broken logs, and stumps in permanently flooded conditions. Photograph is by S. Riggs.

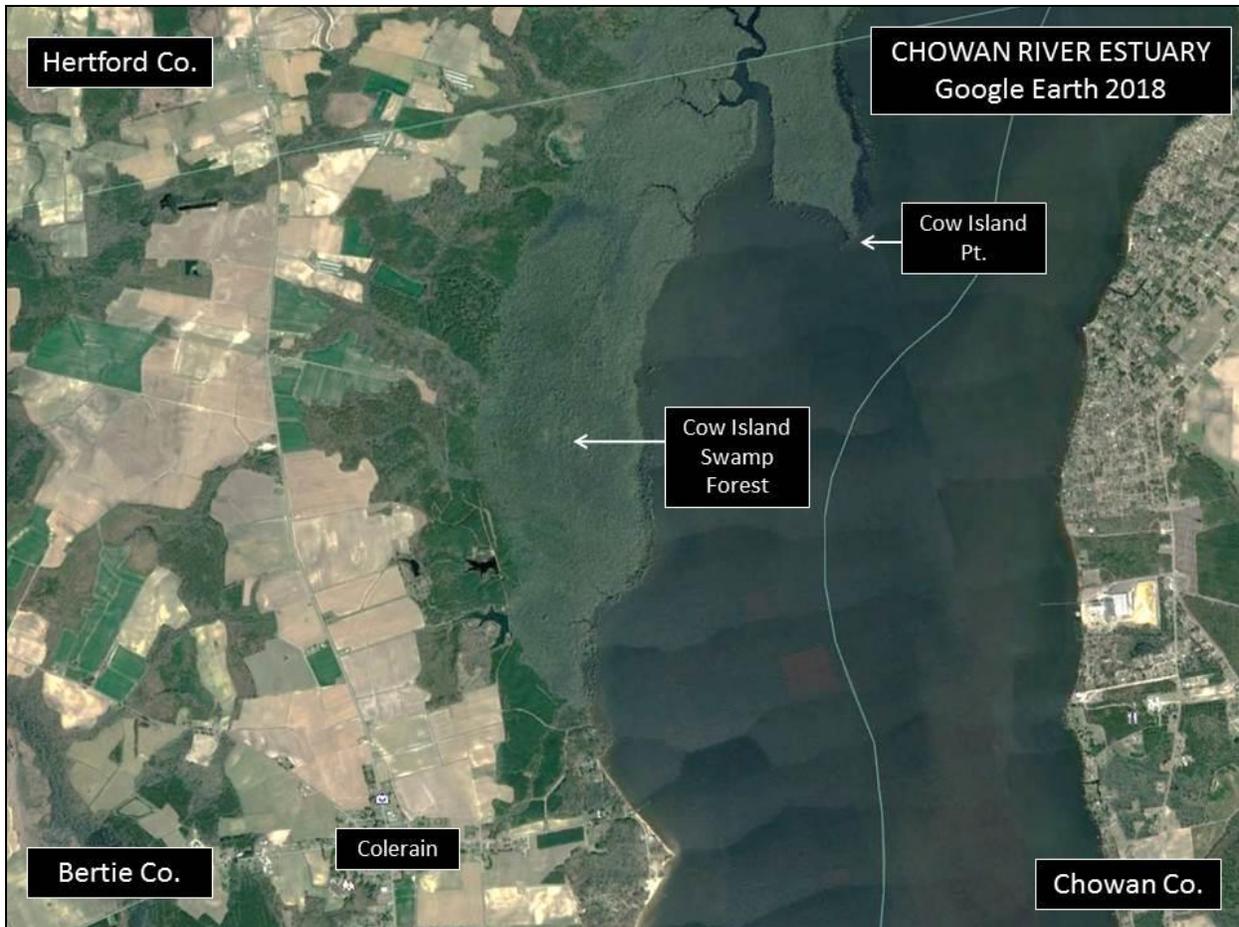
FIGURE 4-11. This Google Earth aerial photograph of shoreline segment 1 extends from the Hertford County line in the N to Cape Colerain in the S. Notice the abrupt change along the western side of the Cow Island Swamp from swamp-forest vegetation (gray green) to the Wicomoco Bluff with its ravines filled with old hardwood forests (bright green) and the upland agricultural fields. Also, notice the cypress fringe that occurs along the E side of the Cow Island Swamp (Figure 4-12).

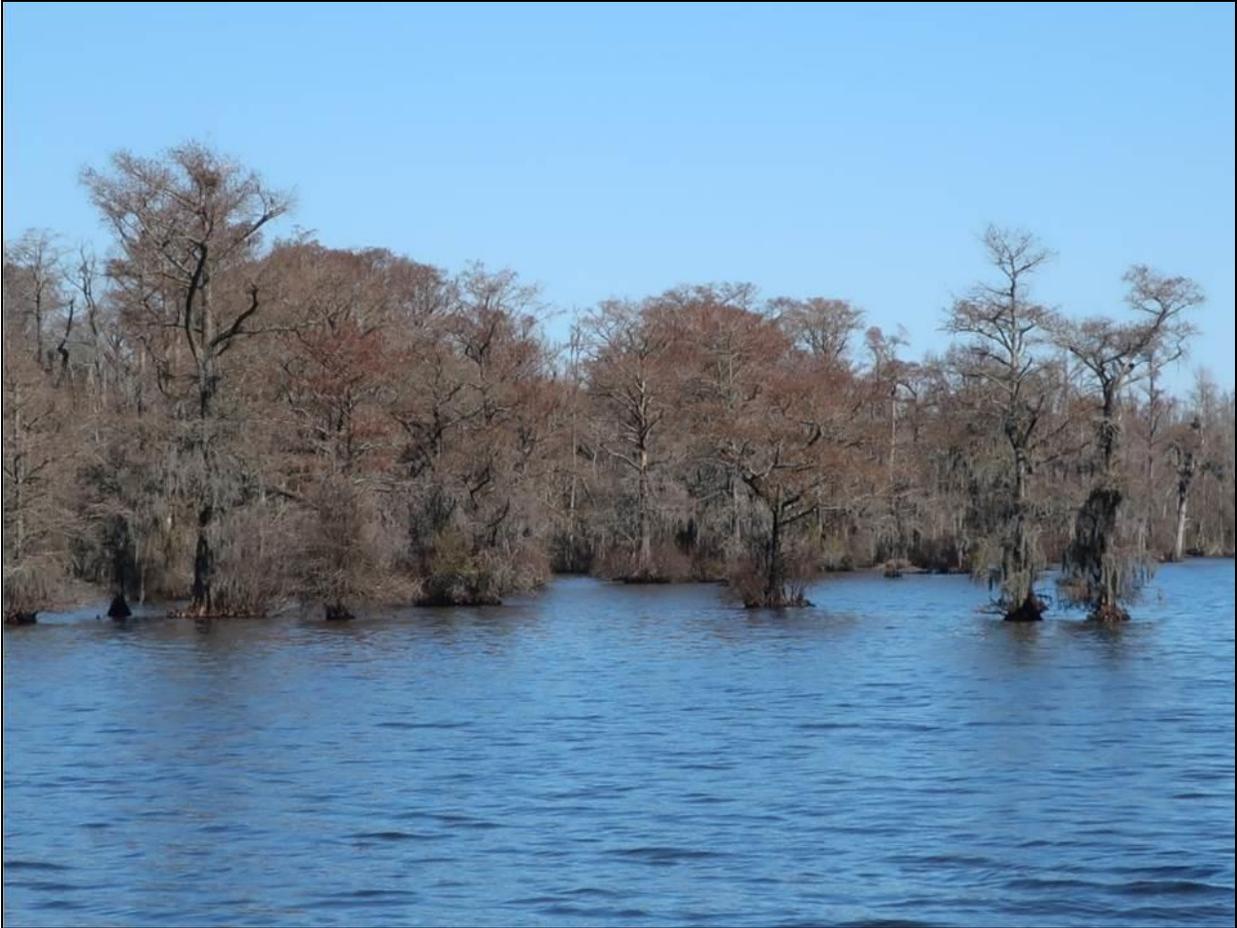
FIGURE 4-12. Photograph of the cypress fringe along the east side of the Cow Island Swamp Forest. This cypress swamp acts as a natural storm buffer for the Wicomoco Bluff and associated uplands to the W and the cypress fringe and associated creeks form natural tracks for kayakers and canoers. Photograph is by S. Riggs.

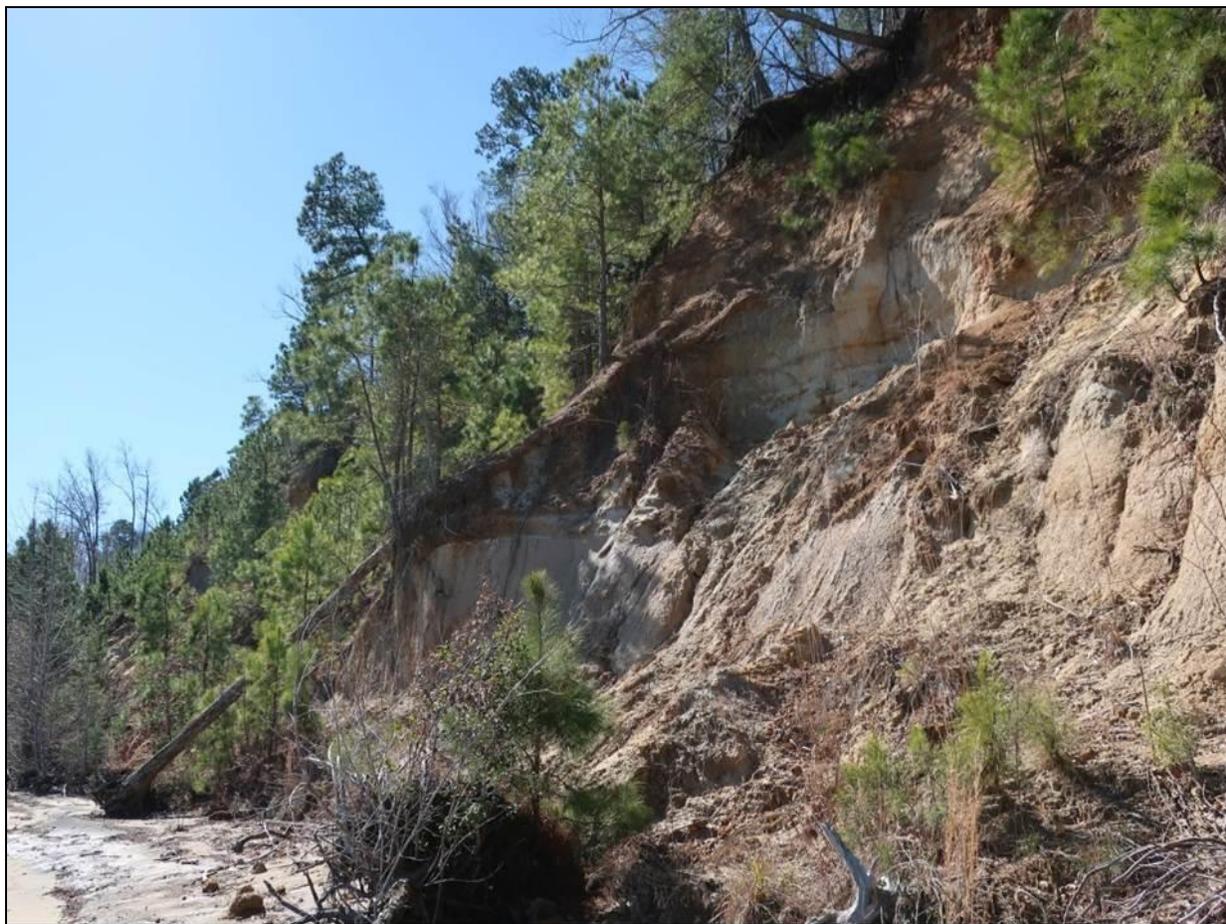
FIGURE 4-13. The Wicomoco Bluff shows a partially vegetated bank on the left grading to a recently eroded segment on the right with a new slump block in the middle. Notice the new young pines starting to revegetate an older slump block on the lower right. Not only do these slump blocks supply new and sole source of sand to the narrow strand-plain beach, but if allowed to revegetate, will provide short-term buffer protection for the eroding cliff. Photograph is by S. Riggs.

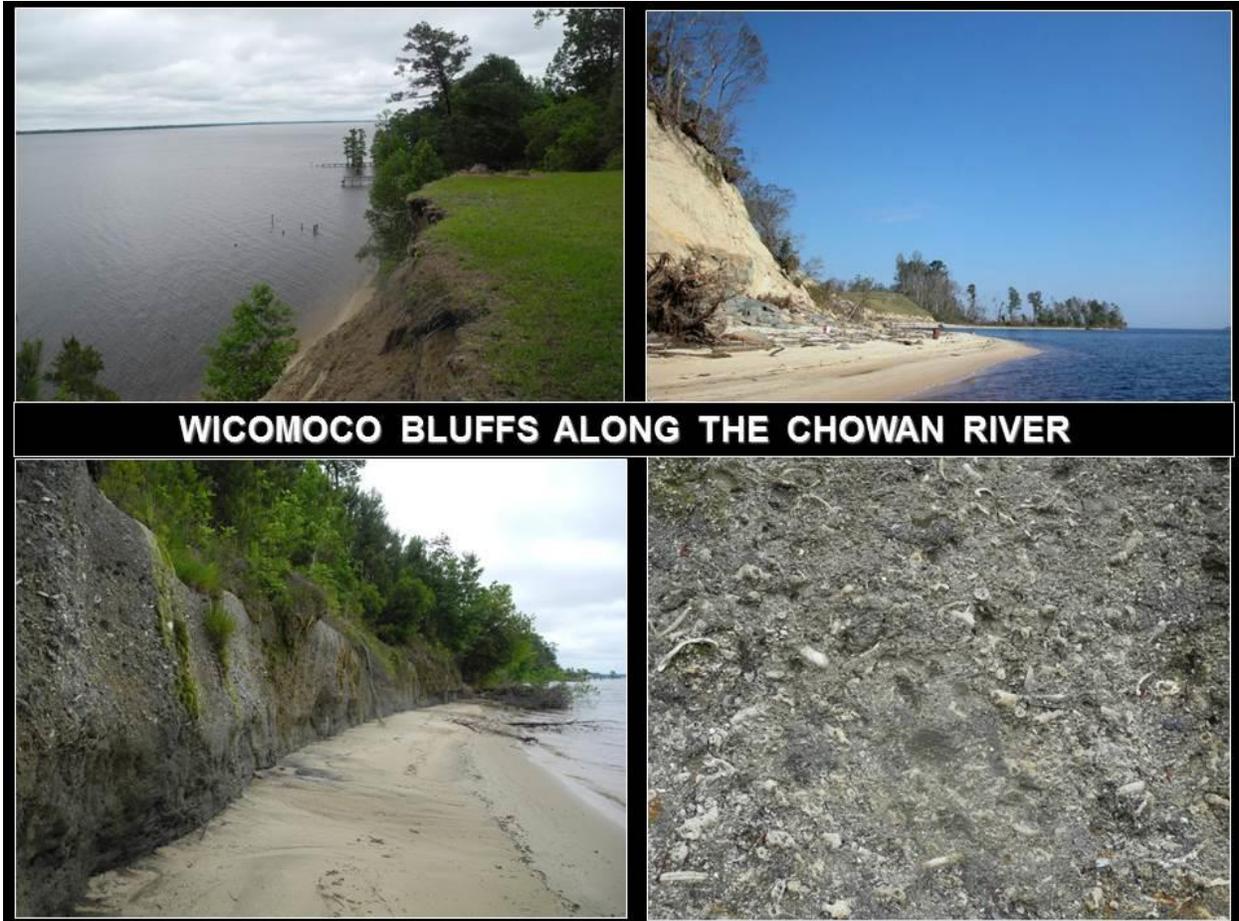
WICOMOCO BLUFFS ALONG THE CHOWAN RIVER

FIGURE 4-14. Upper left panel is a view looking south from the Wicomoco Terrace on top of the eroding bluff with the Chowan River estuary. Upper right panel is a water level view looking north at the Wicomoco Bluff. Notice the large delta flat and cypress that form a resistant headland sticking out into the Chowan River estuary. Lower left panel is a view looking north along a different section of Wicomoco Bluff in which the upper sand bed is highly vegetated with water seeping out of the bank on top of the very thick lower clay bed. Notice the very tough and pure clay bed at the base that grades upward into a very fossiliferous sandy mud bed in the upper 2/3. Also, notice the very narrow strand-plain beach and the natural vegetation jetties trapping sand in the distance. Lower right panel is a close-up of the fossil bed in the lower left panel. The elongate and rounded fossils are all finger corals, the arcuate fossils are clams, and minor amounts of scallops and oysters; all organisms that live in warm, shallow, and calm ocean waters deposited during a former time when sea level was at least 20-25 feet higher than it is today. Photographs are by S. Riggs.

The bluff is generally composed of the following marine strata (Figure 4-14). A basal layer of tight and slick, highly burrowed, blue to gray clay. The clay bed in certain areas grades upward into an extremely fossiliferous muddy sand containing abundant marine finger corals, scallops, oysters, and clams. Above the clay is a very thick layer of clean quartz sand that is often cross-bedded and full of crab burrows. The contact between the overlying sand and underlying clay contains many small springs that continuously weep water and precipitate orange iron oxide that can form a bed up to two to three feet thick. As the bluff erodes it supplies the sand that forms a thin strand-plain beach along with fragment to boulder size pieces of ironstone, mudstone, and fossils.

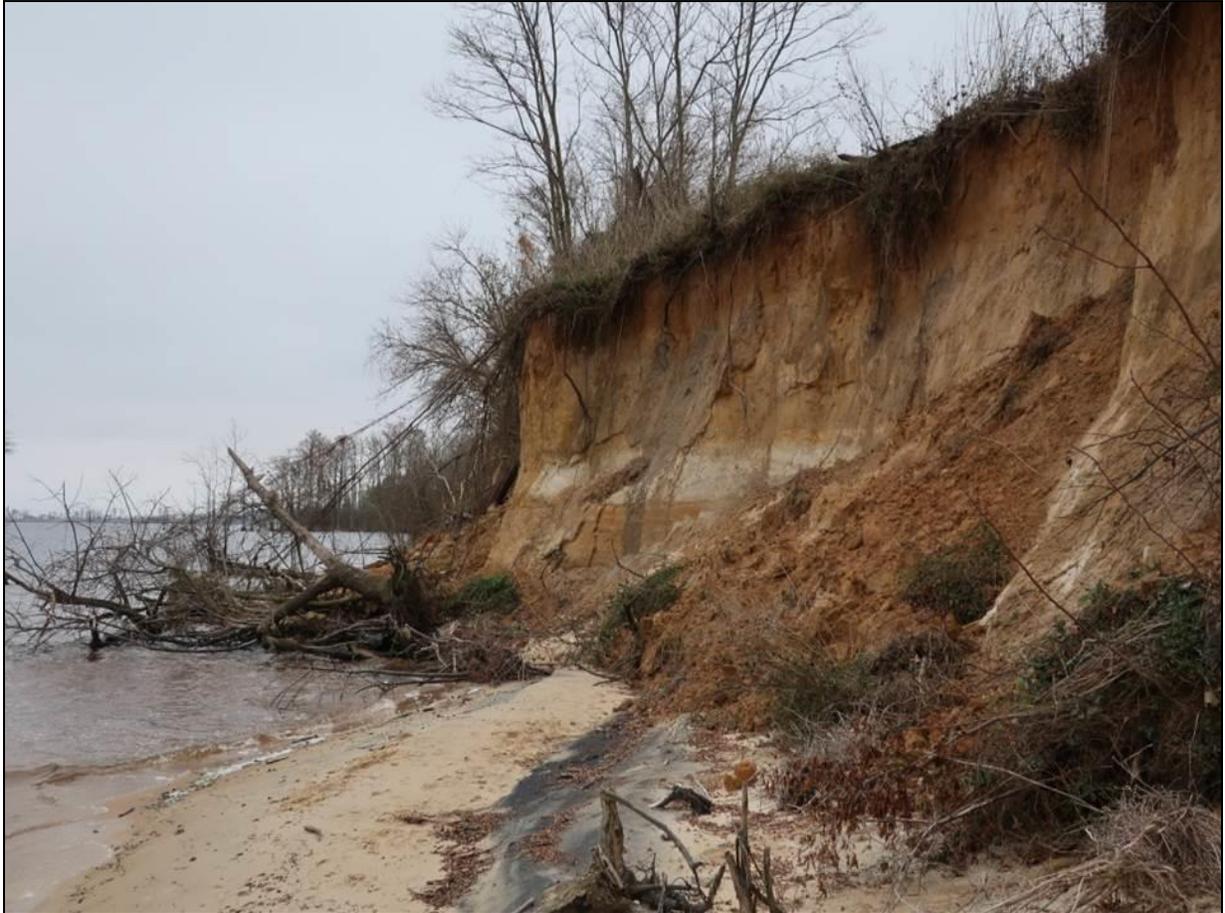
FIGURE 4-15. Photograph is a view looking south at the erosional bluff associated with the Talbot Terrace with elevations between 30 to 40 feet in shoreline segment 3. The eroding bluff has a recent landslide that has not been rained on yet. Notice the different kind of sediments as compared to the Wicomoco bluffs in Figure 4-14 and 4-13. Also, notice the importance of the collapsed vegetation in protecting a small headland and in trapping the small amount of beach sand in the foreground. The water body is the western end of Albemarle Sound. Photograph is by S. Riggs.

The shoreline from Heritage Wharf south to Salmon Creek, Scotch Hall, and Black Walnut Point consists of the smaller 20 to 40 foot high cliffs of the Talbot Terrace. The cliffs are also highest in the north and slope gently southward. South of the Hwy 17 Chowan River Bridge, increased wave energy and storm surge resulting from the direct influence of the 75 mile long east-west fetch of Albemarle Sound, increases the erosional impact on the southeastern shorelines of Bertie County.

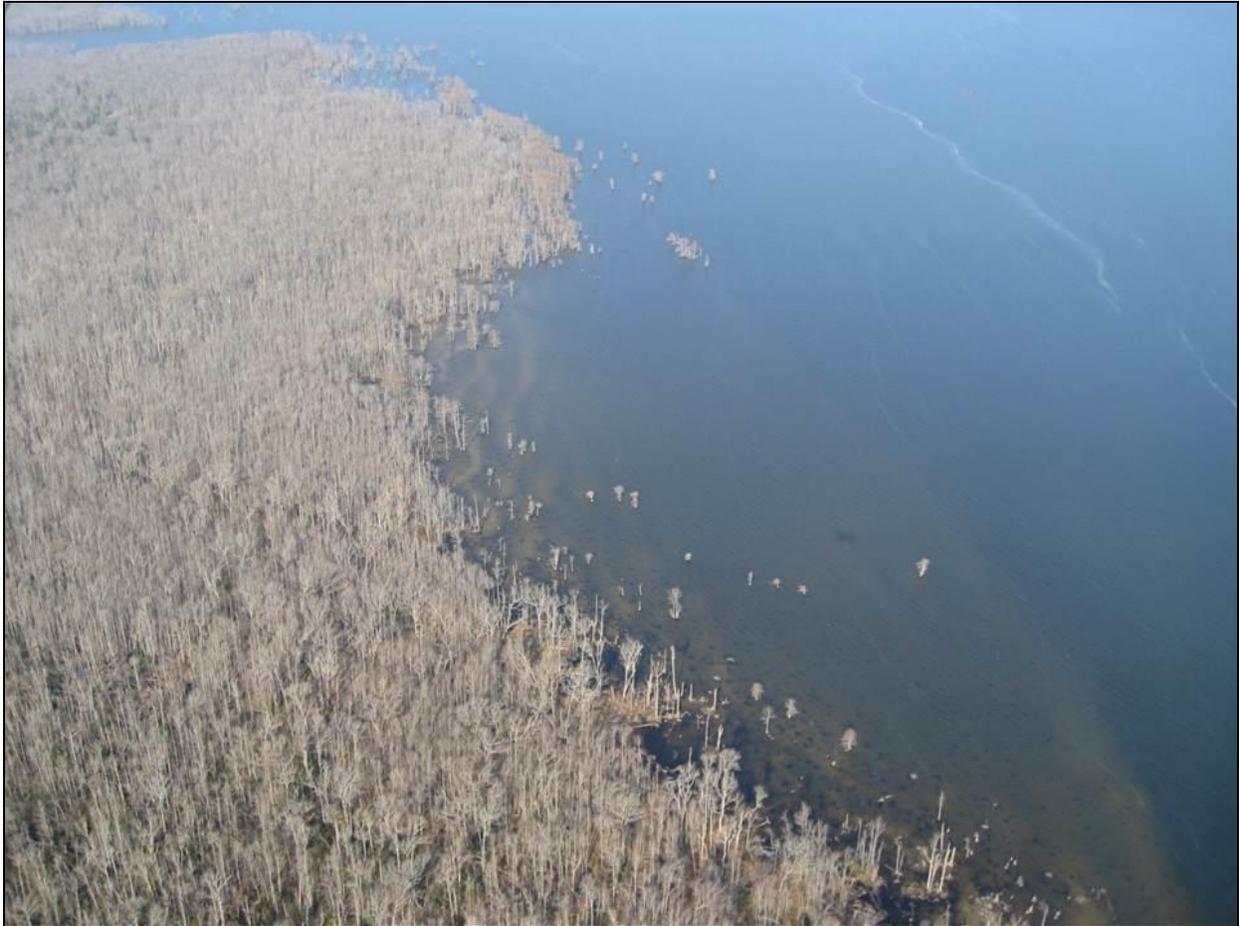
FIGURE 4-16. An oblique aerial photograph of the eastern edge of the Roanoke River floodplain the faces the long fetch of the east-west oriented Albemarle Sound. Notice the drowning process that kills most of the trees and leaving a narrow cypress rim growing in Albemarle Sound. Photograph is by S. Riggs.

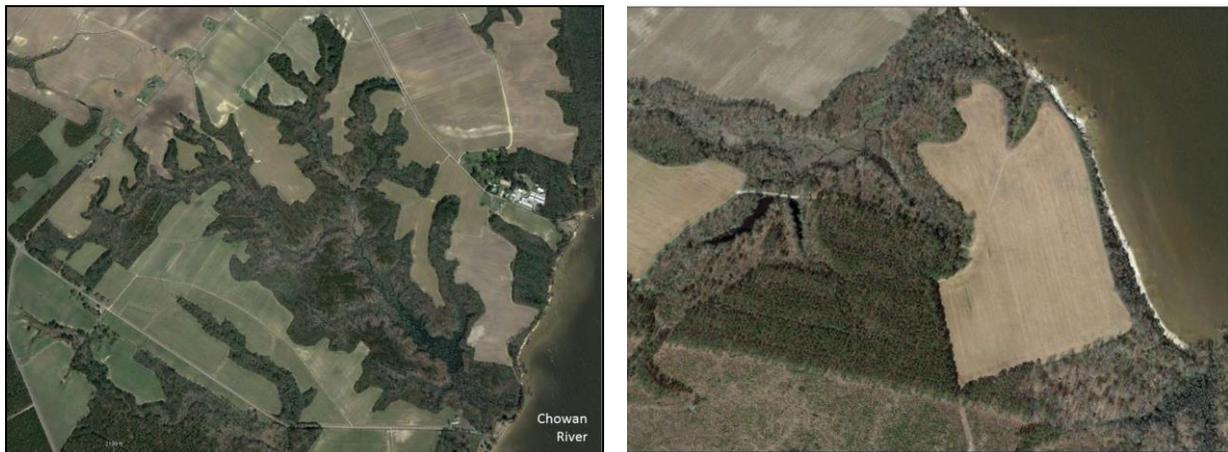
FIGURE 4-17. Google Earth 2018 images show two different short, steep, incised ravine systems with their significant hardwood ecosystems draining into the Chowan River Estuary and surrounded by agricultural fields. The left panel is an entire ravine drainage system incised into the high Wiccomoco Terrace in the vicinity of Ashland. The right panel is a partial ravine drainage system incised into the lower Talbot Terrace in Bertie County’s “Tall Glass of Water”. Notice the ephemeral ponds and the small delta and cypress fringe in the left panel and the dammed ponds on a tributary to the trunk ravine and its smaller delta and cypress fringe in the right panel.

The drainage system off the eastern side of the Talbot Terrace (east of Hwy. 45) is dominated by a dozen or more short (less than 1 to 2 miles) steep ravines that are deeply incised into the bluffs (Figure 4-17). Where each ravine flows into the Chowan River estuary, there is a shallow delta flat that is generally surrounded by a cypress fringe. This is where all of the older shoreline communities occur. The delta flat is semi-protected from shoreline erosion by the cypress fringe. Consequently, each ravine and its delta flat forms a cypress headland. The bluffs between the cypress headlands are much more vulnerable to erosion and results in a series of cusped-shaped embayments between cypress headlands.

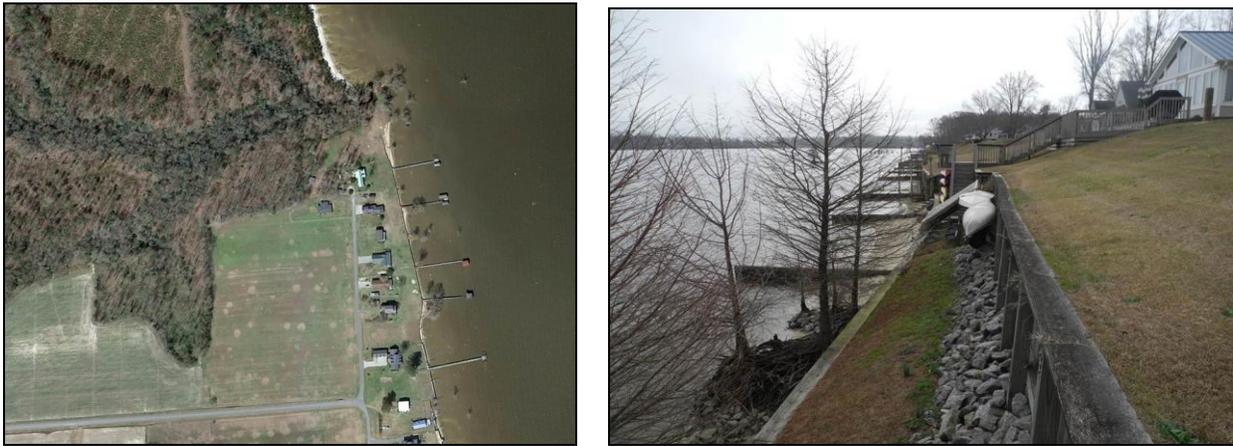
FIGURE 4-18. Left panel shows a Google Earth 2018 image of an incised ravine with its delta and cypress headland at the top and a housing development on the top of the adjacent Talbot Terrace overlooking Albemarle Sound. Since the Talbot bluff was severely eroding, the development bulldozed the bluff and put in several levels of wood and rock bulkheads, along with an array of jetties as shown in the right panel. Now that the sand supply from the eroding bluff is no longer available, the beaches are disappearing. Major storm surges will continue to destroy the bulkheads and take away the remaining sand (see Hurricane Isabel section). Right panel photograph is by S. Riggs.

Since the ravines are incised into either the Wiccomoco Terrace (45-80 foot elevations) or the Talbot Terrace (20-45 foot elevations), the adjacent areas between ravines form spectacular coastal bluffs along the Chowan River, Albemarle Sound, and Roanoke River. These bluffs are continuously sculpted by the dynamics of the adjacent water bodies and are generally areas of severe erosion. Consequently, as more and more people move to the edge of water bodies with spectacular view-scapes, they also, tend to clear the natural forests for manicured lawn-scapes and bulldoze down the steep and eroding bluffs for water access and erosion control structures (Figure 4-18). An end result is that the significant fauna and flora expose a critical component of North Carolina's history of past climate change and sea-level fluctuations within the natural bluffs and associated ravine habitats, which are both rapidly becoming endangered ecosystems.

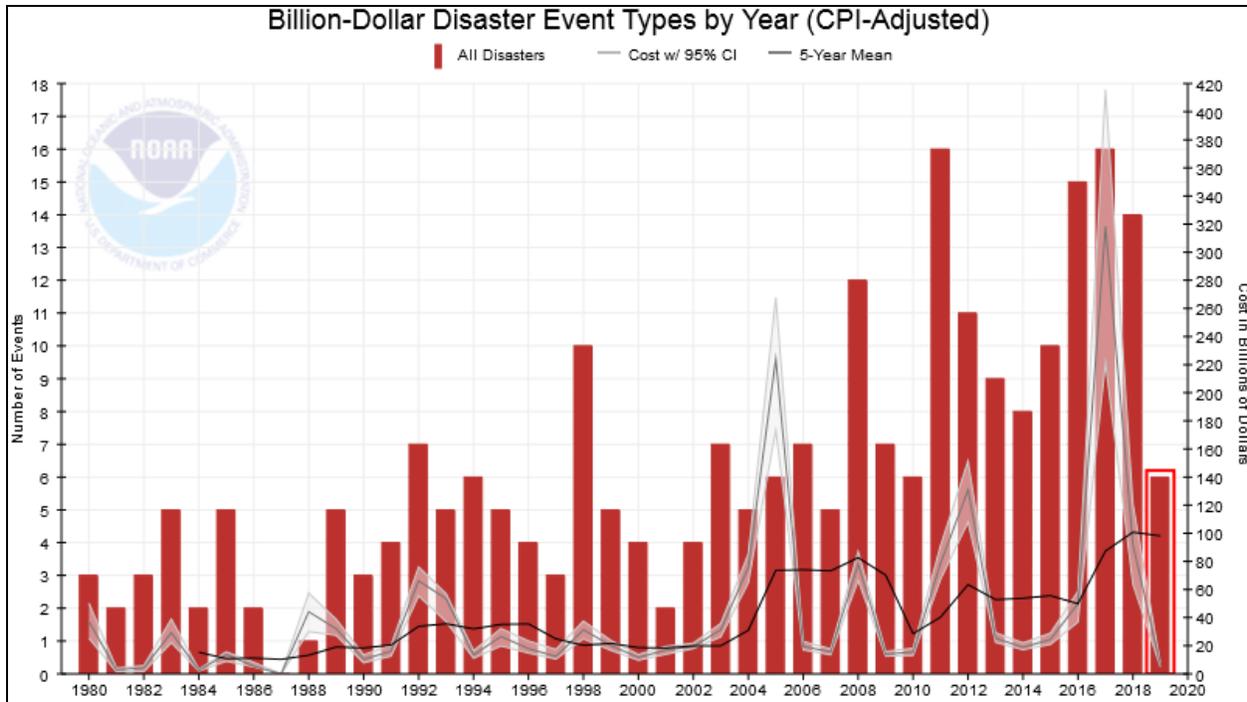
FIGURE 5-2. The 1980 to July 9, 2019 NOAA plot of number and cost of billion-dollar weather and climate disaster events per year (NOAA National Centers for Environmental Information (NCEI) U.S. Billion-Dollar Weather and Climate Disasters, 2019 <https://www.ncdc.noaa.gov/billions/>).

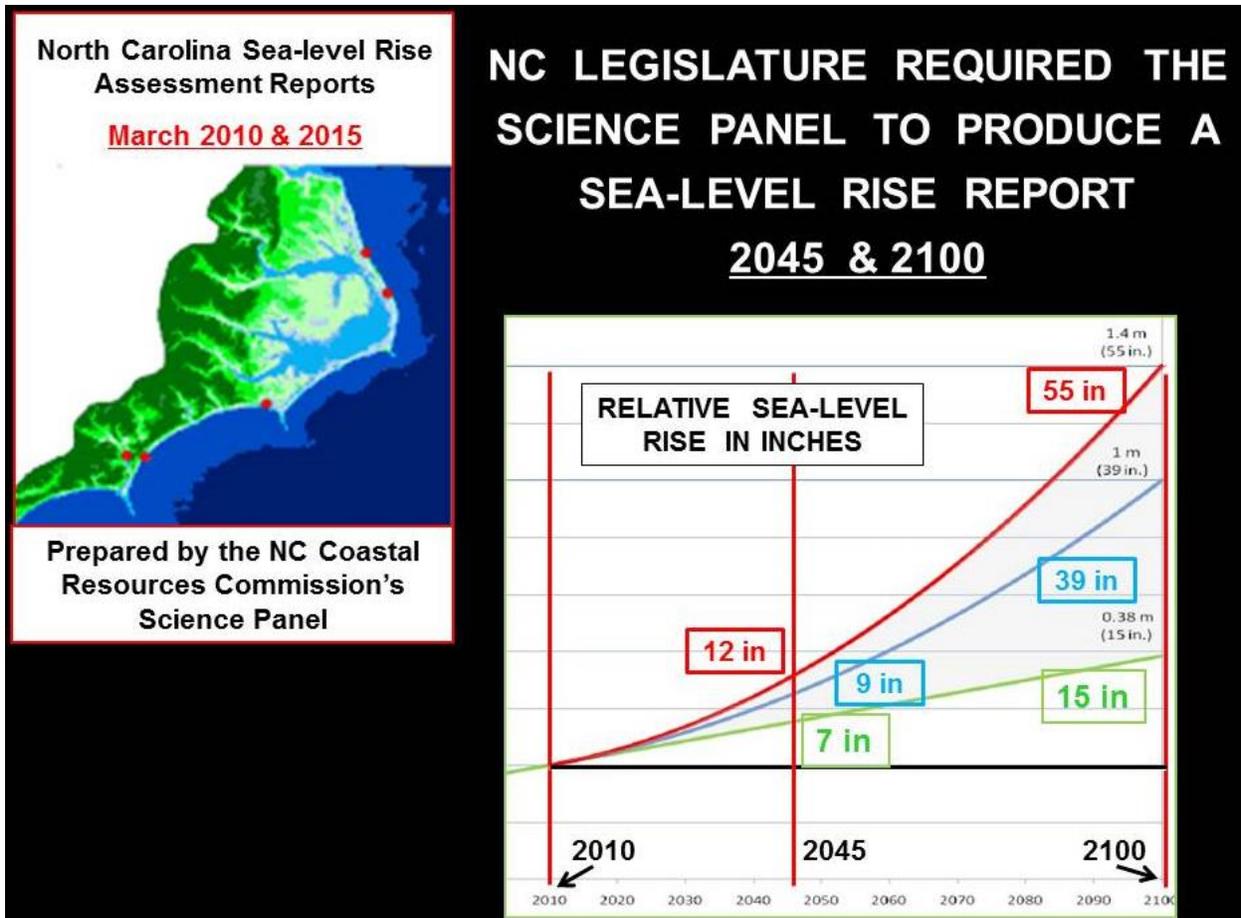
FIGURE 5-8. Projected rates of sea-level rise published in the 2010 and 2015 NC legislative reports by the NC Science Panel. The projections of sea level rise in NC were for the years 2045 and 2100, respectively (blue line). The error bars are in red and green. These projections are based on tide gage data going back to the early 20th century.

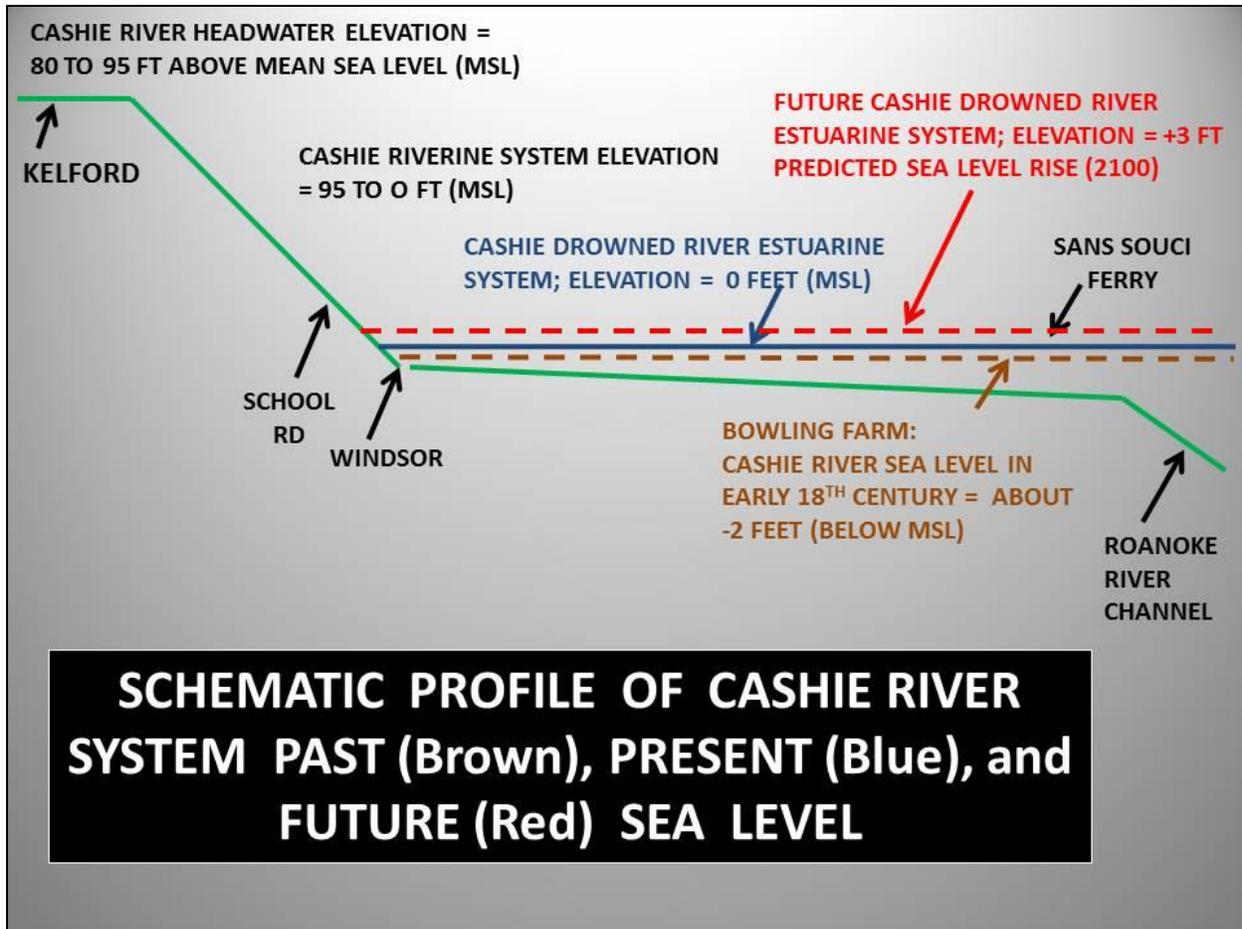
FIGURE 5-9. A schematic cross section shows the upper Cashie River gradients from the top of the Wicomoco Terrace at Kelford, across the Talbot Terrace to sea level at Windsor. The lower Cashie River from Windsor to Albemarle Sound is today at sea level and carries all of the wind tide and astronomical tide signals of Albemarle Sound, as well as evidence of past (brown) and future (red) sea level rise since the early 18th century and projected to 2100. MSL is the present mean sea level.
