FLOOD DYNAMICS IN THE BERTIE WATER CRESCENT

INTEGRATING THE DYNAMICS OF COMPLEX DRAINAGE
SYSTEMS TO MINIMIZE STORM IMPACTS AND MAXIMIZE
AQUATIC ENVIRONMENT VIABILITY, BERTIE COUNTY, NC

NORTH CAROLINA LAND OF WATER (NC LOW)

August 20, 2019

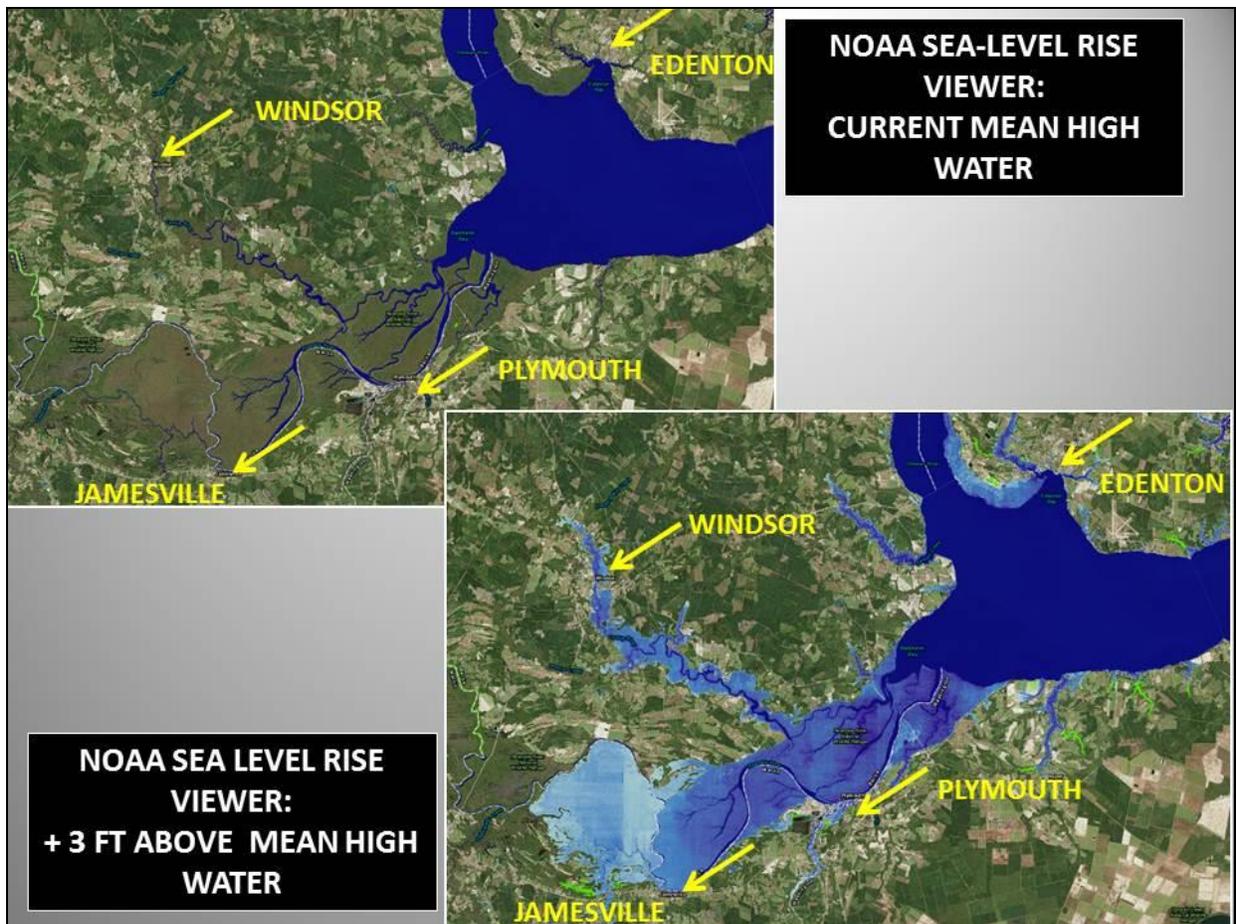
FIGURE 5-10. Aerial photographs from NOAA's "Sea Level Rise Viewer" shows 4 villages located at the water's edge under present sea level conditions. The lower panel raises sea level by 3 feet above today's mean water level. The medium to lite blue colors represent the present wetland and low upland that will be permanently flooded. The real problem for the four villages comes when there is a storm tide or rainfall flood on top of this higher water level.

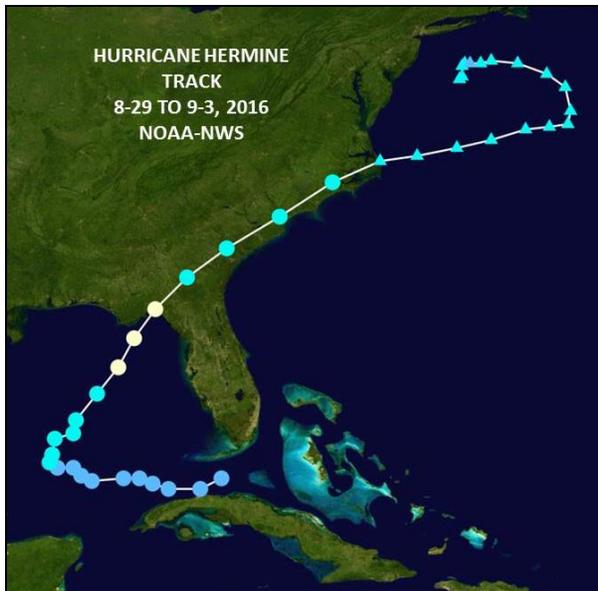
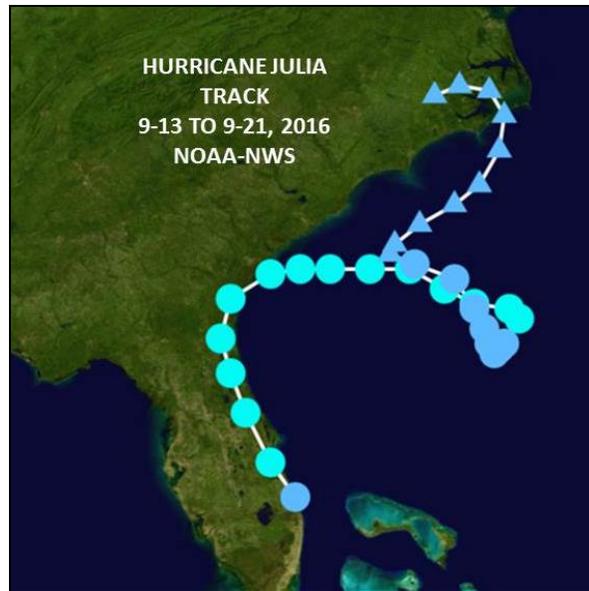
FIGURE 6-9. Storm tracks show the first two tropical storms, *Hermine* (left panel) and *Julia* (right panel), to impact Bertie County flooding in the fall of 2016. The circles represent the hurricane designation categories 1-5 and the triangles represent tropical storm designation. The maps are from NOAA's Nation Weather Service.

On September 2, 2016, Hurricane Hermine was downgraded to a tropical storm as it traveled NE through coastal NC (Figures 6-8 and 6-9). It was a fast moving storm as it passed over the Albemarle Peninsula and the Outer Banks north of Cape Hatteras with sustained tropical storm-force winds and heavy rainfalls, 6 inches of rain was recorded in the Jamesville area. This storm produced a 2.5 ft. storm surge in western Albemarle Sound, but because of its track and rate of travel, there was no following storm surge on the backside of the Outer Banks (Figure 6-11). But the rains did fill the river systems of eastern NC.

Hermine was followed on September 15, 2016 by Hurricane Julia which passed east offshore of Georgia, drifted erratically offshore and finally turned back the NW towards Charleston (Figures 6-8 and 6-9). As it approached the coast the hurricane was downgraded to a tropical storm, turned NE and slowly curved to the west and came ashore in the vicinity of Ocracoke Inlet as a slow moving tropical storm. Its western track along the Albemarle Peninsula resulted in a 2 foot storm surge in western Albemarle Sound along with severe rainfalls of up to 12 inches or more throughout Bertie region. The combination of Albemarle wind set up, heavy rains, and an already full river system, led to a catastrophic flood in Windsor with over 14 ft crest at School Rd. (Figure 6-11). The Windsor King St. gage was not functioning during either Hermine or Julia. Because of the westerly track along the Albemarle Peninsula, there was no following storm surge on the back side of the Outer Banks.

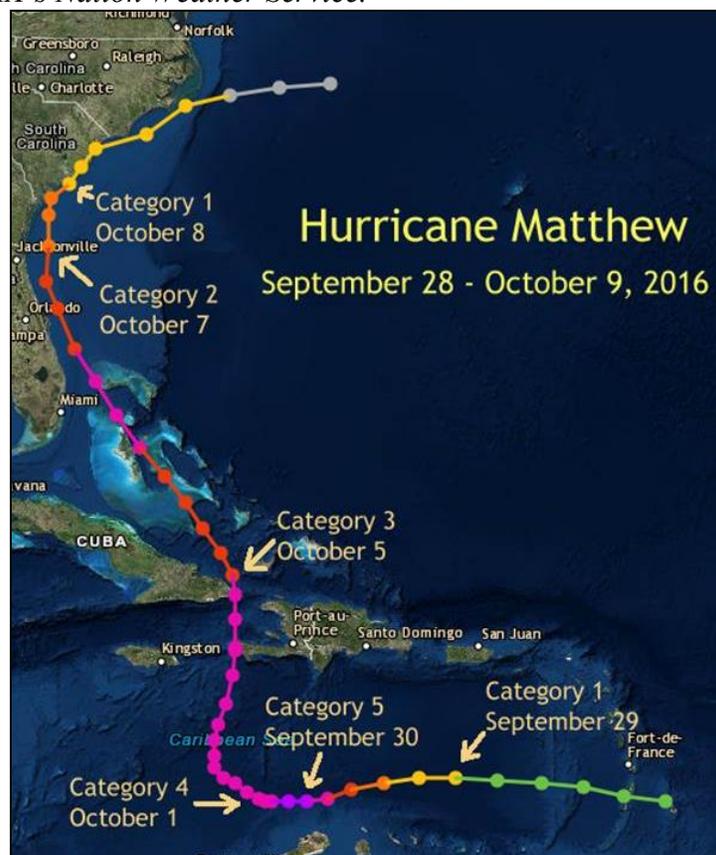
FIGURE 6-10. Storm track for the third tropical storm, *Matthew*, to impact the Bertie County flooding in October 2016. The map is from NOAA's Nation Weather Service.

The Bertie County region had already received up to a 1.5 feet of rain when the third storm came along. On October 8, 2016 Hurricane Matthew after making landfall in South Carolina as a category 2 storm, moved offshore and tracked NE hugging the NC coast as a category 1 storm (Figures 6-8 and 6-10). The storm track was shore parallel towards Cape Lookout where it turned more easterly leaving the Outer Banks. The large size of Matthew caused a 3.5 foot storm tide in western Albemarle Sound (Figure 6-11) and torrential rains that were up to 15.65 inches in the Cape Fear River and up to 10 inches in the Bertie County region. Wilmington set a new storm tide record at 3.53 feet beating the previous record of 3.47 feet set during Hurricane Hazel on October 15, 1954. The consequence of the third major event in 1.5 months was another catastrophic flood in Windsor with the flood crest at School Rd. of 16.63 feet and a crest at King St. of 12 feet on the Cashie River gages (Figure 6-11).

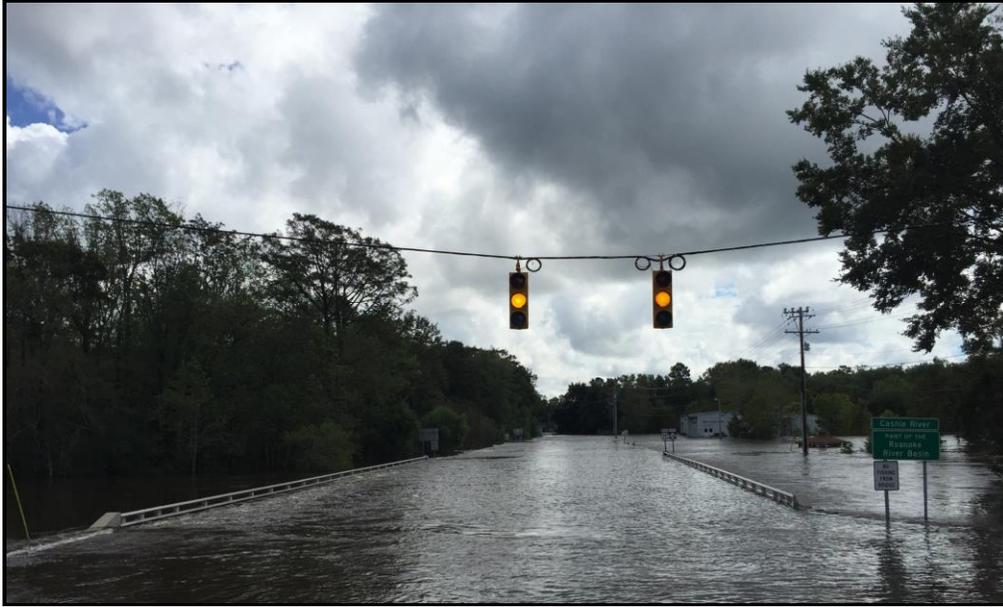
FIGURE 6-13. Photograph of the Cashie River flood waters on the King Street Bridge in the Town of Windsor as a result of Hurricane Matthew on October 10, 2016. The water level gage on this bridge crested at 12 feet. Photograph is by S. Sauer.

The net rainfall for the period from Sept. 1 through Oct. 15 was overwhelming for the region with Williamston recording 27.33 inches (Figure 12). The total rainfall for the entire Bertie region for all of 2016 ranged between 12 to 24 inches above normal. The amount of rain from three storms alone would have caused flooding of the Cashie River, but it would not have been as severe without the cumulative impact of full river/groundwater systems, major storm surges and wind setup on Albemarle Sound, and changing land use buffer zones. The catastrophic impact of these three tropical storms defined the lowest portions of downtown Windsor, which are essentially in the Cashie River floodplain (Figures 6-13 and 6-14).

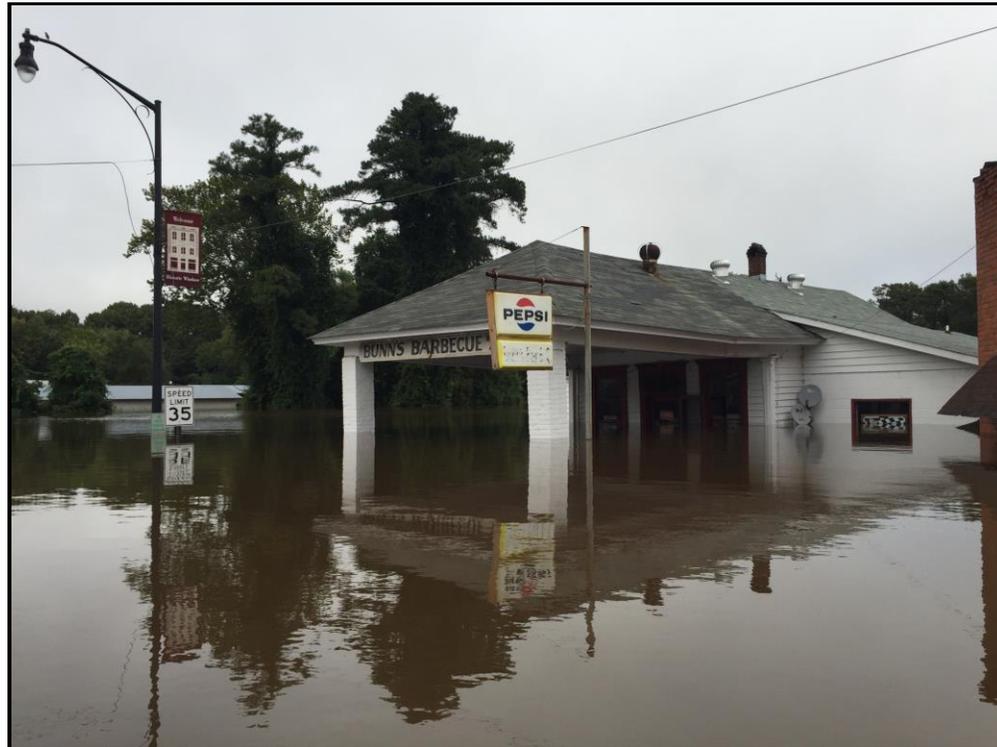
FIGURE 6-14. Photograph of the Cashie River flood waters on King Street in the lowest portion of King Street in downtown Windsor as a result of Hurricane Matthew on October 10, 2016. Photograph is by S. Sauer.

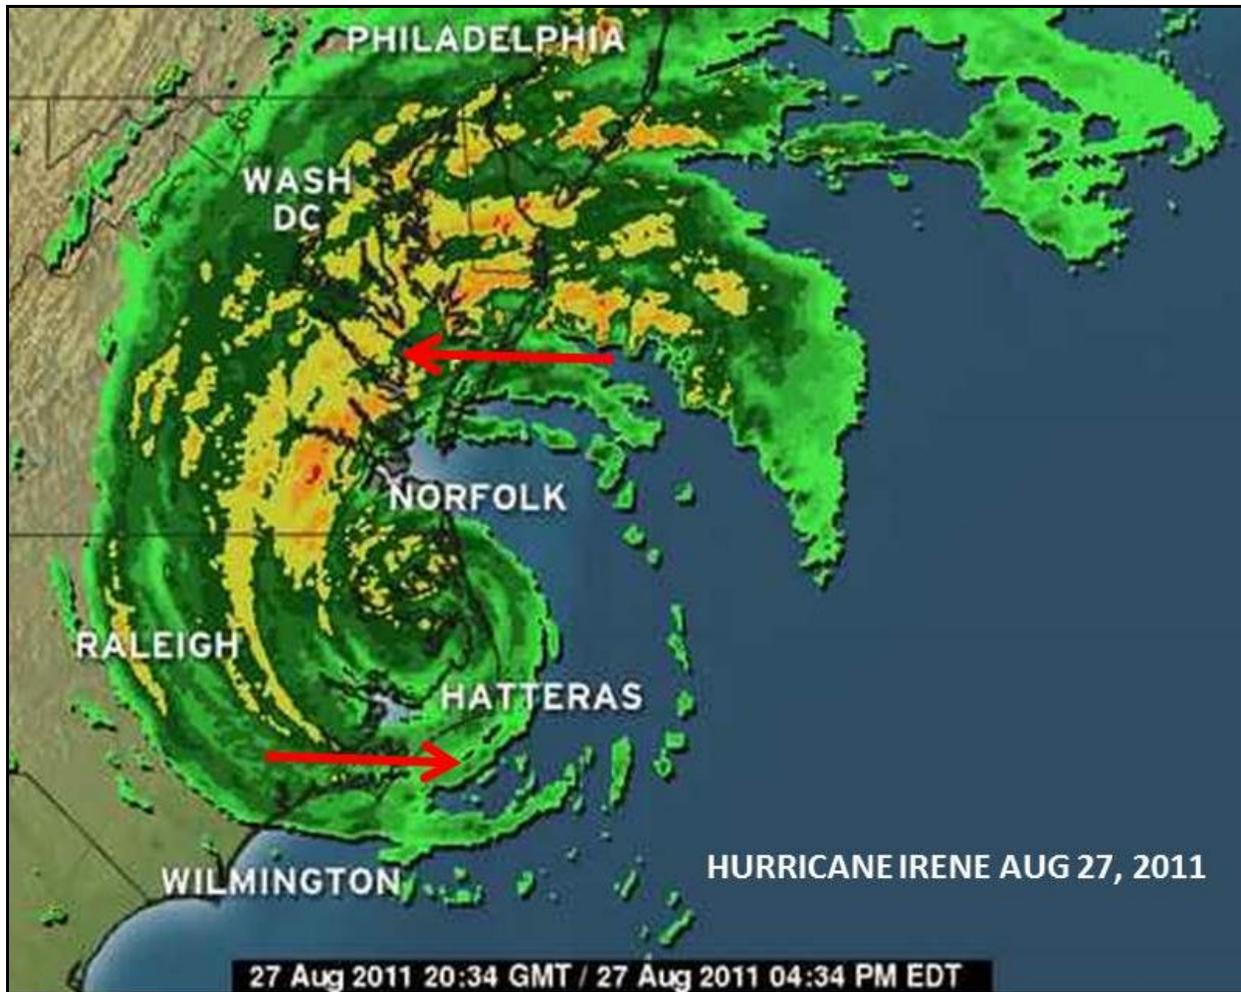
FIGURE 6-16. Satellite image of Hurricane Irene on August 27, 2011 as it traveled north over the Albemarle Peninsula and Albemarle Sound. The red arrows show how the leading winds blew a major storm surge to the western side of Albemarle Sound and the following winds blew the storm surge eastward to impact the backside of the Outer Banks. NASA satellite image.

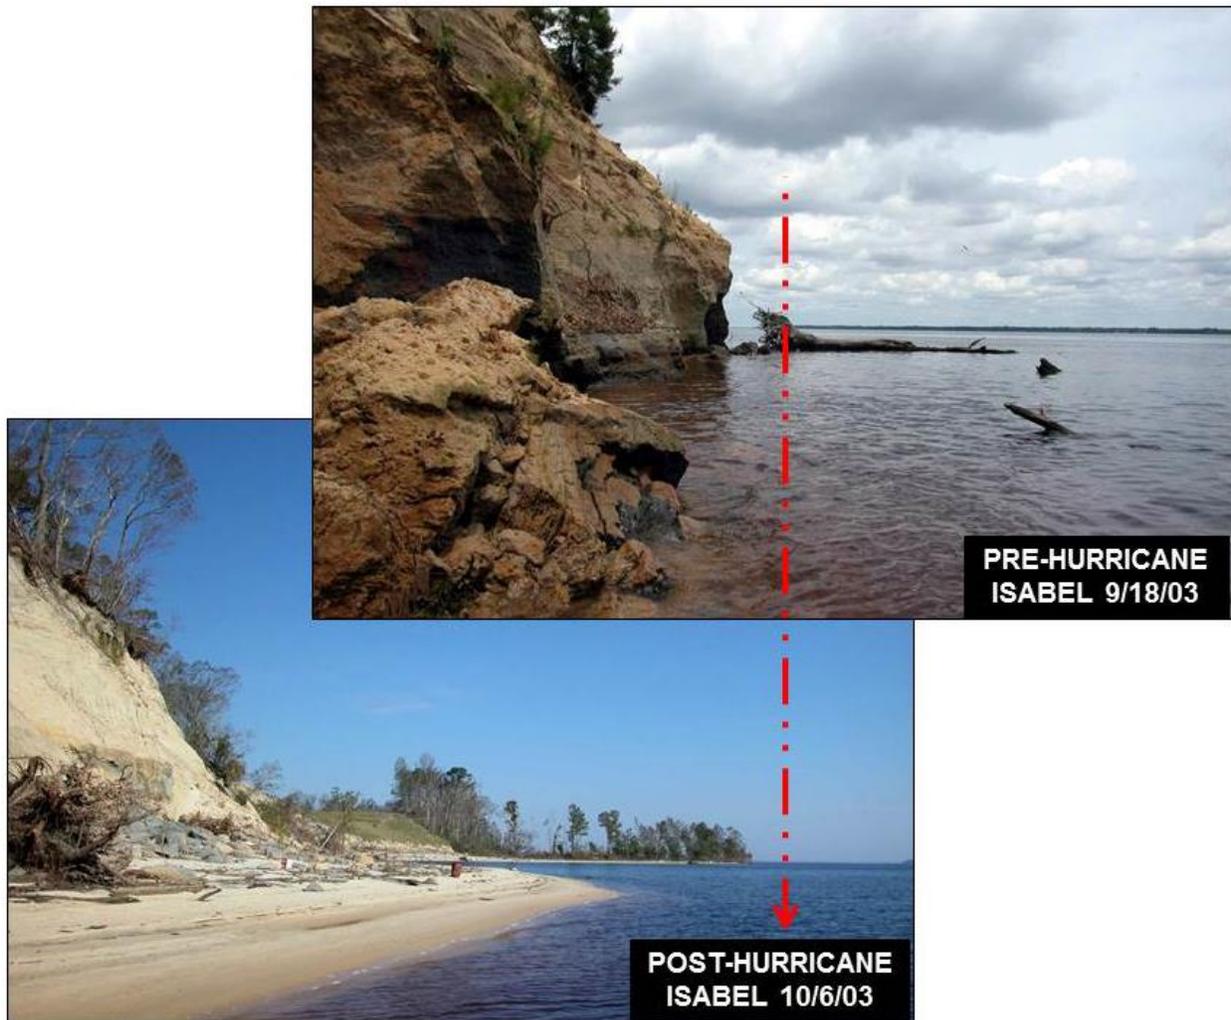
FIGURE 6-22. A pair of photographs of the Chowan River Bluff at Bull Pond before (top) and after (bottom) Hurricane Isabel passed just a few miles west of this location. In a few hours the fast moving storm produced a storm surge up to about 10 to 12 feet against the Chowan River bluffs. With wind gusts up to 100 mph, the waves caused up to 50 feet or more of shoreline erosion of the high sediment bluff shorelines and flooded the low-lying houses. Notice most of the tight gray clay layer has been eroded away leaving large clay boulders on a broad sandy beach. The red line shows the approximate pre-storm location of the shoreline. Photographs are from Riggs and Ames (2003).

Hurricane Isabel made landfall on Core Banks of the Cape Lookout National Seashore as a category 2 storm at noon on September 18, 2003 (Figure 6-19). The eye of the storm tracked NW rapidly across southern Pamlico Sound, inner portion of the Albemarle Peninsula, and then traveled through Bertie County with the eye generally following NC Hwy 45. The fast moving storm dropped 4 to 7 inches of rain, but it wasn't the rain that caused the problems in NC. Rather the strong storm surges on Pamlico and Albemarle Sounds in response to 75 to 100 mph winds caused the major damage. As the storm moved across the Inner Banks, the counter-clockwise rotation was predicted by NOAA to produce storm surges of 4 to 10 feet up the Neuse and Pamlico Rivers, and only 4 to 6 feet up the western Albemarle Sound (Figure 6-20). However, based on visual observations by Bertie County citizens, the 75 mph winds and 100 mph gusts actually produced up to 10 to 12 foot storm surges along the western shores of Albemarle Sound and the Chowan River Estuary resulting in severe shoreline erosion and flooding of low-lying structures (Figures 6-21, 6-22, and 6-23).

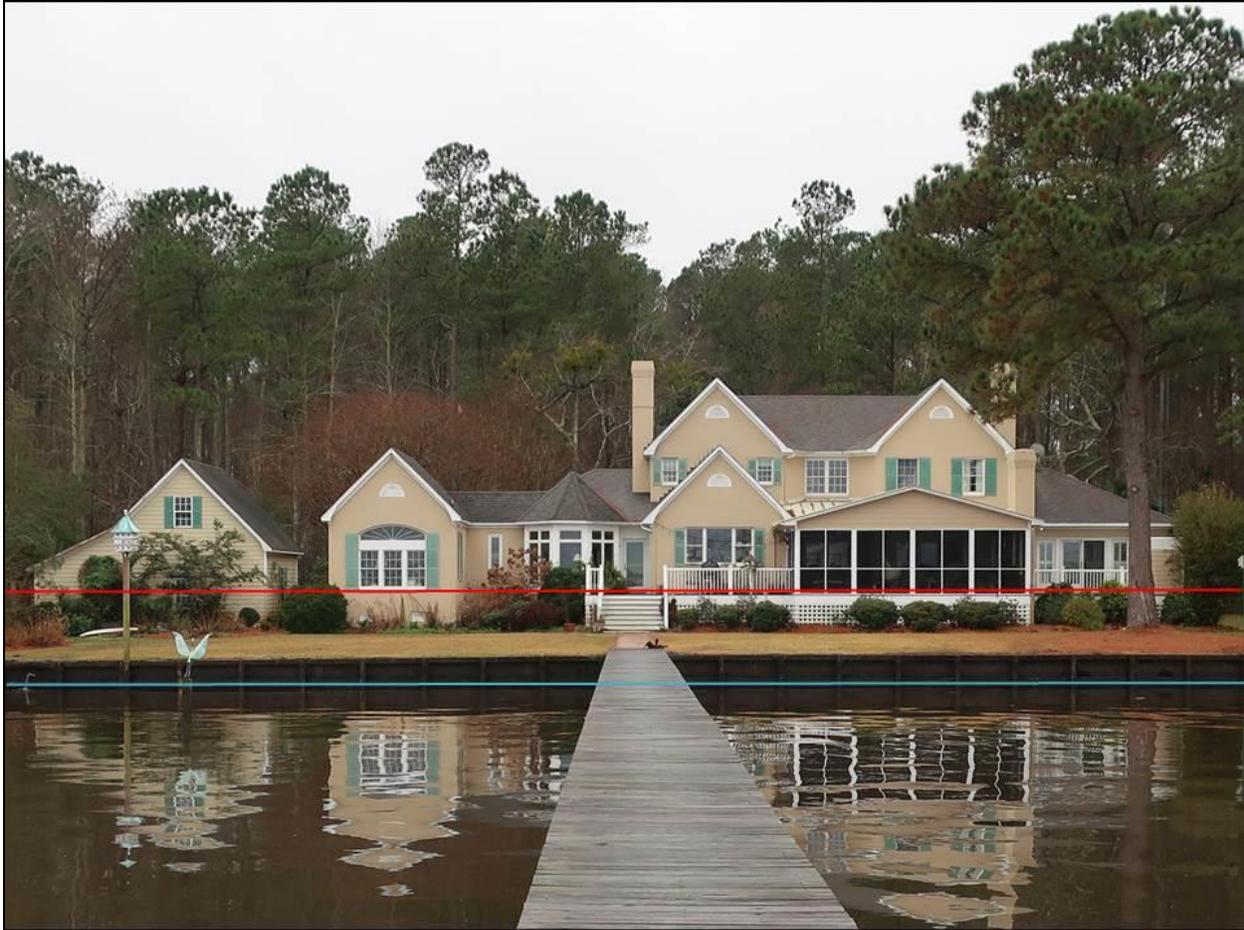
FIGURE 6-23. This house, located on the Chowan River in Colerain, was severely impacted by Hurricane Isabel on September 18, 2003. The red line shows the level of Hurricane Isabel storm surge that was between 9 to 11 feet above mean water level at the base of a wooden bulkhead (blue line). The garage on the left was floated away, windows were broken out, wave driven water flooded the first floor, and the dock floated up against and scoured the large pine tree on the right. Photograph is by S. Riggs.

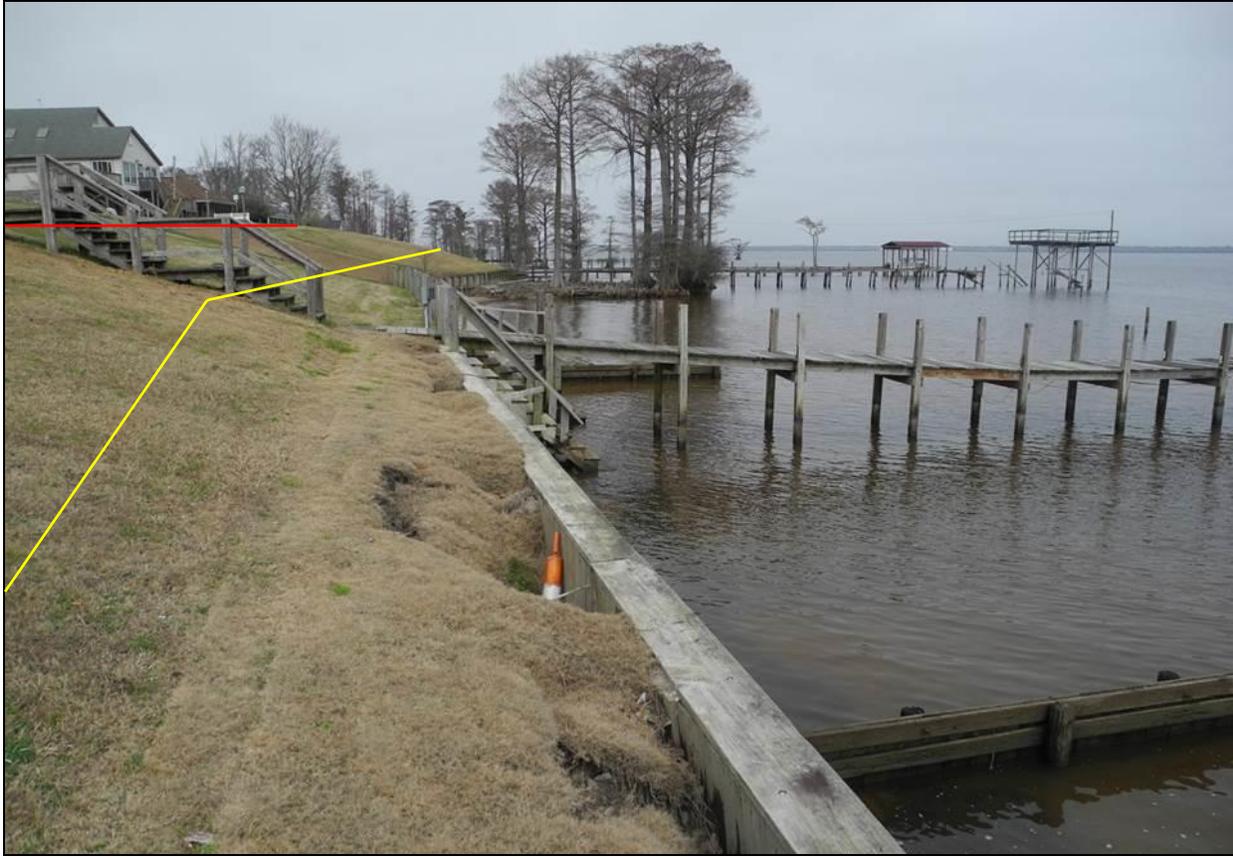
FIGURE 6-24. Photograph of the severely modified Talbot Terrace shoreline (about 30 feet high) at the west end of Albemarle Sound where frequent storm surges up to 5 feet and occasional surges up to about 12 feet above sea level impact the shoreline (e.g., yellow line = approximate level of Hurricane Isabel). After Hurricane Isabel the eroded vertical bluff shoreline was located approximately where the red line occurs. Following the hurricane, a large volume of infill dirt was dumped, the shoreline was bulldozed back into Albemarle Sound, and bulk-headed. The bulk-head frequently fails in response to common smaller storm surges. Also, notice that there is no sandy beach due to the elimination of the eroding bluff, which was the source of the beach sand. Notice the natural cypress headland at the northern edge of the bulk-head. Photograph is by S. Riggs.

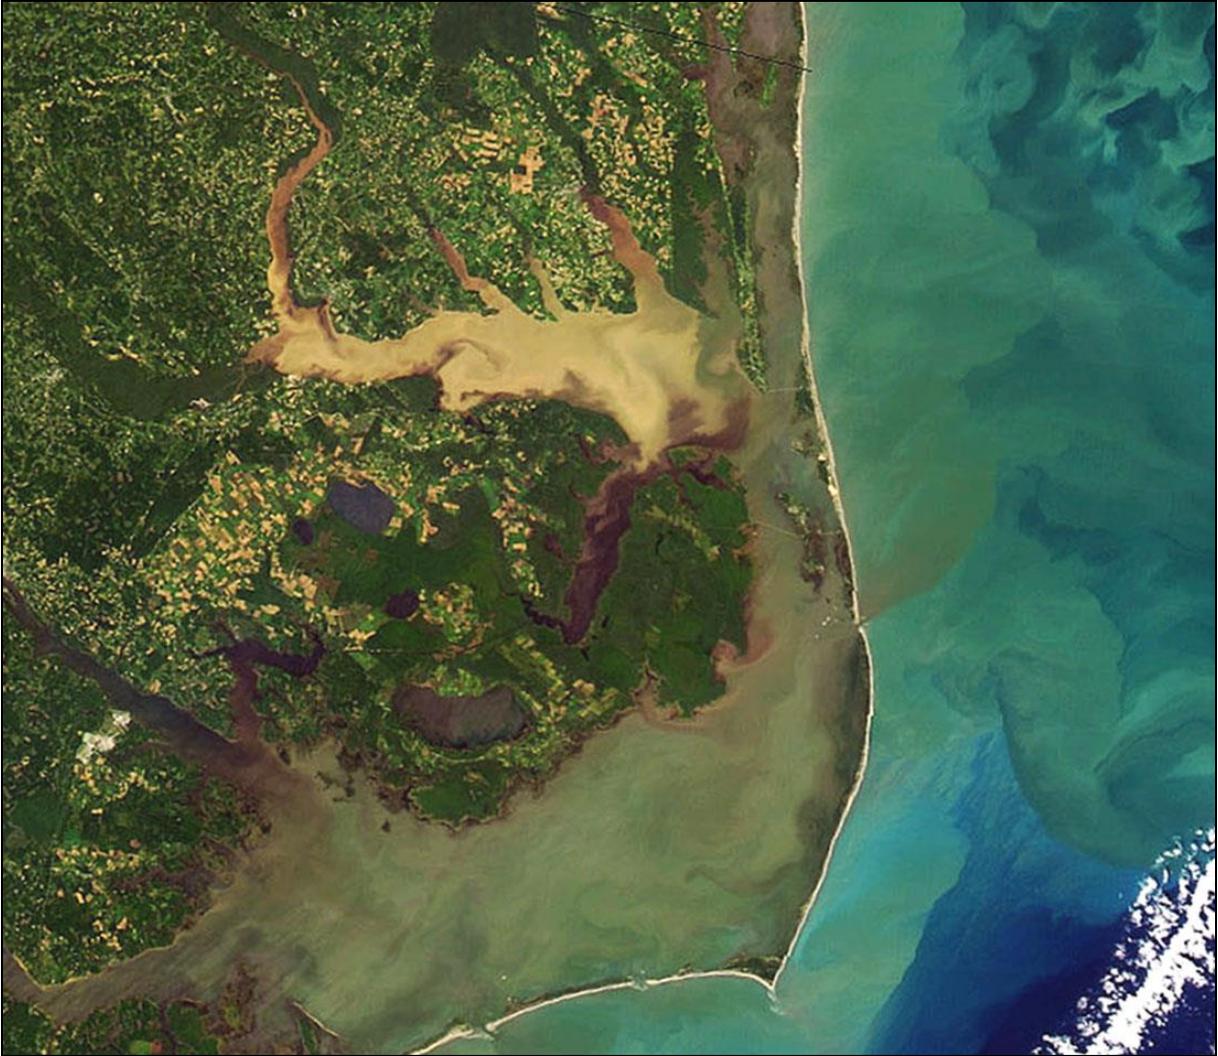
FIGURE 6-25. A post-Hurricane Isabel (September 19, 2003) satellite image of northeastern North Carolina shows the incredible load of suspended sediment in the waters of Albemarle Sound and its tributaries. The severe storm surge caused massive erosion of sediment bank shorelines along the western Albemarle Sound and Chowan River as a direct result of the counter-clockwise wind flow that produced a 9 to 11 foot storm surge as the storm approached Bertie County. As the storm moved into Virginia the west winds blew the sediment-laden, storm surge waters eastward flooding the sound-side of the Outer Banks. Satellite image is from MODIS Image Gallery, Space Science and Engineering Center, University of Wisconsin, Madison, WI.

The fast moving Isabel decreased to a tropical storm as in entered Virginia that evening with the backflow of the counter-clockwise circulation blowing the water out of the Chowan and western Albermarle. This 180 degree shift in wind resulted in severe storm-surge flooding and destruction on the sound-side of Kitty Hawk on the Outer Banks. This rapid wind change probably caused the southerly and easterly winds on the back side of the storm to blow out the Cashie River allowing the rain runoff that followed to cause minimal flooding. Satellite imagery on the following, clear-sky day (September 19, 2003) shows the incredible amount of eroded sediment suspended in the waters of Albemarle Sound and associated tributary estuaries (Figure 6-25).

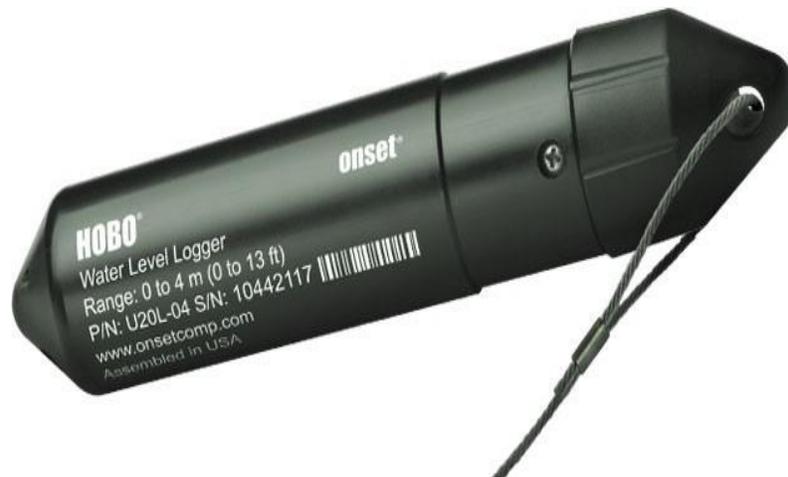
FIGURE 7-2. Picture of the HOBO Water-Level Logger utilized at four sites in this report.

HOBO data loggers measure pressure and use the measurements to convert to depth of water. The under-water HOBO component measures the combination of atmospheric pressure, hydrostatic pressure, and water temperature. A separate HOBO component placed at the top of the PVC pipe or somewhere in the air in a nearby location to measure only atmospheric pressure. Software subtracts the atmospheric pressure from the combined pressure to derive hydrostatic pressure. Hydrostatic pressure is calibrated to water depth measured at the time of downloading data. The five underwater HOBOS were mounted within a 2 inch PVC pipe that was attached to a pier piling or driven into the creek bottom. The HOBO's were set at a measurement interval of 5 minutes with a field data download time of about six weeks. One water level recorder mounted on a pier at Bal Gra at the west end of Albemarle Sound was lost during Hurricane Florence. The other four recorders listed above worked perfectly through the time of this final report and provided data utilized in combination with the other pre-existing water level gauges (listed above) for this report.

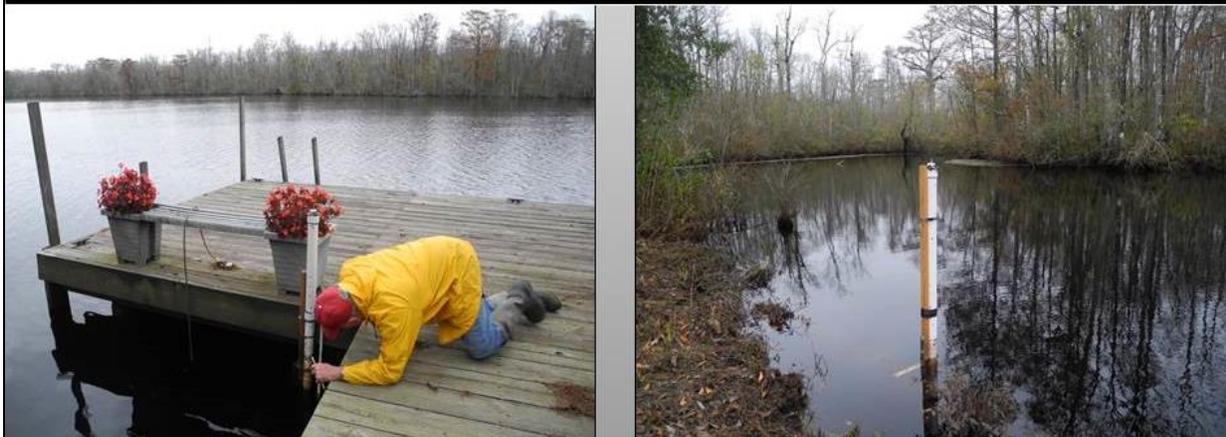
INSTALLING HOBOS AT SALMON CREEK, COLRAIN, LOWER CASHIE RIVER, & ROQUIST CREEK

FIGURE 7-3. Bob Christian and Bo Dame install HOBOS water level recorders at Salmon Creek State Natural Area (upper left), Colerain on the Lower Chowan River estuary (upper right), Bowling Farm on the Lower Cashie River, and east end of Roquist Creek. Photographs are by S. Riggs.
